# Vehicle Surge Between 40 and 50 mph

**Service Category** Drivetrain

**Section** Automatic Transmission/Transaxle

YEAR(S)	MODEL(S)	ADDITIONAL INFORMATION
2016 - 2018	Tacoma	WMI(s): 3TM, 5YF VDS(s): AZ5CN, BZ5DN, CZ5AN, DZ5BN, EZ5CN, GZ5AN, HZ5BN, RZ5CN, SZ5AN Engine(s): 2GR Transmission(s): 6AT

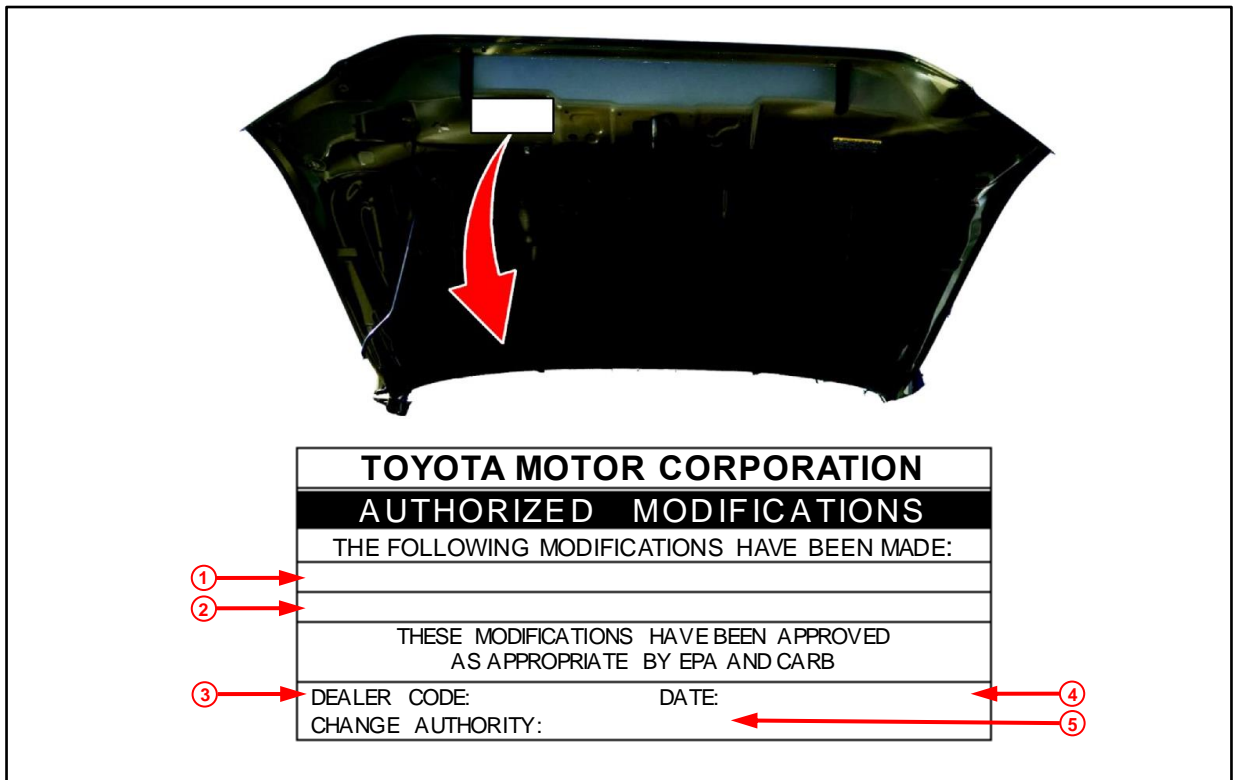
**Figure 1. Location of Authorized Modifications Label for 2016 – 2018 Tacoma**

<b>1</b>	<b>Replacement ECM (PCM) Part Number (e.g., 89661-04K54)</b>
<b>2</b>	<b>New Calibration ID (e.g., 8966304B0400)</b>
<b>3</b>	<b>Dealer Code</b>

<b>4</b>	<b>Date Completed</b>
<b>5</b>	<b>This SB Number</b>

2. Check for the Authorized Modifications Label affixed to the vehicle in the location shown below. Confirm if the ECM (PCM) calibration has been updated.  
Is the calibration ID listed the latest ECM (PCM) calibration?
  - **YES** — This bulletin does NOT apply. Continue diagnosis using the applicable Repair Manual.
  - **NO** — Continue to step 3.

- Prepare and install the Authorized Modifications Label.
  - Using a permanent marker, enter the following information on the label:
    - ECM part number [*Refer to the **Parts Information** section for the **NEW PART NUMBER***]
    - Calibration ID(s) [*Refer to the **Calibration Information** section for the **NEW CALIBRATION ID***]
    - Dealer Code
    - Repair Date
    - Change Authority [***This bulletin number***]
  - Install the Authorized Modifications Label on the vehicle at the location shown in Figure 1. The Authorized Modifications Label is available through the MDC, P/N 00451-00001-LBL.
- Start the engine and warm it up to normal operating temperature.
- Test-drive the vehicle to confirm proper vehicle operation.
