Technical Service Bulletin

**CLUNKING NOISE FROM FRONT SUSPENSION WHEN DRIVING
OVER BUMPS**

Bulletin No.: 02-012/18

APPLICABLE MODEL(S)/VINS

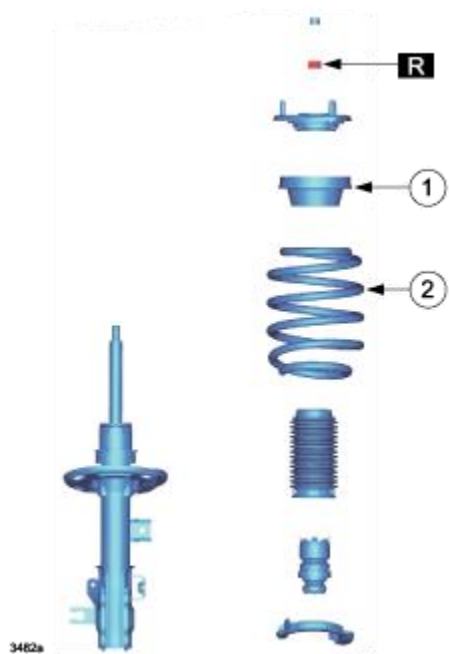
Some vehicles may exhibit a clunking noise from the front coil springs when driving over bumps. The noise is due to stick-slip between the front strut bearing (1) and the coil spring (2).

To eliminate the noise, protectors have been installed onto the coil spring.
