Technical Service Bulletin

Subject: TRUNK BOARD STRAP COVER CRACKED / BROKEN	Bulletin No.: 09-027/18
	Last Issued: 06/01/2018

2017 CX-5 vehicles with VINs lower than JM3KF*****133707 (produced before April 11, 2017)

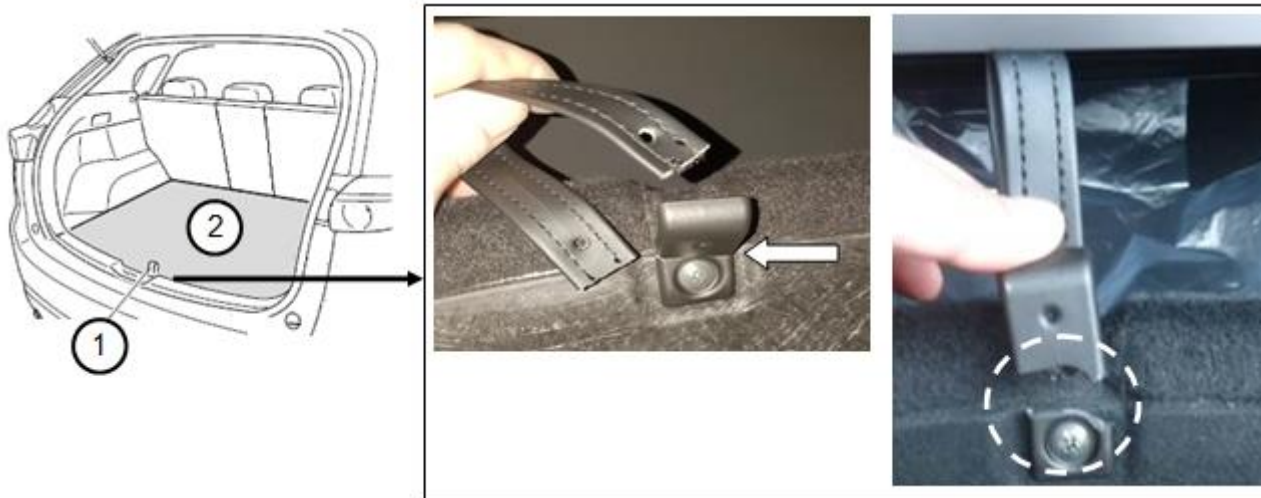
Some vehicles may have a broken trunk board (2) strap (1). This may be caused by insufficient strap cover strength. To eliminate this concern, the material of the strap cover has been changed to increase the strength.

CRACKED COVER

BROKEN COVER

1. Verify the customer concern.
2. Replace the strap (1), cover (2) and bolt (3) with new ones.
