Subject: SCRATCH ON SEAT BACK BAR GARNISH FROM CONTACT WITH CONVERTIBLE TOP	Bulletin No.: 09-028/18
	Last Issued: 06/21/2018

2016-2018 MX-5

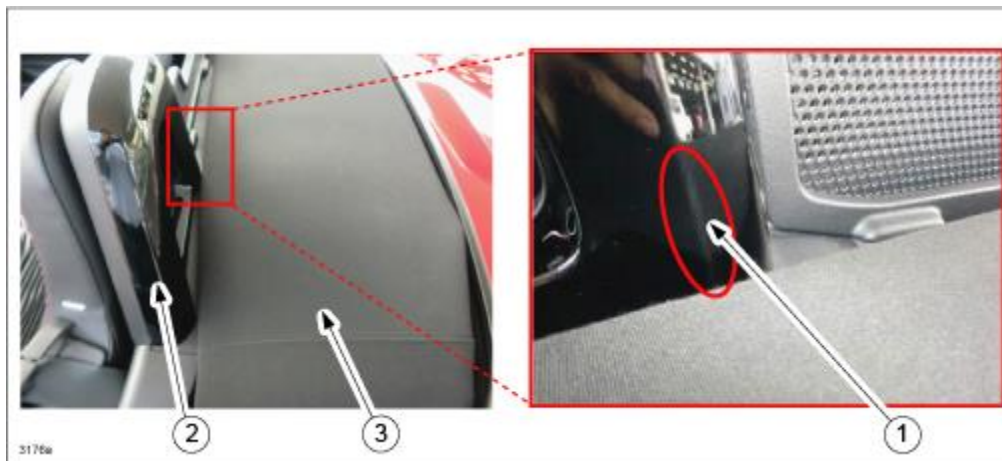
Some vehicles may exhibit scratches (1) on the rear of the seat back bar garnish (2) from contact with the convertible top (3).

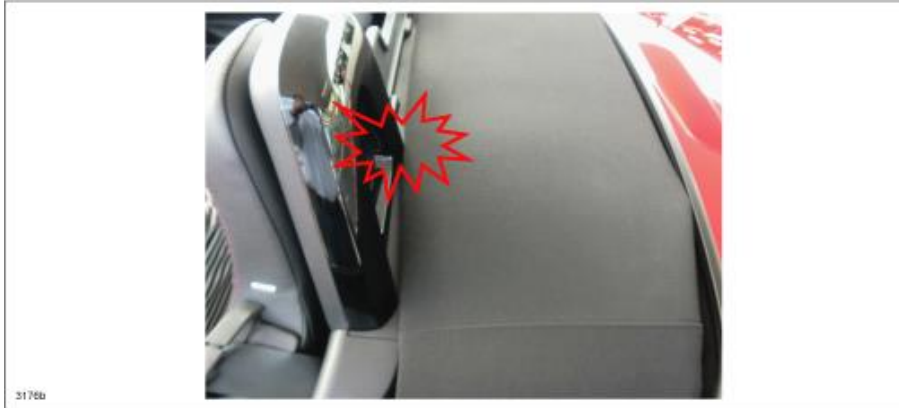
Due to assembly variations, the clearance between the seat back bar garnish and the convertible top is too small on some vehicles.

On later 2016 models (starting with VINs JM1ND*****117681), the link stopper of the convertible top has been changed to adjust the opening angle and folding position of the convertible top. This increased the gap between the seat back bar garnish and the convertible top when folded down. On these later models, the issue seems to occur if the customer does not completely lock the convertible top down when lowered.

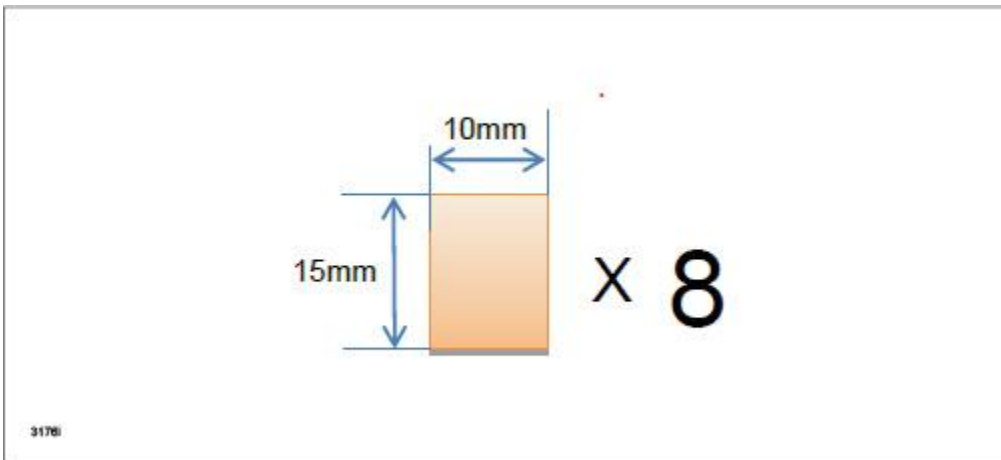
NOTE: The holes may be damaged when removing the metal fasteners of the back trim from the square holes of the seat back crossmember. A loose fit of these fasteners could cause a creak noise.

a. Select a 0.25 mm thickness fabric sheet from the "Noise Repair Kit" (TA01-76-100) and cut out 8 equal squares 15mm x 10mm.
