Technical Service Bulletin

POPPING AND/OR SQUEAKING NOISE FROM FRONT SHOCK ABSORBER AND/OR CREAKING NOISE FROM FRONT LOWER ARM BUSHING Bulletin No.: 02-001/18

Last Issued: 07/13/2018

2014-2018 Mazda3 vehicles (Japan built and Mexico built) with VINs starting with JM1 and 3MZ

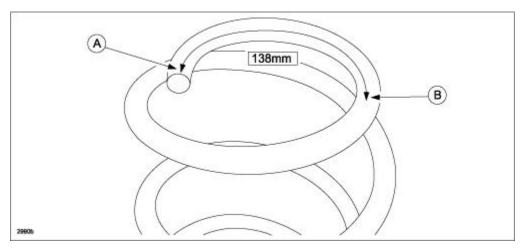
- 3. Remove the spring according to the online instructions on MGSS (FRONT SHOCK ABSORBER AND COIL SPRING DISASSEMBLY/ASSEMBLY).
- 4. Degrease 1.5 turns of the spring from the top.
- 5. Cut a thin strip of paper to 138 mm in length (or use a cloth type measuring tape).
- 6. Place the strip of paper (or cloth measuring tape) along the inner side of the coil spring starting at point (A) and mark the spot on the spring where (B) is. (B) is the starting point for the protector installation.
