Technical Service Bulletin

CRACK ON FRONT SHOCK ABSORBER DUST BOOT

Bulletin No.: 02-013/18

Last Issued: 07/13/2018

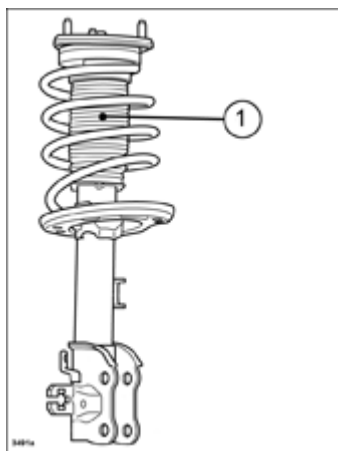
Some vehicles may exhibit a crack on the front shock absorber dust boot (1). This may be caused by the dust boot having insufficient resistance to the cold. The shape and material of the dust boot has been changed to improve its resistance to cold.

Customers having this concern should have their vehicle repaired using the following repair procedure.
