Technical Service Bulletin

**SCBS / SBS, LAS / LDWS, MASTER AND/OR HBC WARNING LIGHTS
ON WITH DTC U3000:98 STORED DURING HOT WEATHER**

Bulletin No.: 15-002/18

Last Issued: 07/06/2018

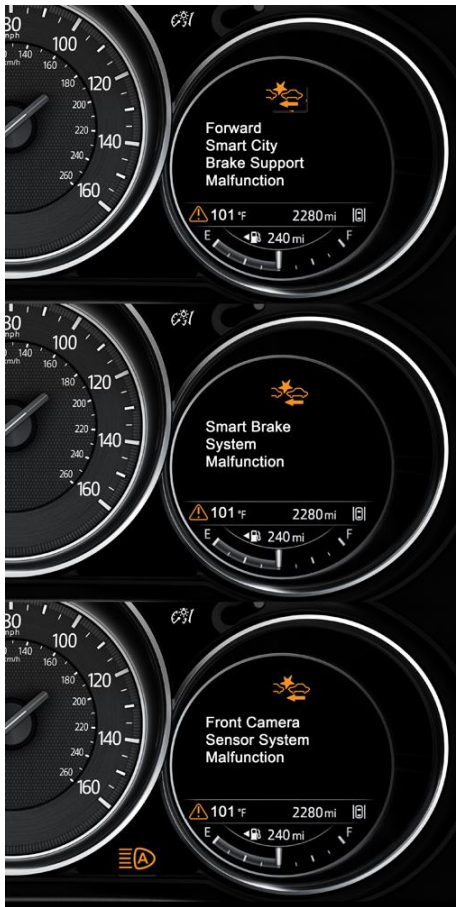
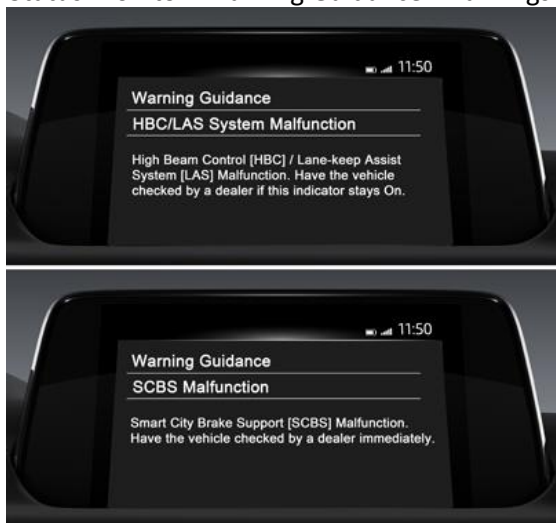
Instrument Cluster Warning Lights (Without Multi-Information Display)	Instrument Cluster Warning Lights and Warning Messages (With Multi-Information Display)	MAZDA CONNECT Warning Messages

This condition may be caused by FSC control logic that is too sensitive. When the FSC detects DTC U3000:98 during high temperature, it stops the internal communication and stores DTC U3000:04. DTC U3000:04 will not clear and SCBS/SBS, LAS/LDWS, and/or HBC functions will not resume until the ignition switch has been turned OFF even if the temperature of the FSC cools.

The warning lights/messages will be displayed until the FSC cools and the ignition is turned OFF, then back ON.

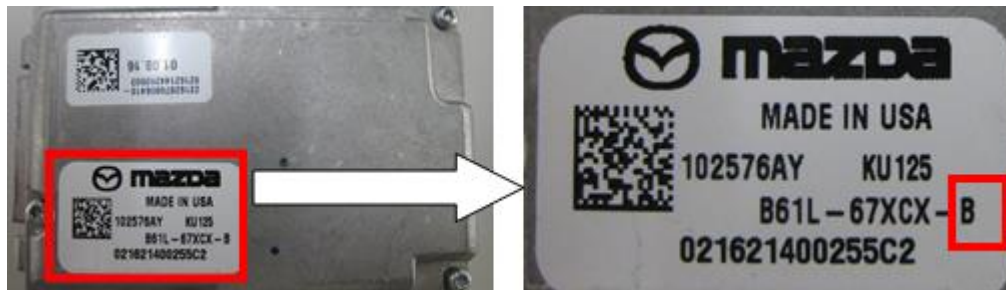
3. Remove the FSC according to the instructions on MGSS (FORWARD SENSING CAMERA (FSC) REMOVAL/INSTALLATION) and check the part number suffix on the label (sample shows suffix "B").

- If the part number suffix is "T" or later, this is the modified part that should NOT be replaced. Go to step 6.
- If the part number suffix is "S" or before, go to next step.

4. Replace the FSC with a modified one according to the instructions on MGSS (FORWARD SENSING CAMERA (FSC) REMOVAL/INSTALLATION).
5. Verify repair.

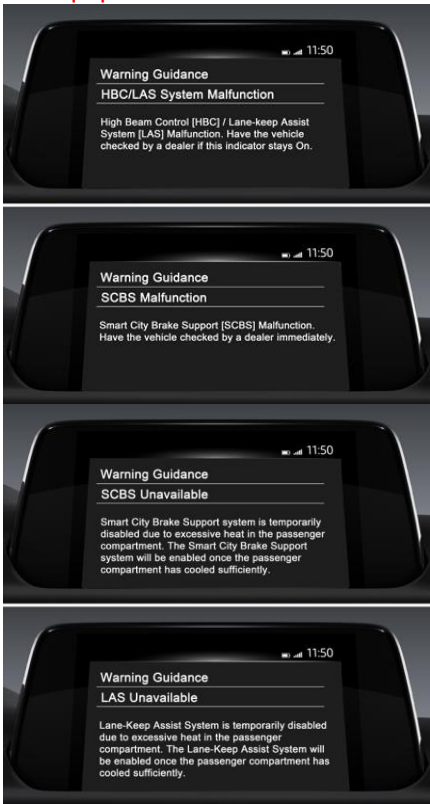
Instrument Cluster Warning Lights (Without MID)	Instrument Cluster Warning Lights and Warning Message (With Multi-Information Display (MID))	MAZDA CONNECT Warning Messages

After FSC Replacement:

The warning lights/messages will be displayed until the FSC cools (No need to turn the ignition OFF).
