Model: USA 2017-2018 RSV4 RR/RF & 2018 Dorsoduro/Shiver 900

Subject: New Instrument cluster calibration- technical update

Campaign Code: PA2ZZQ1801

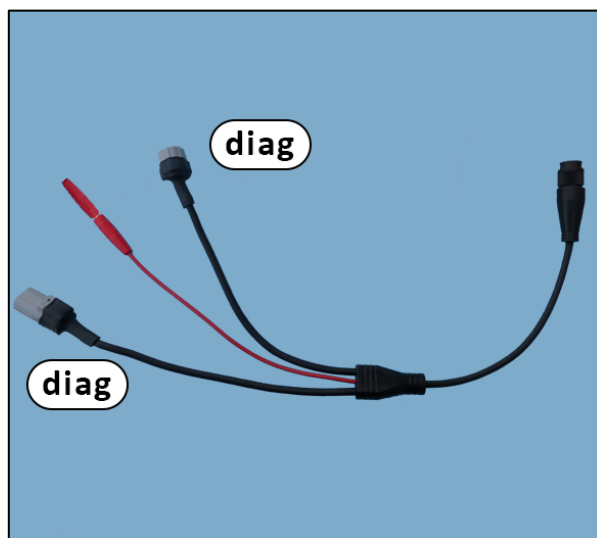
IMPORTANT: The red power feed wire **MUST NOT BE CONNECTED** but only insulated to prevent the risk of short circuiting.

Please note that to update the instrument cluster software for the models in question, you must use the AMP interface cable code 021011Y (which can be purchased as a P.A.D.S. accessory) and update the P.A.D.S. diagnostic tool to the latest available release.
