Re: Load Span Tag Axle – Axle Seat Inspection and Torque Value Verification Procedure

# **H** TECHNICAL BULLETIN

## **Oshkosh: Load Span Tag Axles**

**SUBJECT:** Axle Seat Inspection & Torque Value  
Verification Procedure

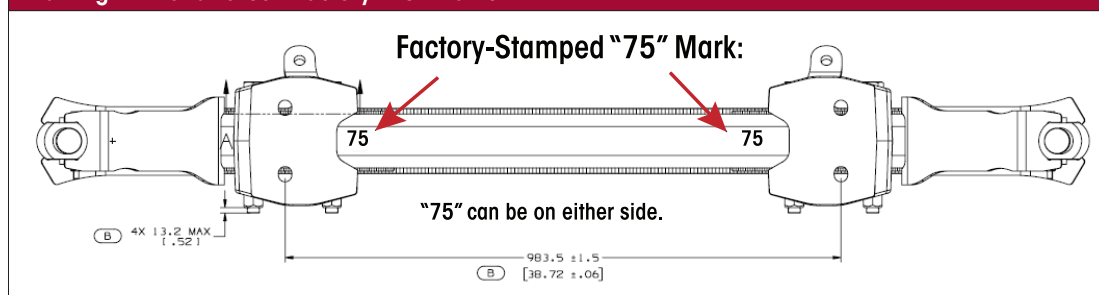
**Drawing-1: Hendrickson Factory "75" Marks**

IF YOUR AXLE HAS A "75" MARK STAMPED ON THE TOP OF THE AXLE BEAM (SEE DRAWING-1 BELOW), YOUR LSTA HAS BEEN PROPERLY TORQUED AT THE FACTORY AND IS NOT AFFECTED BY THE ISSUES COVERED BY THIS HENDRICKSON TECHNICAL BULLETIN.

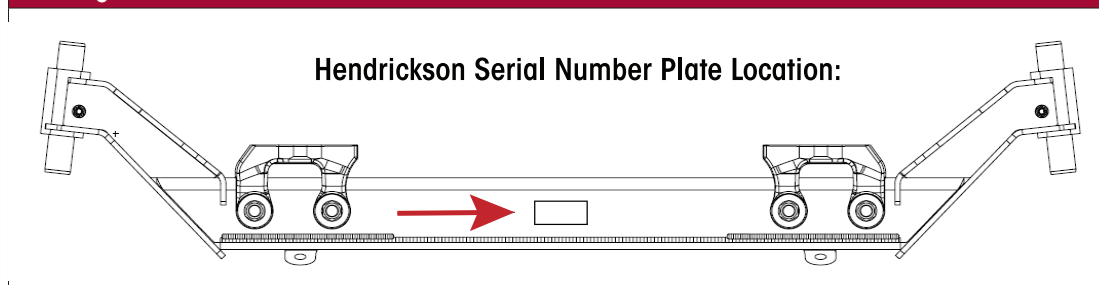
**Drawing-2: Hendrickson Serial Number**

- Your **Oshkosh Date of Manufacture** (of the vehicle for which the LSTA was originally manufactured). The Oshkosh date of manufacture can be found on the driver's door jamb (See Photo-2 on page 4).
- The **Hendrickson Serial Number**, which can be found on a tag on the axle beam as shown below in Drawing-2:

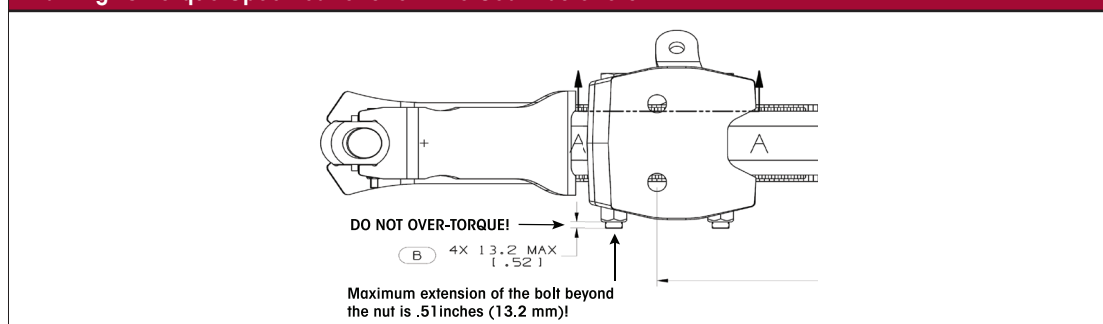
**Drawing–3: Torque Specifications for Axle Seat Fasteners**

**DO NOT OVER–TORQUE THE NUTS! MAKE SURE THAT EACH BOLT DOES NOT EXTEND MORE THAN .52" (13.2 MM) BEYOND THE EDGE OF THE RESPECTIVE NUT (SEE DRAWING–3 BELOW). IF YOU HAVE OVER–TORQUED THE FASTENER, YOU WILL HAVE TO CONTACT HENDRICKSON FOR ADDITIONAL FASTENERS.**

1. Chock the drive wheels of the vehicle.
2. Place the axle on the ground and turn off the truck (This should result in zero pressure being applied to the LSTA assembly).
3. By hand, firmly hold the upper part of the fender mount as referenced in Photo–1 on the page 4. Attempt to "rock" the LSTA back and forth. While rocking the axle, visibly inspect the axle seats for signs of movement relative to the axle beam.
4. If there is no evidence of movement, re-torque the factory-installed axle seat nuts to 500–520 FT–LBS using only a properly calibrated manual torque wrench; do not use an impact driver or other tool to perform final torque of the nuts.

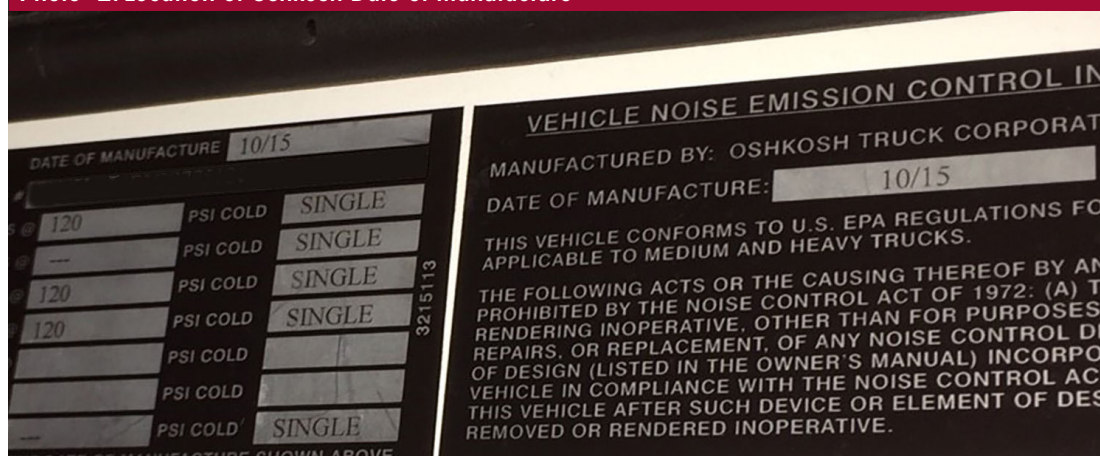
**Photo-2: Location of Oshkosh Date of Manufacture**

5. Provide the Oshkosh Vehicle Identification Number (VIN) and the axle's serial number and note "movement not apparent" to Hendrickson Technical Service. The VIN can be found on the driver–side door jamb (See Photo–2 on page 4).
