Subject: ELECTRICAL CONCERN AND/OR MULTIPLE DTC'S DUE TO AFTERMARKET DEVICE	M-Tips No.: MT-004/18
	Last Issued: 07/20/2018

APPLICABLE MODEL(S)/VINS

2011-2014 Mazda2	2007-2018 Mazda6	2007-2012 CX-7	2007-2011 RX-8
2007-2018 Mazda3	2016-2019 CX-3	2007-2018 CX-9	
2007-2015 Mazda5	2013-2018 CX-5	2007-2019 MX-5

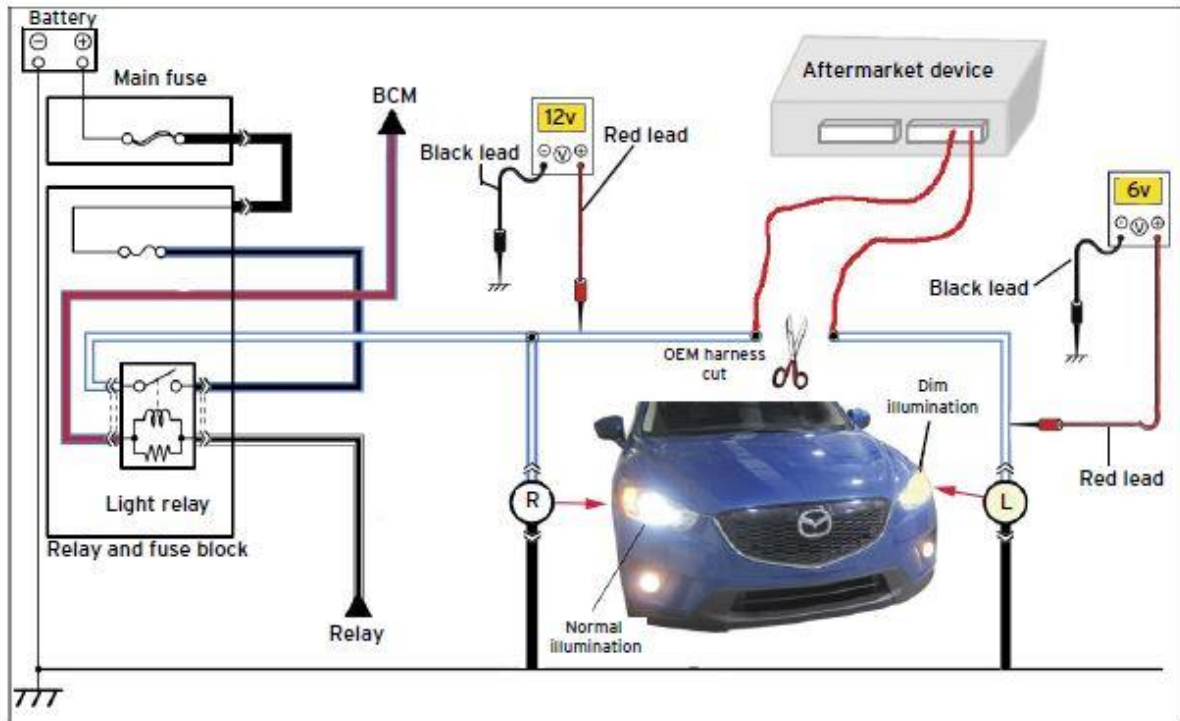
Example 3

Some aftermarket devices that are wired to the vehicles's wiring harness may create unusual electrical symptoms and/or store DTCs. Below is an example of a dim headlight. The aftermarket device changed the headlight circuit resistance, causing a dim headlight.
