<b>Subject:</b> <b>POWER LIFTGATE INOPERATIVE WITH DTC U3003:16</b>	<b>M-Tips No.:</b> MT-006/18
	<b>Last Issued:</b> 07/03/2018

2017-2018 CX-5 Equipped with Power Liftgate  
2016-2018 CX-9 Equipped with Power Liftgate

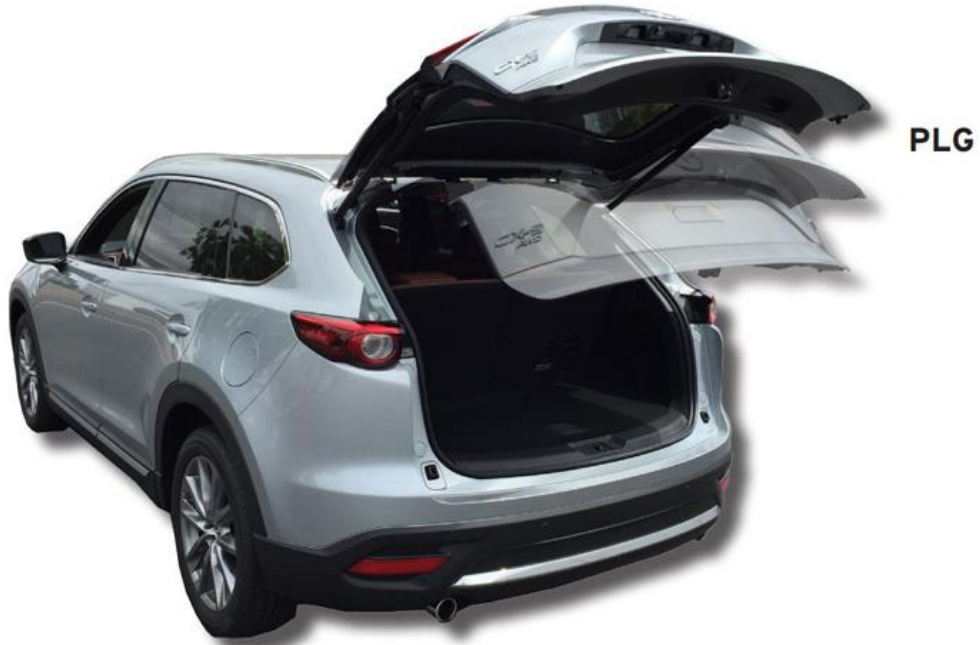
Some customers may complain about an inoperative power liftgate (PLG) with DTC U3003:16 (Power liftgate (PLG) control module power supply voltage low input) is stored in memory. This may be caused by low vehicle battery voltage.

1. Recharge the vehicle battery.
2. Confirm the lift gate is closed, disconnect the negative battery terminal.
3. Clear the KAM by stepping on the brake pedal and holding high beam on for one (1) minute.
4. Reconnect the negative terminal and confirm PLG operation.
5. Clear DTC's.
