Subject: ENGINE NO START AND / OR REAR VIEW MONITOR DISPLAY IS BLURRY DUE TO AFTERMARKET ELECTRICAL DEVICE	M-Tips No.: MT-007/18
	Last Issued: 07/20/2018

APPLICABLE MODEL(S)/VINS

2014-**2018** Mazda3
 2014-2018 Mazda6
 2016-**2019** CX-3
 2013-2018 CX-5
 2016-2018 CX-9
 2016-2019 MX-5

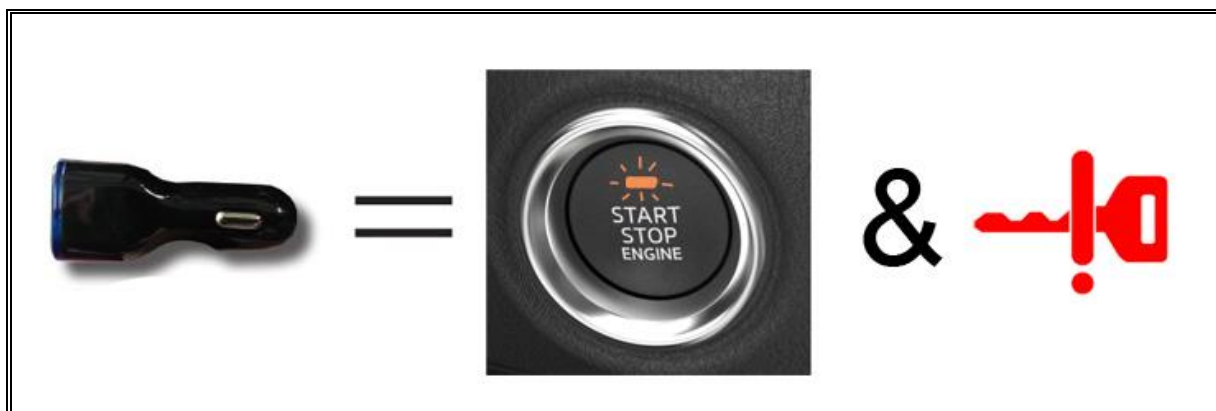
Example 1

Engine No Start:

Aftermarket Cell Phone Charger connected to 12V outlet	Engine Start/Stop Button	Key Warning Light
	Amber Indicator Light Flashing	(red)

Warranty Compliance Note: Repairs for this concern are not covered under Mazda's warranty policy. Advise the customer not to use the aftermarket device that is causing the concern.

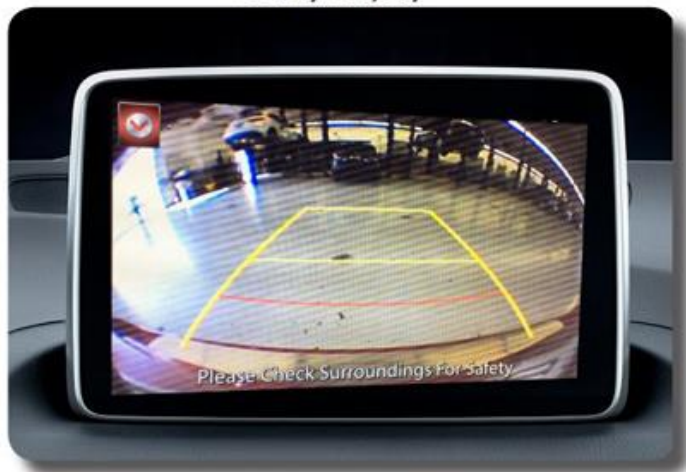
Rear View Monitor Display is Blurry:

Blurry Display
