## MAYBACH lettering on steering wheel trim shifted/detached

| Topic number | LI46.10-P-066990 |
| Validity | Model series:X222 Facelift (S-Class Maybach) |

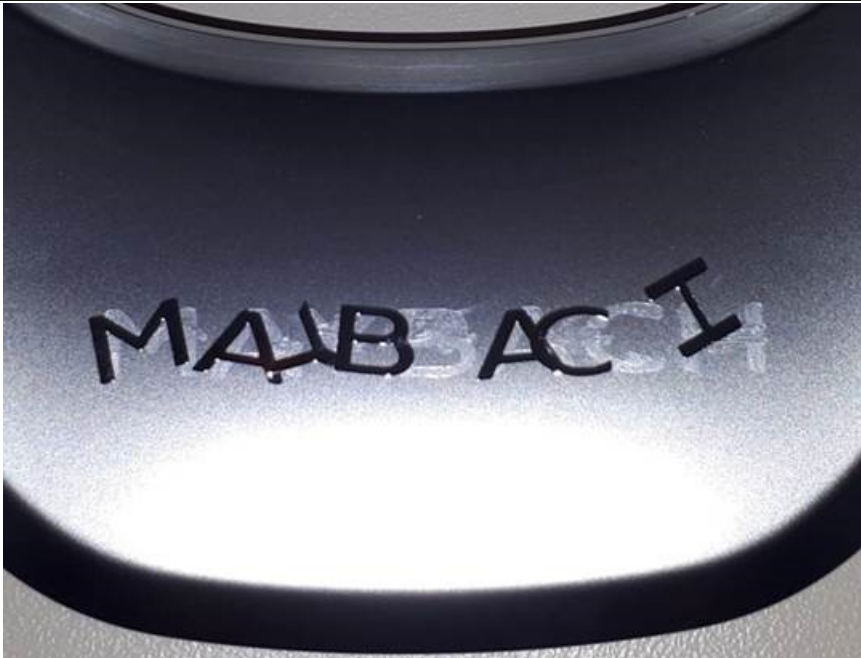
Complaint.jpg:

The MAYBACH lettering on the steering wheel trim could be shifted/detached.

In isolated cases, the effects of high temperatures can lead to the shifting/detachment of individual letters of the MAYBACH lettering.

In the event of complaints, it is only necessary to replace the steering wheel trim.

NOTE: It is NOT necessary to replace the entire steering wheel.
