AMG front splitter cracked in the middle

Topic number	LI88.20-P-067779
Version	1
Function group	88.20 Bumpers
Date	03-01-2018
Validity	BR117 with code 772 and code P55/P60
Reason for change	
Reason for block

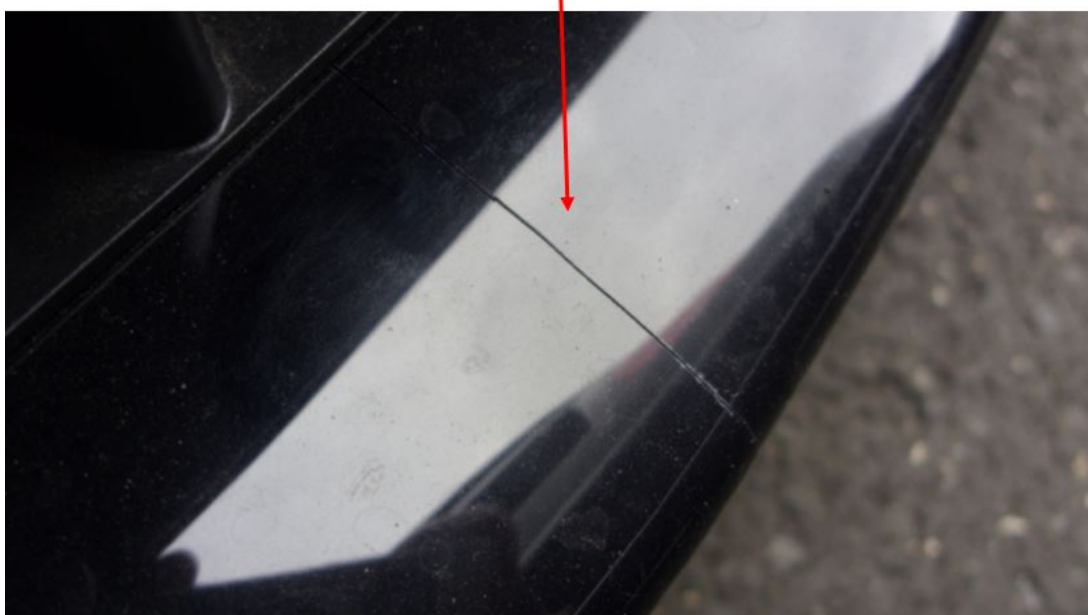
Riss_Frontsplitter.JPG:

Front splitter cracked/broken in the middle (see attachment, picture 1).

Front splitter may have been installed under stress.

If the manufacturing date of vehicle is after September 4 2017: Create a PTSS case with pictures of damage for further instruction.

If the manufacturing date of vehicle is on or before September 4 2017 : Check front splitter for effects of external influence.

If no signs of external force are visible, replace the front splitter (as per sub-steps in WIS document ar88.20-p-2000nkb).
