## Load compartment cover does not move upwards when liftgate is opened

| Topic number | LI68.50-P-062299 |
| Validity | BR 212.2 |

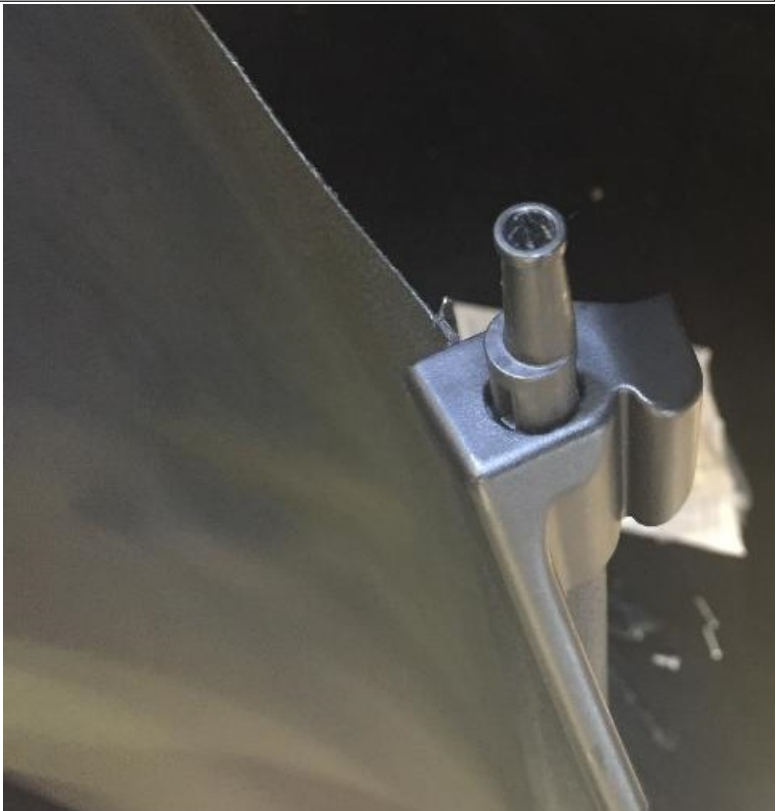
pic 2.JPG:

If the magnet is not detected, the load compartment cover may not move upwards when the liftgate is opened.

Pic 2: Not OK/magnet not present

| Attachments | |
|---|---|
| pic 2.JPG | Magnet is not present |

Check whether the magnet is present in the passenger-side guide pin.

If not, the right guide pin must be replaced. (See Pic 3)

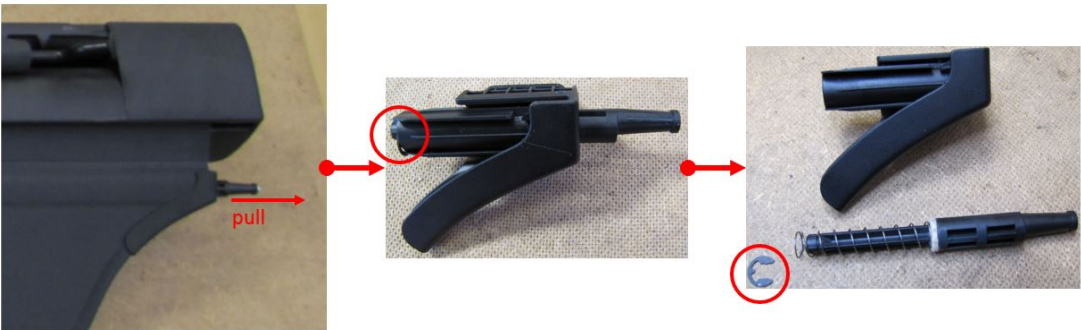
pic 3.JPG:

| Attachments | |
|---|---|
| pic 3.JPG | Replace guide pin |

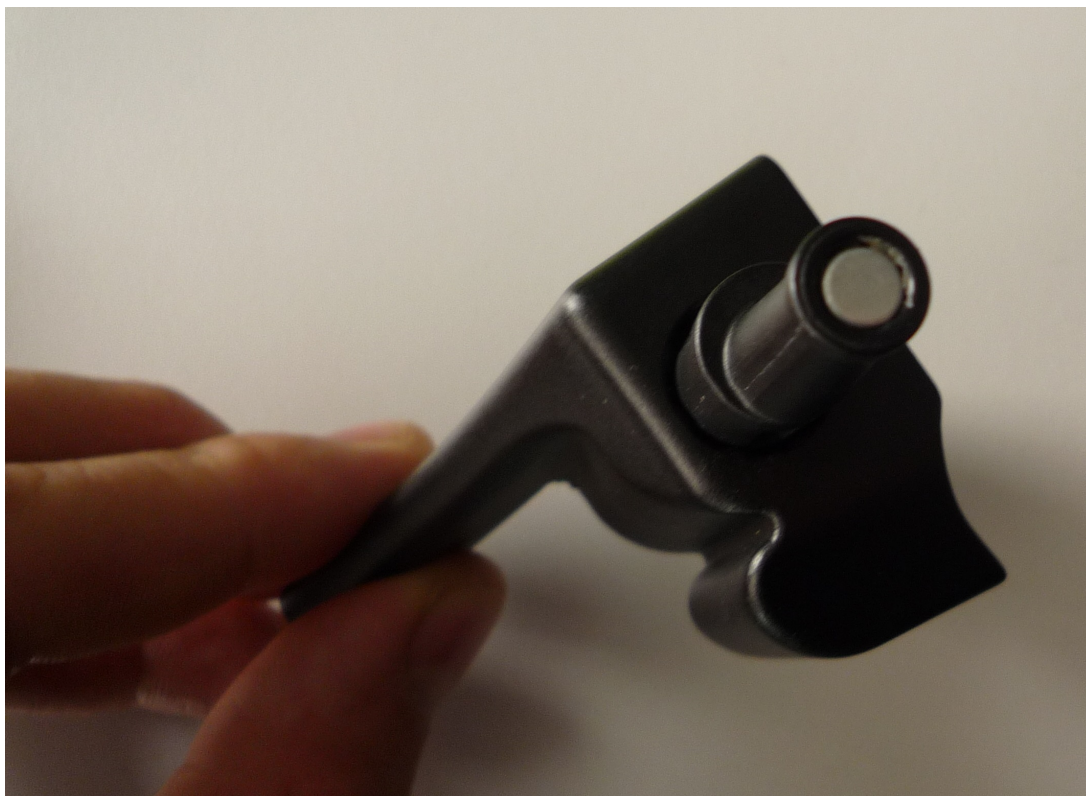
pic 1.JPG:

Pic 1: OK/magnet present

| Attachments | |
|---|---|
| pic 1.JPG | Magnet is present |
