## Noise in area of steering column after conducting service measure 1709P46C60 "Check mechanical steering column, rework if necessary"

Topic number	LI46.10-P-067941
Version	1
Function group	46.10 Steering wheel, jacket tube, steering shaft, steering lock
Date	03-26-2018
Validity	Model series 204, 207, 212 affected through measure 1709P46C60 "Check mechanical steering column, rework if necessary"
Reason for change	
Reason for block

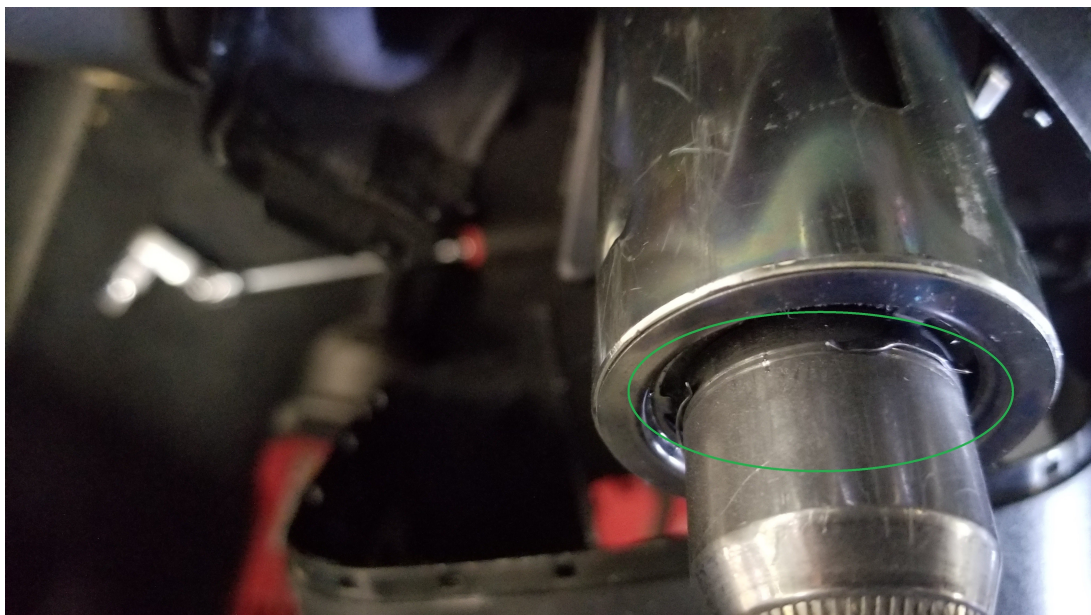
C.jpg:

**IMPORTANT:** The groove on the steering shaft is not a problem (see Attachment C, green marking). This groove serves to ensure that good contact is made and it is supposed to be there.

On no account should the steering column be replaced as this is not necessary from a technical point of view!

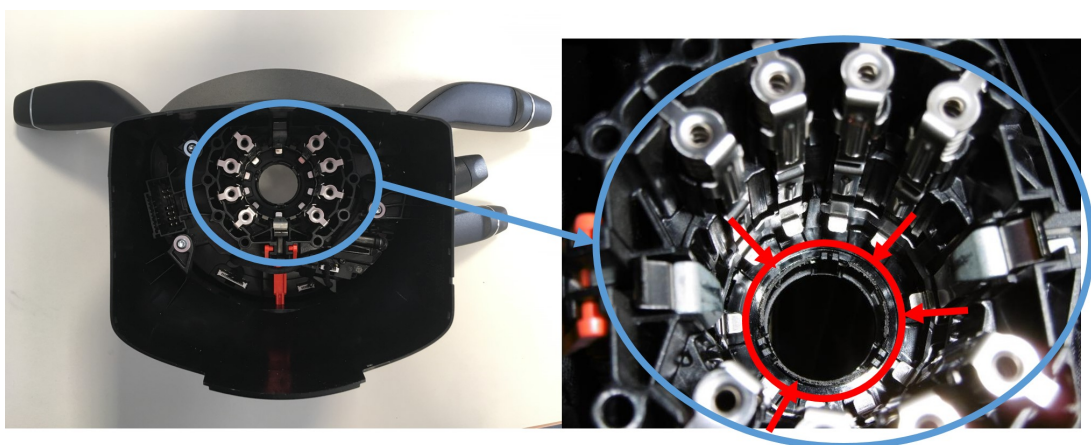
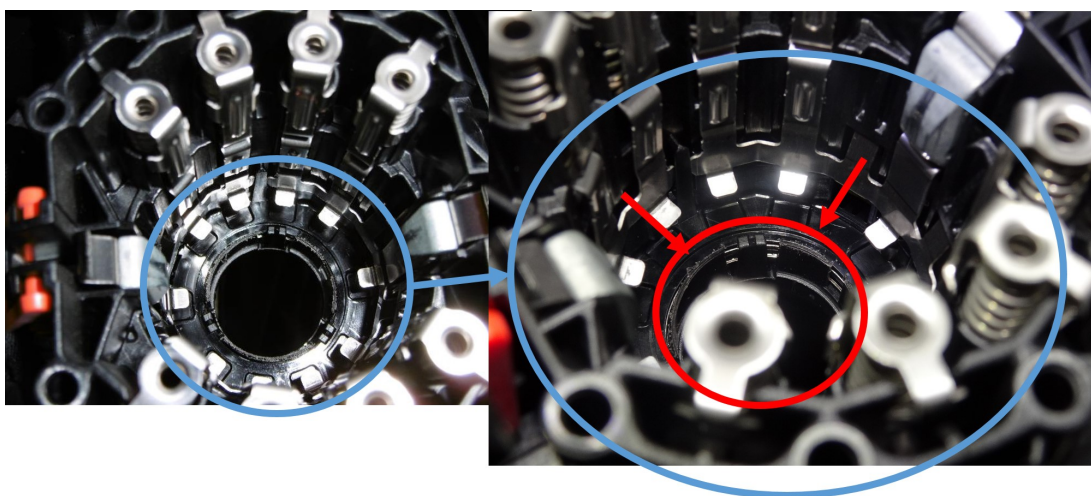
The contact bridge may grind on the steering column switch module, which may cause the noise.

Case 1) Ground off areas on steering column switch module (see Attachment D and E), the plastic lugs are fully intact (see Attachment F, green marking):

Replacement of contact bridge with new object number A099 546 04 00 (see Attachment H).

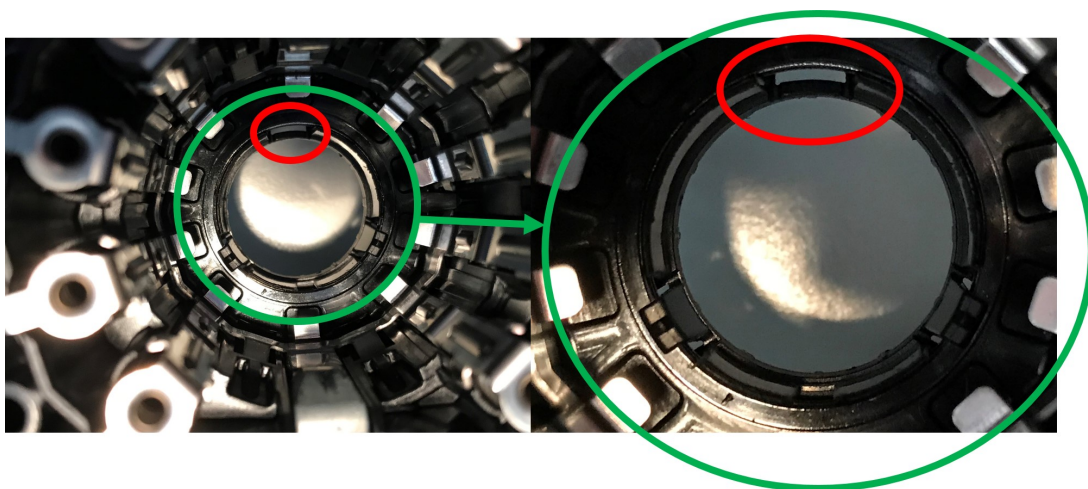
G.JPG:

Case 2) Ground areas on steering column switch module (see Attachment D and E), at least one plastic lug is damaged or even completely broken off (see Attachment G, red marking):

Replacement of contact bridge with new object number A099 546 04 00 (see Attachment H) and steering column switch module (part number as per EPC).
