**Model:** TUONO 1100 Euro4

**Subject:** checking silencer fastening position - technical update

**Campaign Code:** PAJZZQ1802

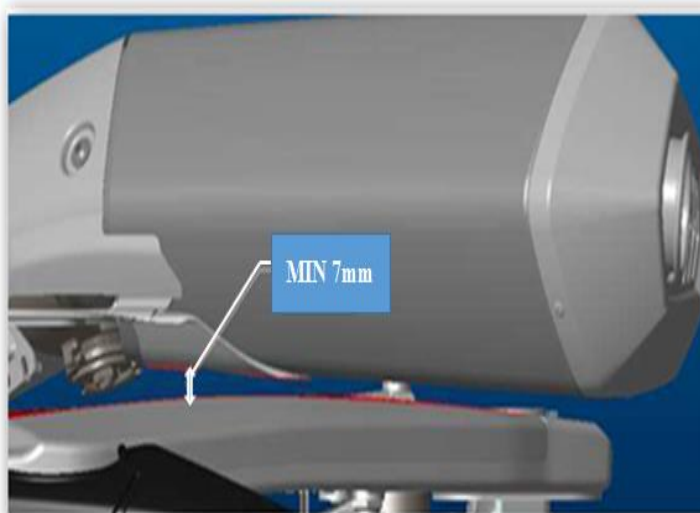
- Place the vehicle on the paddock stand.
- Measure the distance between the silencer and the swingarm and take a picture. The distance measured must be at least 7 mm (see detail in figure).
