**Model:** TUONO V4 1100 Euro4 MY17

**Subject:** new instrument cluster calibration

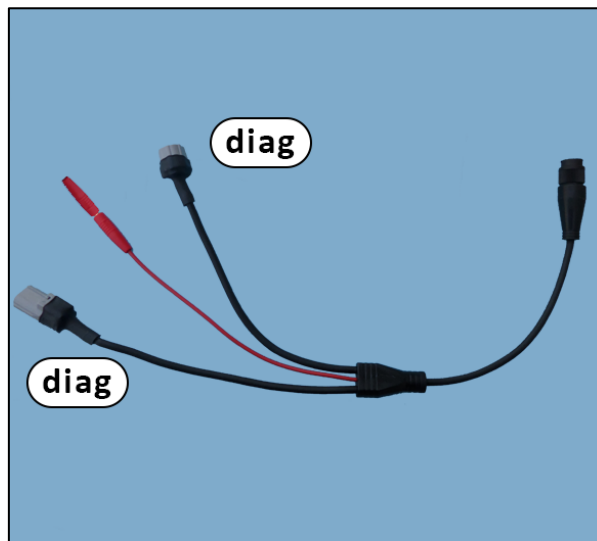
**IMPORTANT: The red power feed wire MUST NOT BE CONNECTED but only insulated to prevent the risk of short circuiting.**

Please note that to update the instrument cluster software for the models in question, you must use the AMP interface cable code 021011Y (which can be purchased as a P.A.D.S. accessory) and update the P.A.D.S. diagnostic tool to the latest available release.

- Before starting the instrument cluster update, check that the battery is charged and working correctly, or connect to an external power supply.
- Connect the PC to the mains and disable any screen savers.
- With the vehicle in key OFF state, connect the 021011Y interface cable between the wiring harness and the AMP control unit (outside of rear subframe –left side- grey connector). For models that do not have the AMP control unit installed as an accessory, remove the “dummy” plug and connect the 021011Y cable to the exposed connector.
