Noise in area of steering column after conducting service measure 1709P46C60 "Check mechanical steering column, rework if necessary"

Topic number	LI46.10-P-067941
Version	3
Function group	46.10 Steering wheel, jacket tube, steering shaft, steering lock
Date	05-17-2018
Validity	Model series 204, 207, 212 affected through measure 1709P46C60 "Check mechanical steering column, rework if necessary."
Reason for change	Remedy revised
Reason for block

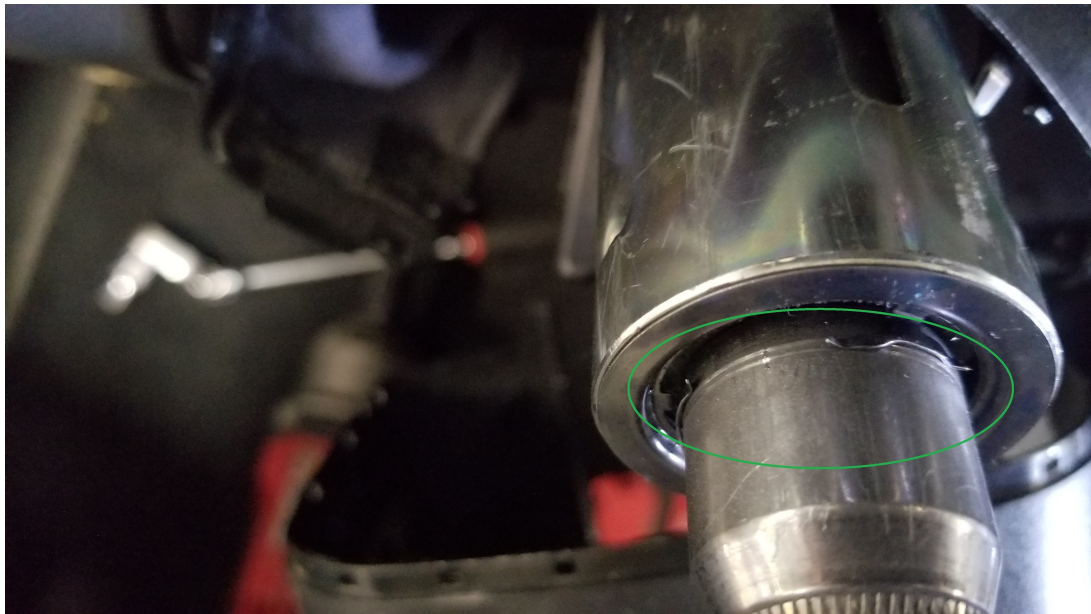
C.jpg:

IMPORTANT: The groove on the steering shaft is not a problem (see Attachment C, green marking). This groove serves to ensure that good contact is made and it is supposed to be there.

On no account should the steering column be replaced as this is not necessary from a technical point of view!

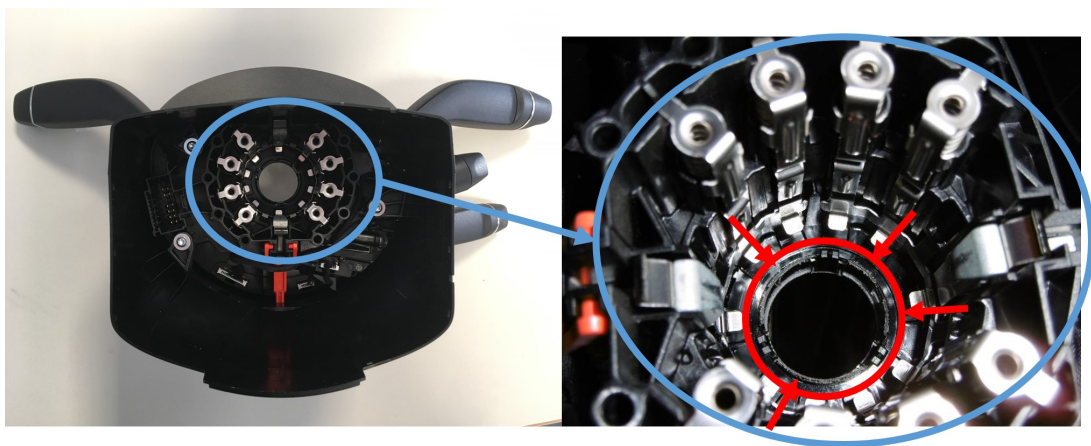
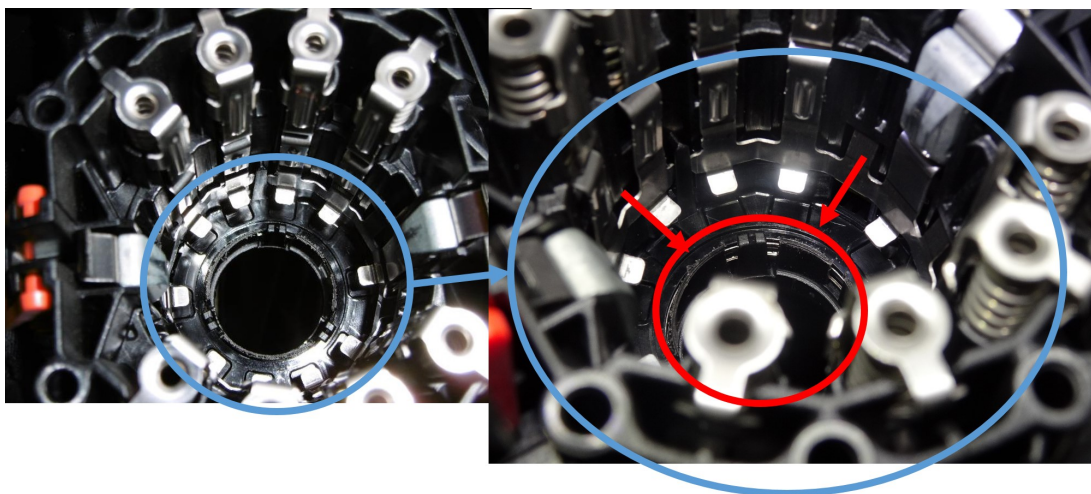
The contact bridge may grind on the steering column switch module. This may cause the noise.

Case 1) Ground off areas on steering column switch module (see Attachment D and E), the plastic lugs are fully intact (see Attachment F, green marking):

Case 2) Ground areas on steering column switch module (see Attachment D and E), at least one plastic lug is damaged or even completely broken off (see Attachment G, red marking):

Replacement of contact bridge with new object number A099 546 04 00 (see Attachment H).

Replacement of contact bridge with new object number A099 546 04 00 (see Attachment H) and steering column switch module (part number as per EPC).
