**Document ID:** IK0800549  
**Revision:** 5  
**Created:** 8/30/2017  
**Last Modified:** 7/16/2018  
**Author:** Charles Schroeder

**Title:** LT Ultrashift 1321-14 Missing Wire for Crank Signal Feedback

**Applies To:** LT Ultrashift

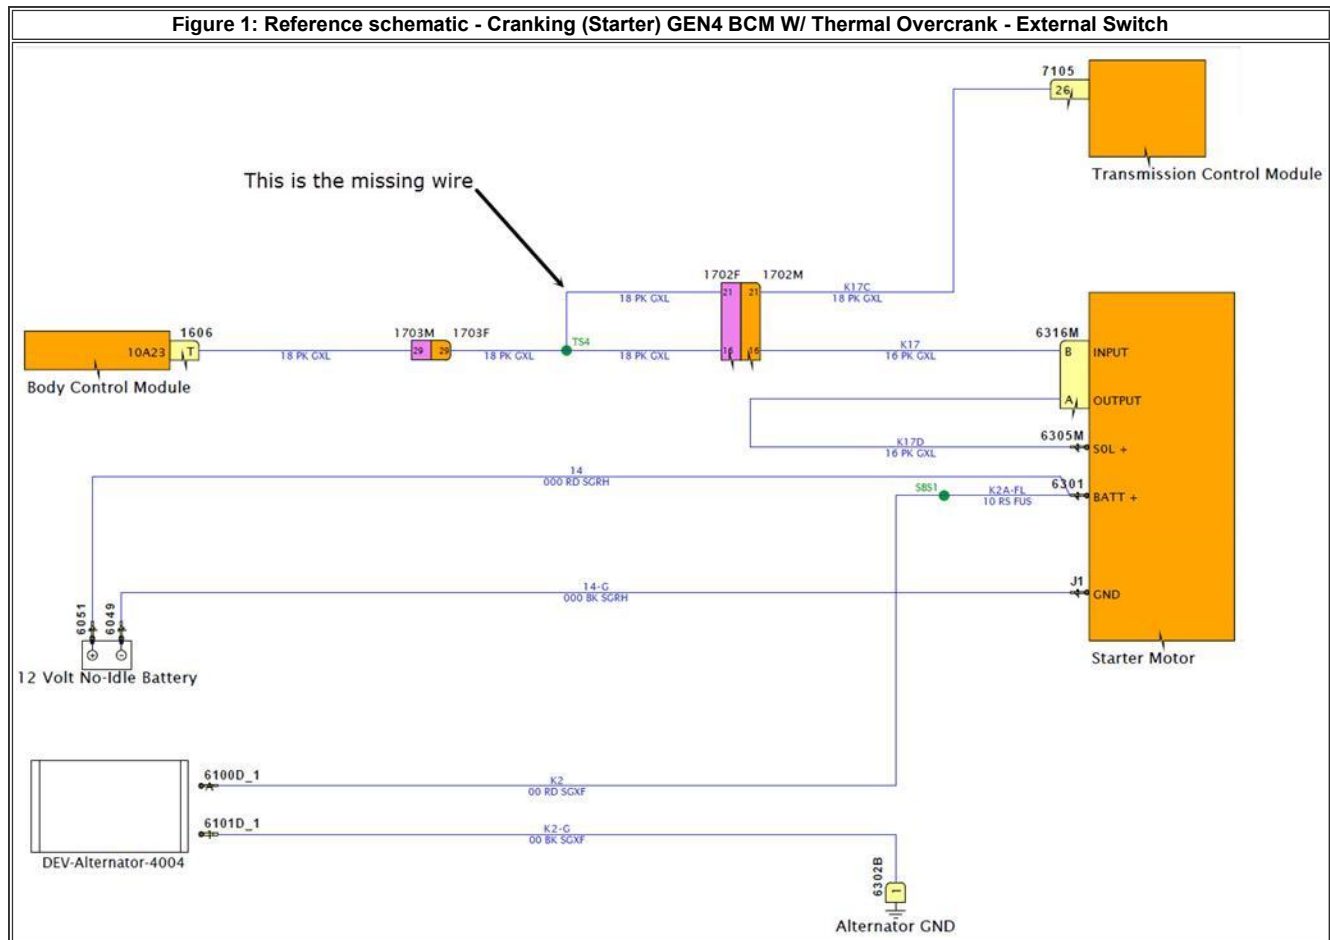
Refer to Figure 1. On IP Harness, use 18 gauge wiring to splice into the wire that is going to 1702-16 and add wire 1702-21. Connector 1702 is a 42 pin connector and it is mounted near the wiper bracket in the engine compartment.

Use [IK0800269 - Proper Wire Repair](#) to find the proper butt connector and heat shrink tubing part numbers

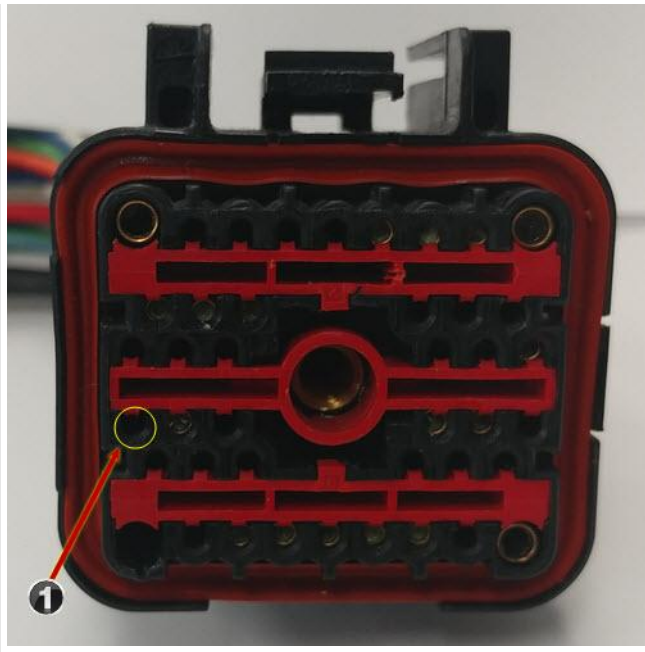
**Figure 2: Terminal Location 21**

1. Terminal Location 21

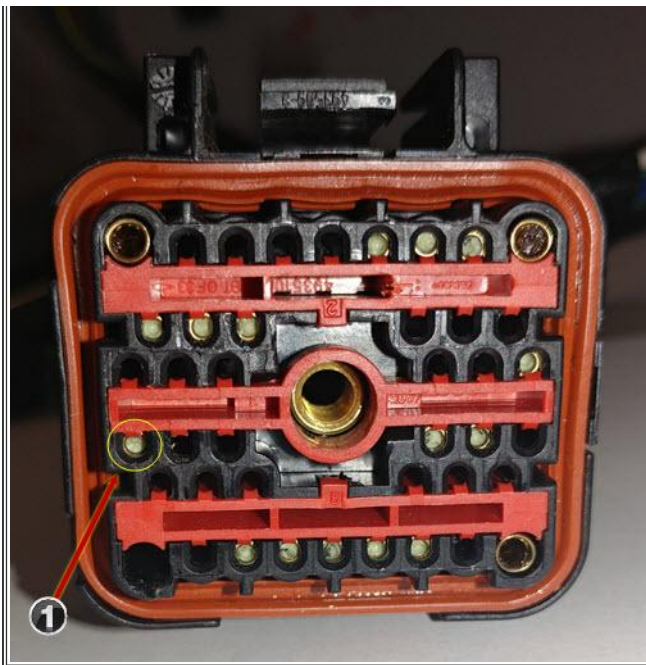
**Figure 6: Terminal installation complete**

1. Terminal fully installed, body lock had been re-installed
