# Non-Calibrated High Pressure Sensor

Sensors & Actuators Plant Trutnov

Affected project - HPS: All analog and digital Projects

Affected amount of parts: 110 pcs of HPS total OEM1 World Wide / 212 Sensors out of TRU Plant

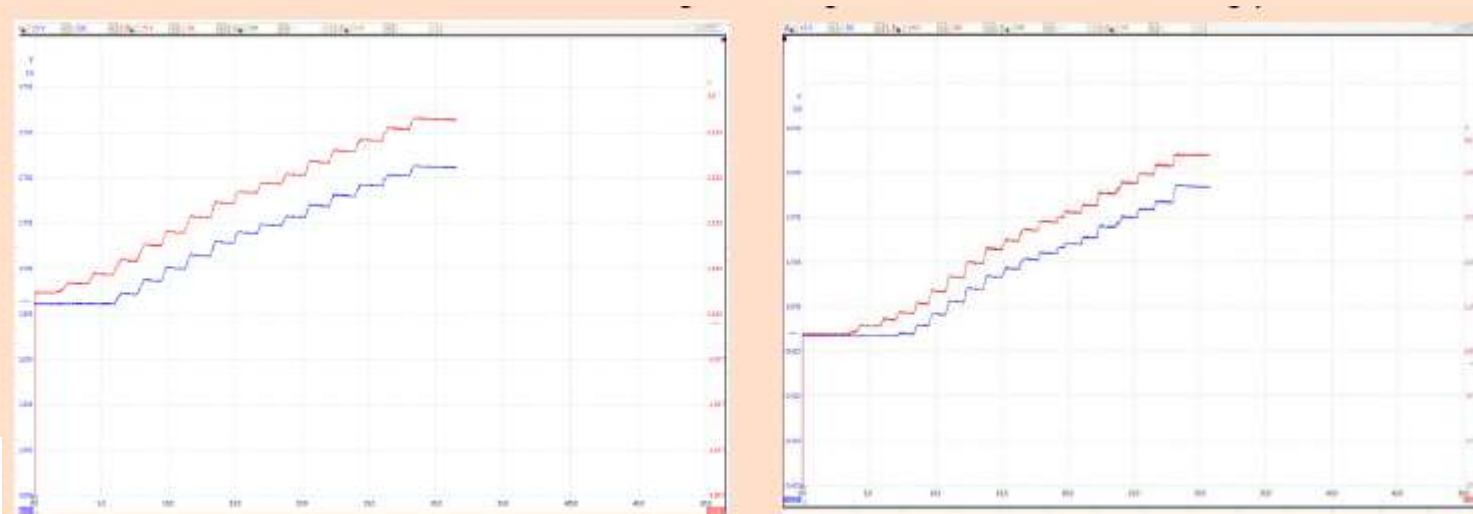
- Output of the sensor signal could be out of specification (see pictures below on this page)
- Effect of the wrong sensor's output could be:
  - Lower or higher power of the engine (depends on offset from specification limits).  
Acc. to IP results, there is very low risk of overpressure of the system.
  - Influence of engine emission (environmental issue).
  - There will be not the error message coming from sensor about wrong pressure in rail.

Red line – master part; blue line – not calibrated part

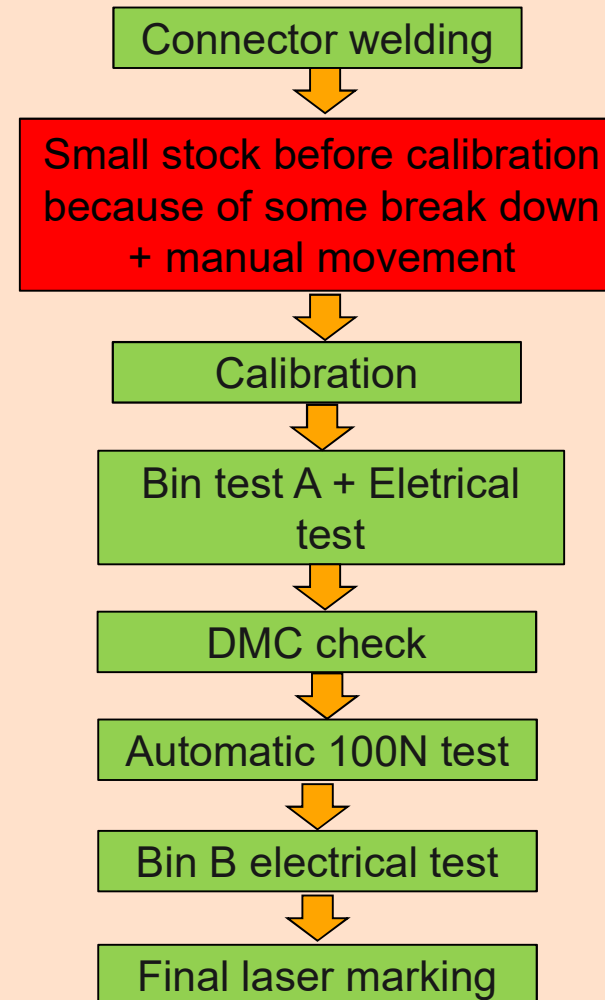
### Flow caused the failure:

Parts were switched in position in tray used for calibration which caused that one part has data belongs to second part. It means first part was scrapped on code verification and the second part sent to calibration few hours later has in traceability data from previous part and was not calibrated (because traceability has data, that the part was already calibrated).

- 1) One (first) part was scanned into tray 1, physically moved back to blister because of any issue occurs during scanning and into the tray placed different part – *this is the operator mistake*.

- 2) Different part was sent through the line and was scrapped on DMX reader because system found that this part is not matching the position in the tray.

- 3) After few hours the first part was scanned again into the tray (*this is the operator mistake*) and sent through the line but:
  - a) Part has information about calibration from the different part – therefore our first part was not calibrated again

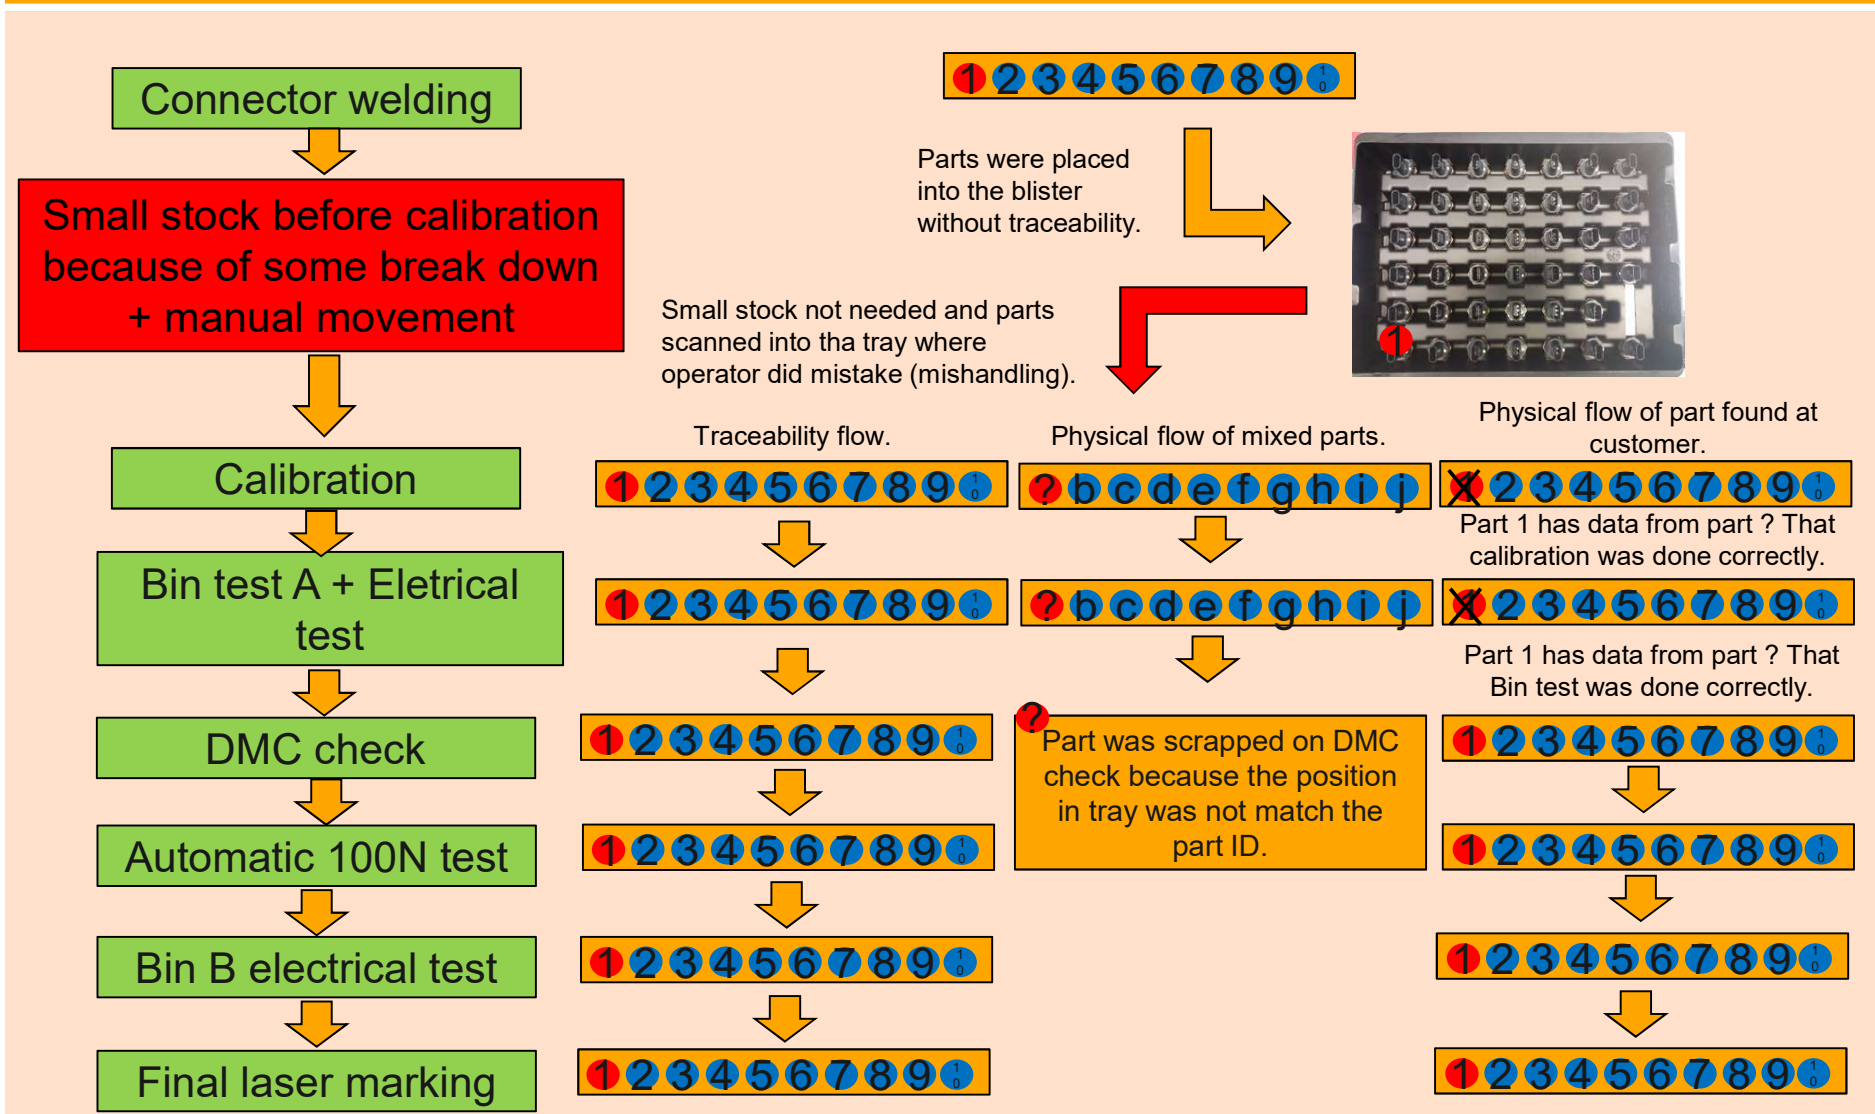
# Visualization of failed part flow

- b) Part has information about Bin test A from the different part – therefore our first part was not Bin A tested.
  - c) DMX reader check if our part match the position in tray and it was correct.

- 4) Part was sent to next operation (100 N automatic test) because system has correct information about previous processes.
- 5) Part was correctly processed through all station next stations, packed into the customer blisters and sent to customers.
