**TECHNICAL SERVICE BULLETIN**

**Bulletin No.:** TSB-031

**Subject:** VP Chassis Modification

**Models:** All Quantum Virtual Pipeline Trailers

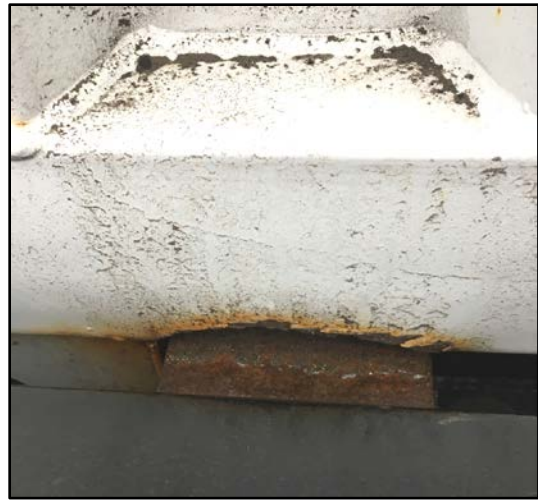
In some cases accelerated wear and corrosion at the interface between the container front sill and the chassis rail have been observed. This accelerated wear can result in weakening of the front of the container and a settling of the container on the chassis.

In certain chassis manufacturers products, if this condition is not addressed, the container may wear to the point that it could interfere with the glad hand bulkhead fittings resulting in an air leak.

The high loads observed in this area of the container in conjunction with corrosion occurring in this area may result in accelerated wear and damage to the front sill of the container.

A reinforcement bracket is being added to the chassis to help distribute the load on the front sill of the container. In addition to distributing this load, a corrosion resistant wear strip is being added to the container sill.

In cases where the container wear has already exceeded established limits, an additional repair process to the container will need to be performed.

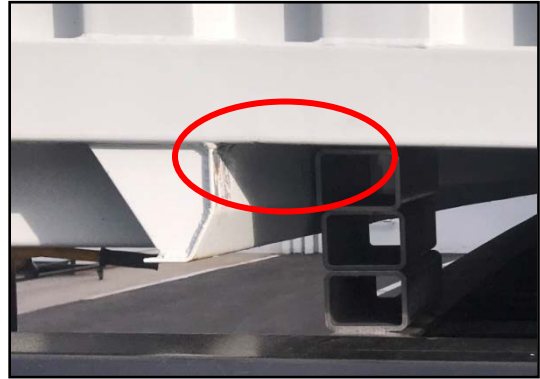
Inspect the container in the area shown where it contacts the chassis, if there is wear in the area shown document the depth of the wear on the work order or paperwork.

If the wear is less than 0.050" (1.3 mm) continue with this procedure.

If the wear is greater than the allowable limit, note the wear on the work order and report the wear to Quantum Service at [QTSservice@gtww.com](mailto:QTSservice@gtww.com) or 800.816.8691 then continue with Chassis retrofit procedures.
