TECHNICAL SERVICE BULLETIN

Lack Of Heat - Blower Motor Frozen - Cold Weather Conditions

18-2185
02 July 2018

Ford 2011-2018 Fiesta

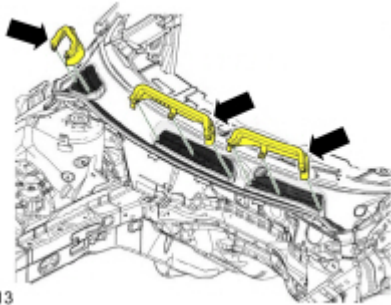
Figure 1

3. Open the hood and inspect for the presence of foam deflectors on the air inlet openings of the cowl opening grille. Are foam deflectors present? (Figure 1)

- (1). Yes - remove and discard the foam deflectors. Proceed to Step 4.
- (2). No - proceed to Step 4.
