GROUP ENG	MODEL 2018MY Soul (PS)
	NUMBER 189	DATE August 2018
TECHNICAL SERVICE BULLETIN		
SUBJECT: SERVICE ACTION: 1.6L TURBO OIL FEED PIPE GASKET REPLACEMENT (SA349)

SERVICE ACTION: 1.6L TURBO OIL FEED PIPE GASKET REPLACEMENT (SA349)

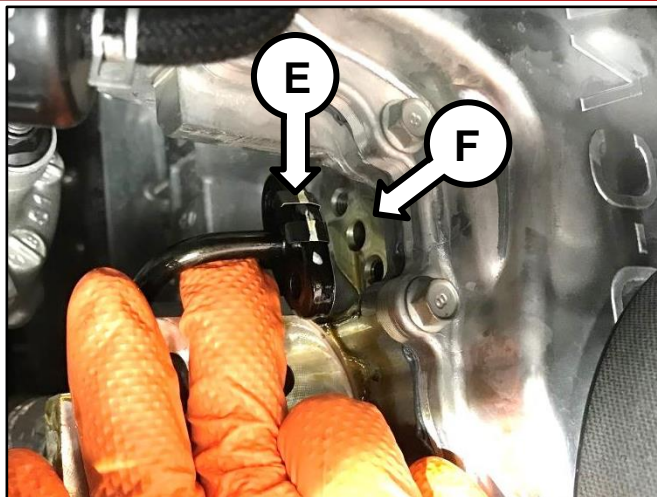
- Remove and discard the old oil feed pipe gasket (E) and then clean the surface of the engine block at the oil feed pipe flange area (F).
