# Special Bulletin

# SP18-305A

## DOUBLE DOOR LATCH PINS

Prevost vehicles

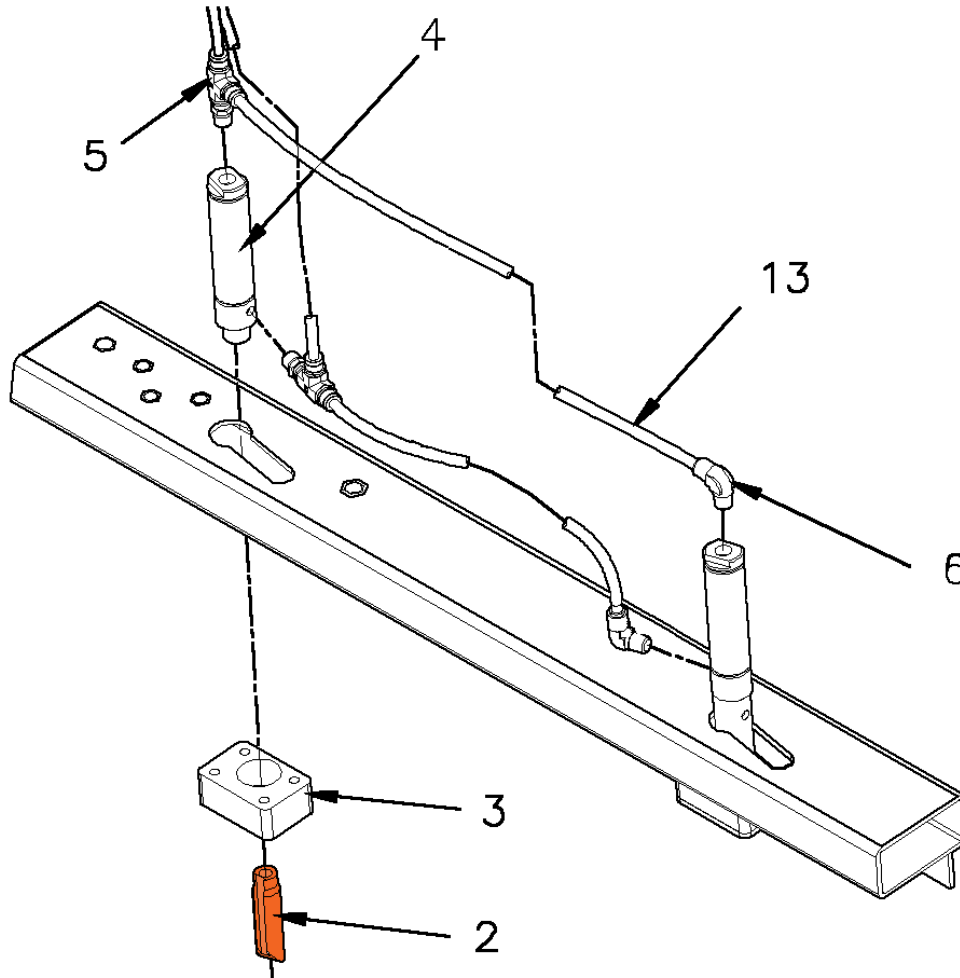
**Figure 4: Latch assembly, pin and air supply.**

- 4) The latches are located above the door (Figure 4) and are composed of air cylinders (4), receptacles (3) and treaded pins (2). There is one latch for each door pane.

- 5) Unplug hose (item 13 in Figure 4) and top fittings (items 5 and 6 in Figure 4).
