Light switch/combination switch, fault code stored

Topic number	LI54.25-P-068219
Version	1
Function group	54.25 Switches
Date	06-11-2018
Validity	smart 453
Reason for change	
Reason for block

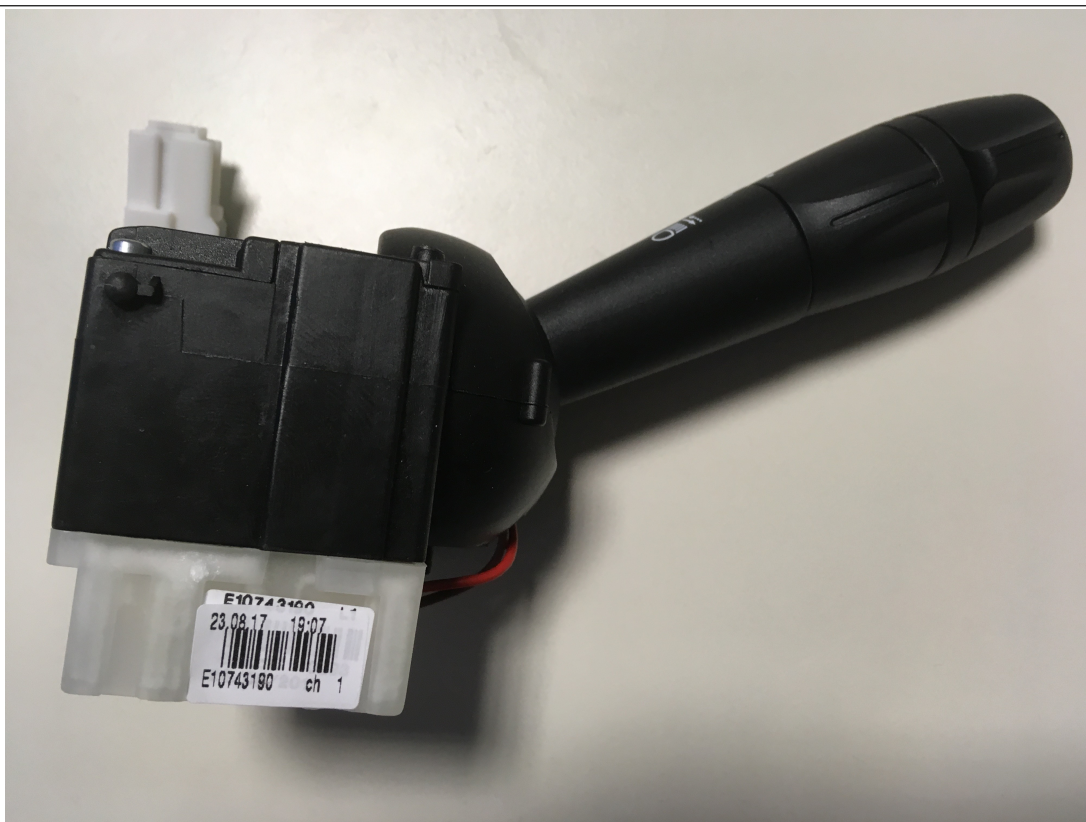
Label.jpg:

Since 1/20/18, modified light switches have been produced (the manufacturing date can be seen on the label on the switch). The part numbers have not been changed.
