# Service Campaign Bulletin

Campaign No. 2018040008, June 2018

SUBJECT: **Model A205, Model Year 2018**  
**Check Luggage Cover**

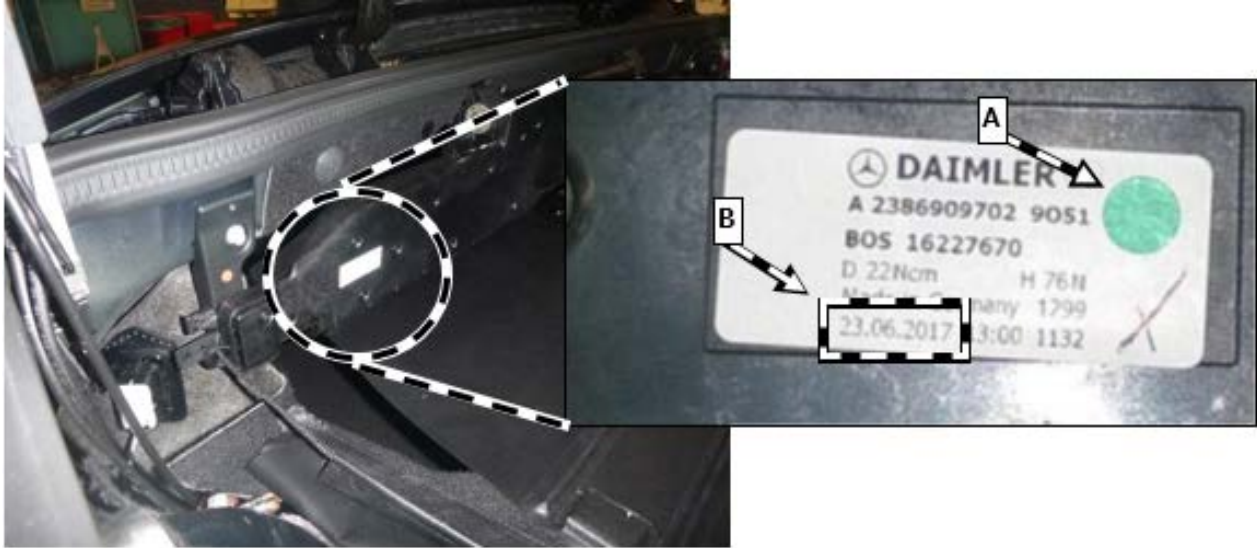
Figure 1

1. Move soft top to repair position R2.  
☐ **i** For basic data, see AR77.30-P-1030LWR.
2. The marking (dot, (A)) and production date (B) must be checked (figure 1) on the object number adhesive label of the partially electric truck luggage cover.  
☐ **i** The marking can be a green, blue or black dot (A).

- a. Marking (dot) present :End measure.
- b. Marking (dot) **not** present and production date **same as/later than** 24.06.2017 :End measure.
- c. Marking (dot) **not** present and production date **before** 24.06.2017 :Carry out **check/test procedure B**.

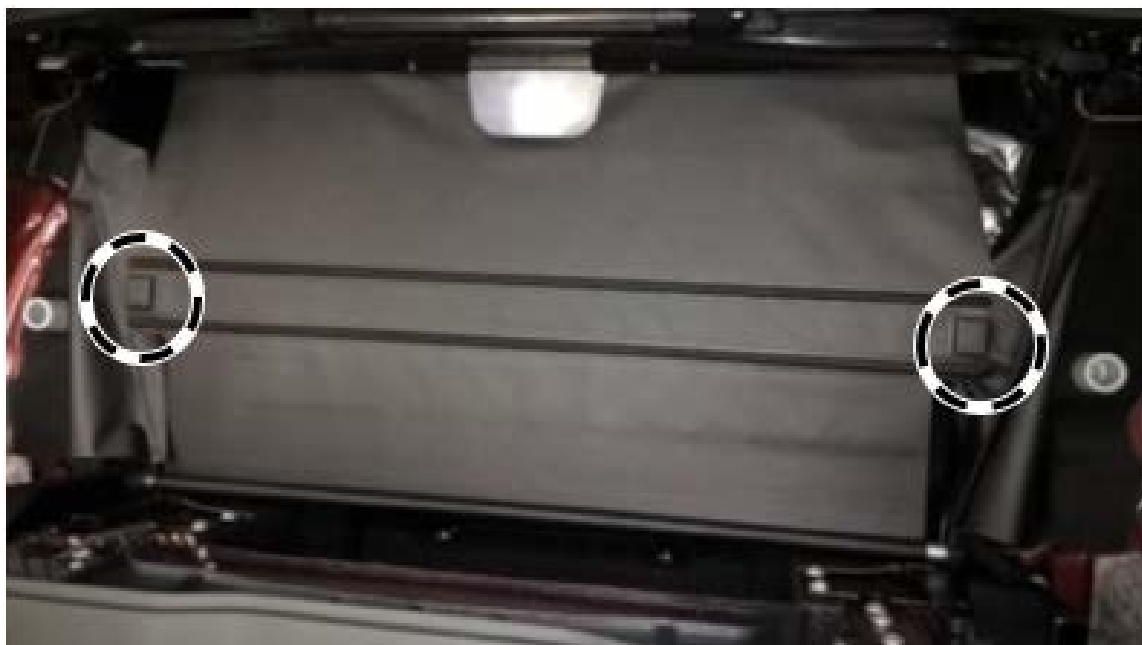
**Figure 2**

1. Check heat-sealing at both magnetic pockets of partially electric trunk luggage cover (**figure 2**).

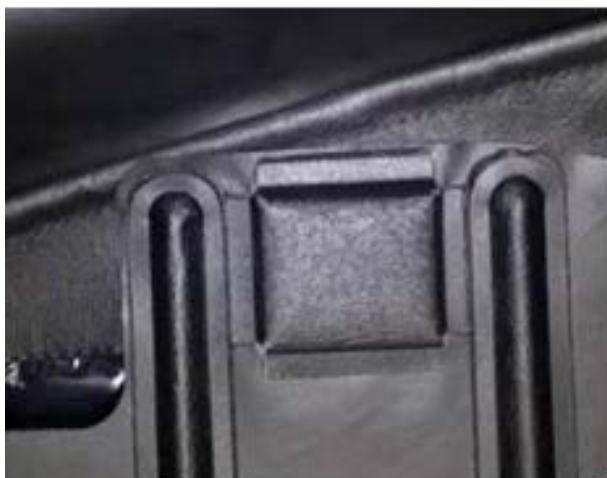
**Figure 3 (OK)**

**i** The heat-sealing of the magnetic pockets must be sealed at all 4 sides (**figures 3 (OK image) and 4 (not OK)**).

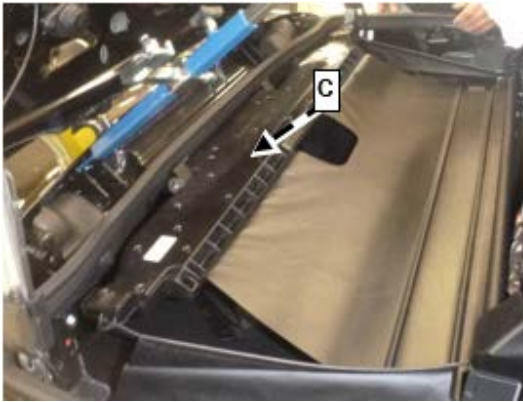
Figure 5

2. Remove cover **(C)** of partially electric trunk luggage cover **(figure 5)**.

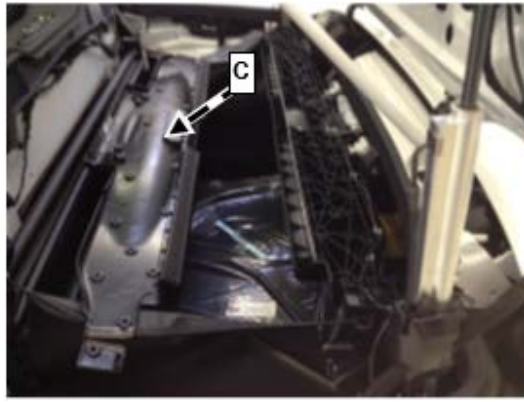
Figure 6

**i** For this purpose, remove all 23 screws and place cover **(C)** to side on net **(figure 6)**.

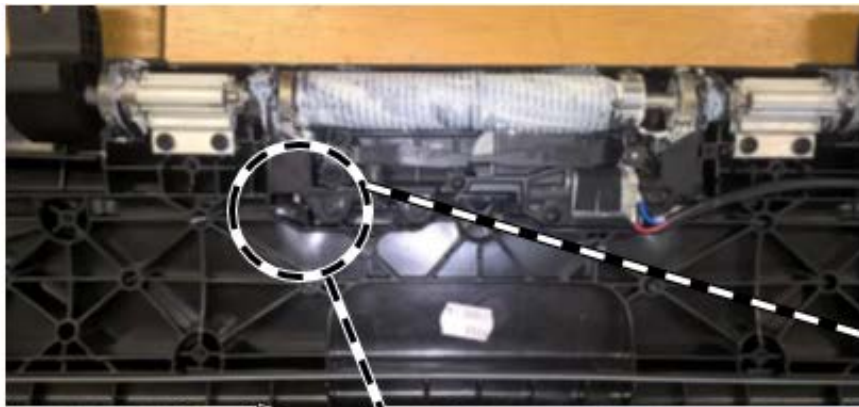
Figure 7 (NOT OK)

**i** Rib of housing may not be damaged **(figure 7)**.

1. Replace partially electric trunk luggage cover.

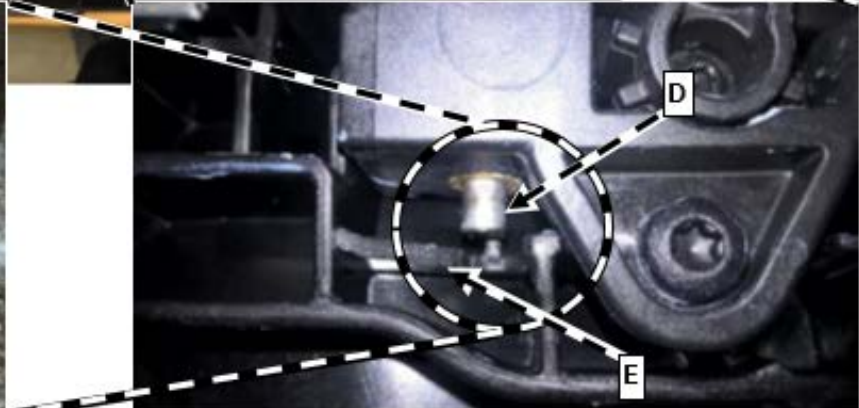
Figure 8 (NOT OK)

**i** The plunger **(D)** must be able to freely move through the rib **(E)** **(figure 8)**.

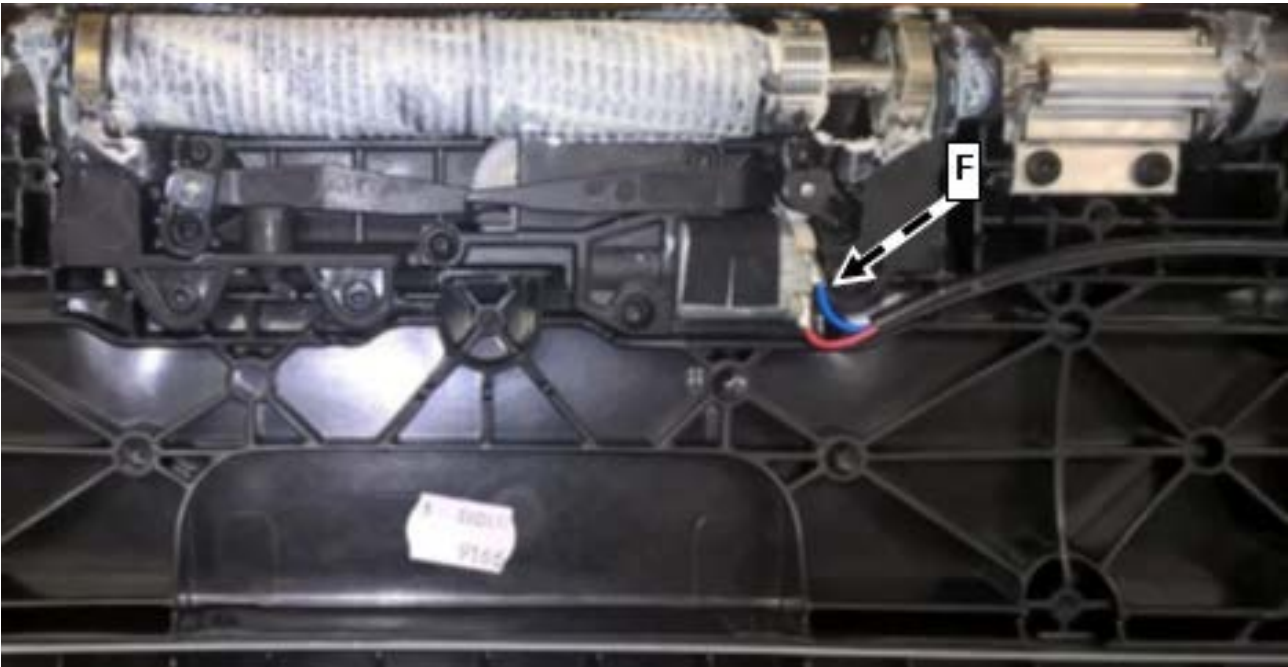
Figure 9

- i Check cable set of partially electric trunk luggage cover.
- 4. Check position of flat-wire connectors (**F**) of electrical cable set for drive (**figure 9**).
- i Flat-wire connectors may not lie one above the other (**figure 10 (not OK image)**).

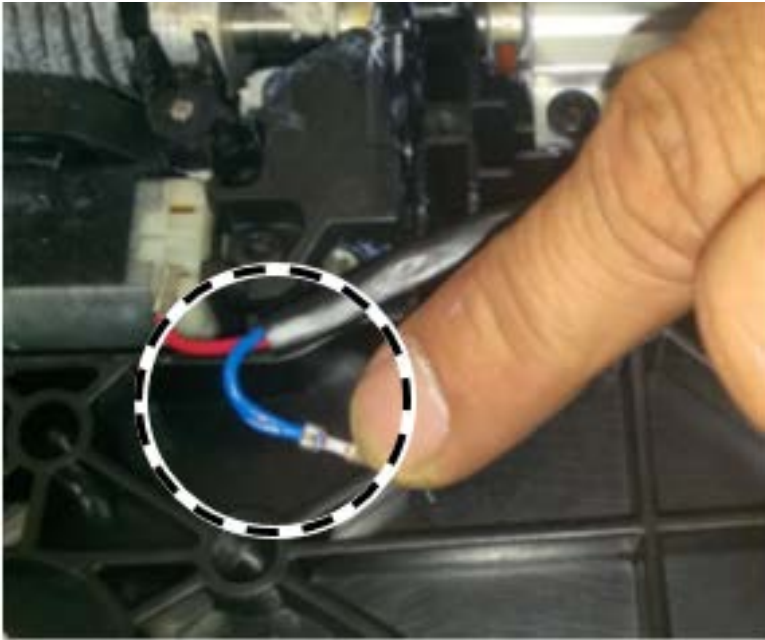
**Figure 11 (NOT OK)**

5. Check cable set for damage (**figure 11**).

1. Repair cable set at damaged location.
