## REPAIR DOCUMENT

### Reefer Trailer – Rub Rail Securement

Repair Document #: RD-00074  
Date: August 3, 2018  
Revision:  
Revision Date: N/A

Repair procedure for replacement of the fasteners used to secure the exterior rub rail to the side wall of the refrigerated trailer.

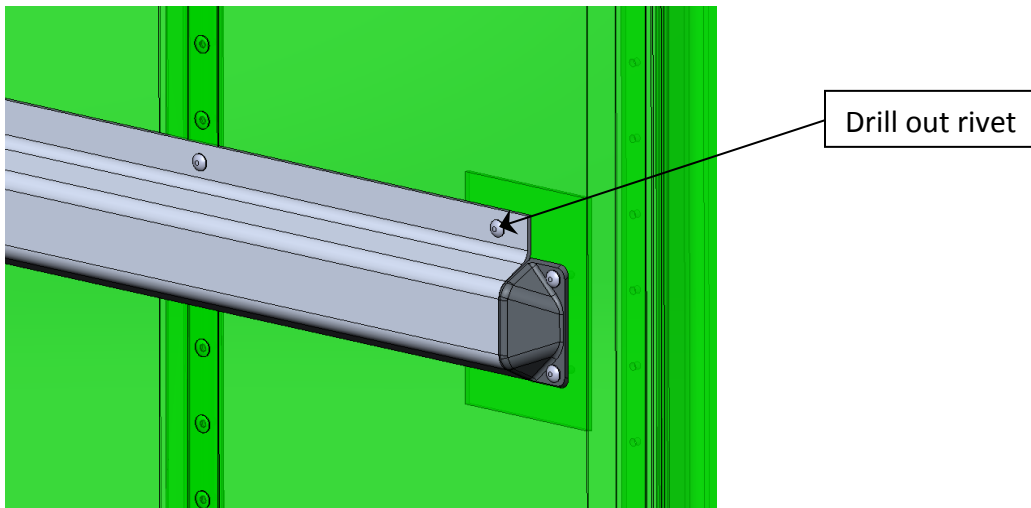
Current fasteners may not be adequate to maintain the securement of the rub rail.

1. Start from one end of the rub rail, drill through center of rivet with #10 drill bit and remove rivet. **CAUTION:** Do not allow drill bit to go more than 1 inch deep. Drill out just one rivet at a time.
