Subject: SQUEAK NOISE FROM RIGHT FRONT DRIVESHAFT	Bulletin No.: 03-002/18
	Last Issued: 08/17/2018

2012-2013 Mazda3 (2.0L SKYACTIV A/T only)

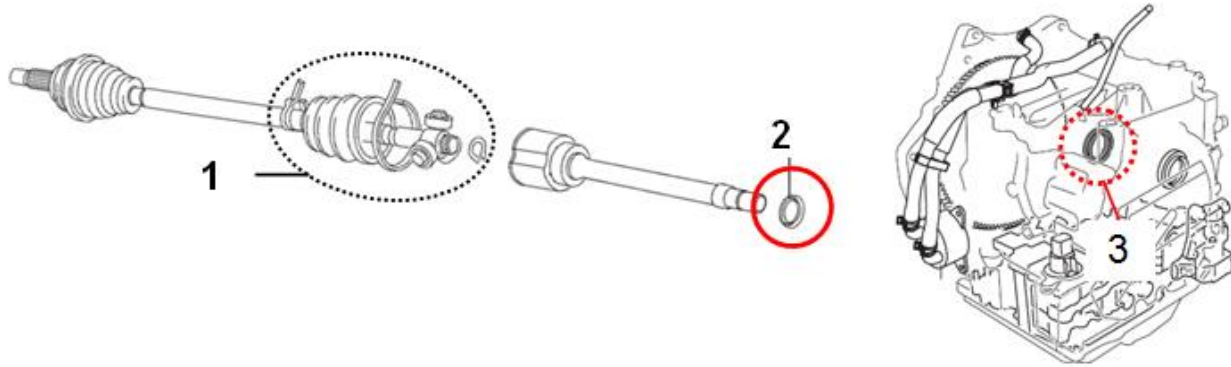
Some vehicles may exhibit a squeak noise from the right front driveshaft at the transaxle when driving. This concern is likely to occur when driving at speeds between 37-50 mph (60-80 km/h) with the ATF at normal operating temperature. The noise is caused by stick/slip between the oil seal at the transaxle and the dust cover of the driveshaft. To correct this issue, the thickness of the dust cover has been increased.

1	Inner joint boot set
2	Dust cover
3	Oil Seal

1. Verify concern
2. Replace the dust cover and the transfer oil seal with modified ones according to the instructions on MGSS (FRONT DRIVE SHAFT REMOVAL/INSTALLATION).
