Subject: REAR DOOR SEAMING WELT COMES OFF WHEN STEPPING IN AND OUT OF VEHICLE	Bulletin No.: 09-030/18
	Last Issued: 08/02/2018

2014-2018 Mazda3

2013-2018 CX-5

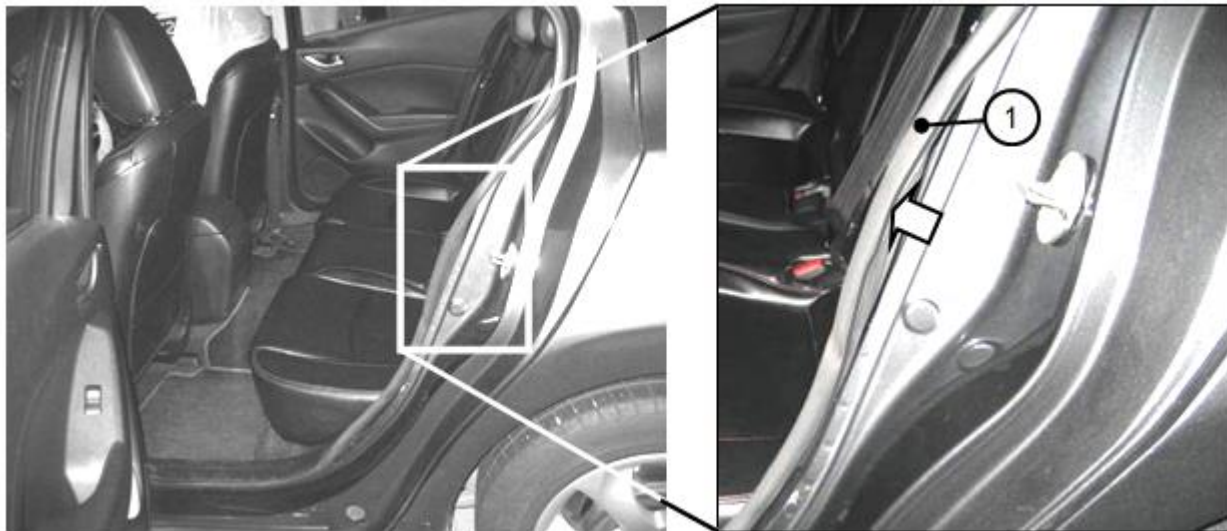
Some customers may complain that the rear door seaming welt (1) comes off when stepping in and/or out of the vehicle. This is caused by the gripping force of the seaming welt being insufficient for frequent usage of the rear seat (vehicle used for ride sharing). No mass production change is planned.

Customers having this concern should have their vehicle repaired using the following repair procedure.
