Technical Service Bulletin

REAR COMBINATION LIGHT(S) ARE FOGGY

Bulletin No.: 09-032/18

2017-2018 CX-5 vehicles with VINs lower than JM3KF*****356208 (produced before Feb. 6, 2018)

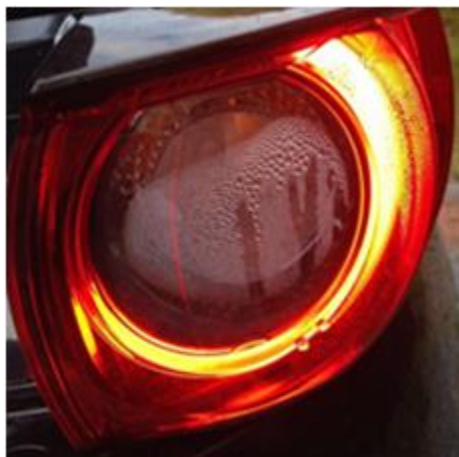
Some customers may complain of foggy rear combination lights (as shown below) after a car wash or heavy rain.

This concern may be caused by water entering into the rear combination lights through the ventilation tubes. To eliminate this from occurring, the ventilation tubes have been changed to a ventilation cap design.

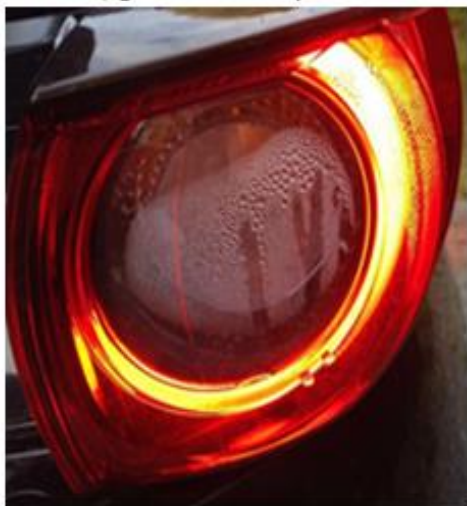
**CONDENSATION RUNNING DOWN LENS -
REPLACE LIGHT UNIT**

1. Verify the customers concern of condensation inside the rear combination lights.
 - a. If condensation is found inside, replace both rear combination light units with new parts according to the instructions on MGSS online (REAR COMBINATION LIGHT REMOVAL/INSTALLATION).
 - b. If condensation is not found inside, go to Step 2.

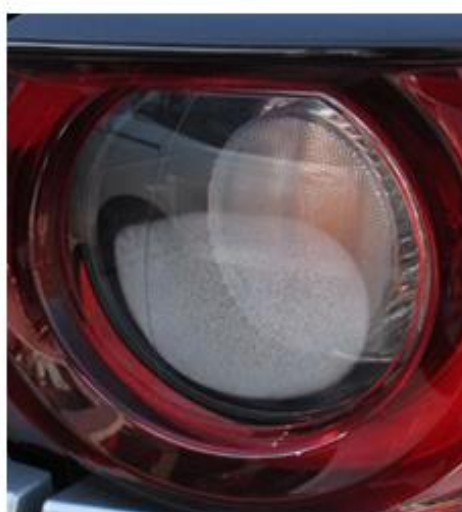
**FOGGY UNIT - DO NOT REPLACE
LIGHT UNIT**

5. **Foggy Unit / No drops on lens:** Hold a dryer to the turn light bulb socket hole and blow **cold air** into the unit for 20 minutes to dry out the inside of the unit.
