Mack Model TE-TerraPro , LR , GR-Granite , PI-Pinnacle , AN-Anthem , CHU , CXU , GU

Volvo Model VNR , VNX , VNL , VHD , VAH

Engine family 11L Engine , 13L Engine , MP7 , MP8

Title Common Rail Fuel System - Engine Wiring Harness Will Not Reach / Is Not Long Enough To Connect To Electronic Pressure Relief Valve (EPRV) Connector, Wiring Harness Pulled Tight At EPRV; Correct Clocking, Symptoms, Repair - [US17+OBD16 And Newer Emissions, Common Model Years 2018 And Newer](#)

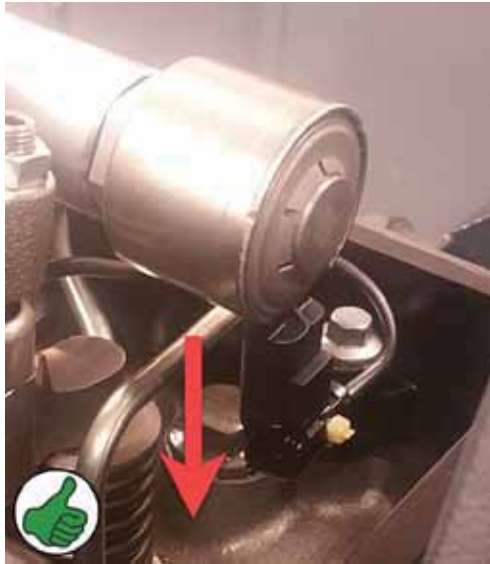
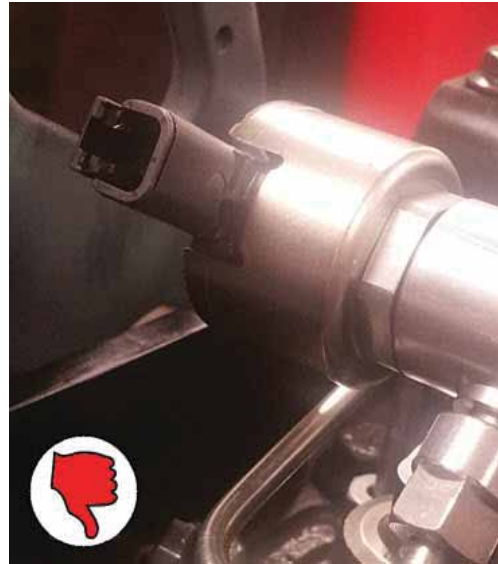
Cause When installing an Electronic Pressure Relief Valve on the fuel rail of a US17 or newer chassis, it may be observed that the engine wiring harness is very tight after the connector is put in place, or that the pigtail with the EPRV connector will not reach the connector on the EPRV itself. Excessive tension on the harness or pins pulled out of connectors may also be seen when the valve cover is removed to inspect fuel system components.

This issue can be caused by an incorrectly oriented—or clocked—EPRV. The housing of the EPRV is able to rotate independently of the fitting that is threaded and torqued to the rail.

n The EPRV should be oriented with the connector directed downward toward the cylinder head and angled slightly toward the right side of the engine.
