TT8045EN, Rev. A  
August, 2018  
Page 1 of 4

SUBJECT: Incorrect Calibration Setting for Primary Mode: Gears in Freightliner Custom Chassis Corporation (FCCC) Motorhome Chassis

MODELS AFFECTED: FCCC Motorhome Chassis MC, XBS, XCR, and XCS with 2500MH Series Transmission

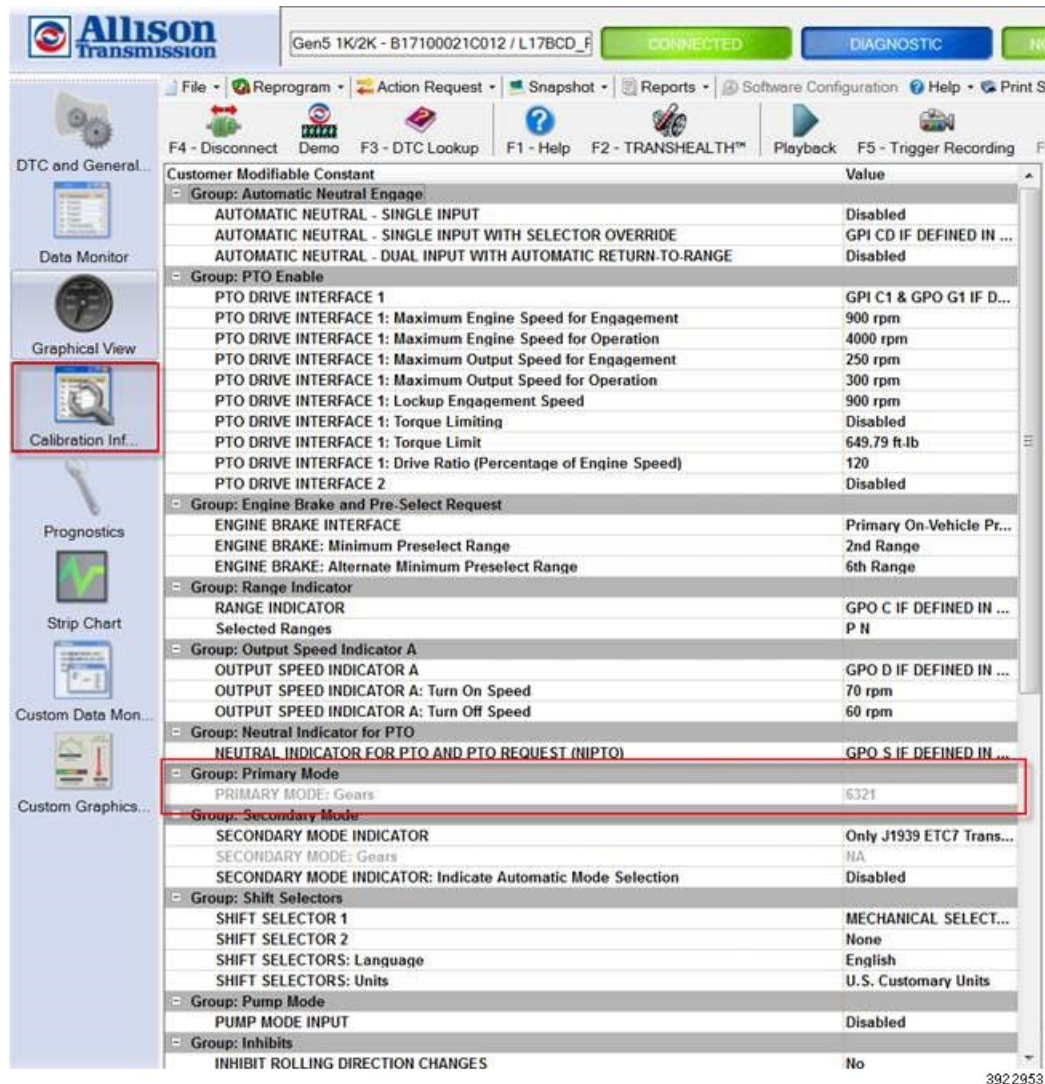
Figure 1. Example of the Incorrect Setting Prior to Reflashing

The Primary Mode: Gear calibration setting was **incorrectly** set to 6321 instead of the **correct** setting of 6M1 for 6-speed units in the affected population. 5-speed units were **incorrectly** set to 5321 instead of the **correct** setting of 5M1 for units in the affected population. This correction will allow preselect downshift, which allow an increase in engine speed, thus increasing the amount of engine braking.

Connect to the TCM using Allison DOC® to verify that the calibration parameters are set to correct settings. Once connected to the TCM, select the Calibration Information icon. Look at Group: Primary Mode to verify the correct setting. Figure 1 is an example of the **incorrect** setting prior to reflashing. Notice the Value for Primary Mode: Gears is set to 6321. The value may be 5321 on some of these motorhomes.

Using Allison DOC®, determine the current setting for the Primary Mode: Gears parameter. Once connected to the TCM, select the Calibration Information icon. Look at Group: Primary Mode to verify the current Primary Mode: Gears setting. Refer to [Figure 1](#). Record the current setting for later reference. Using Allison TCM Reflash™, enter

the TCM serial number into the 5th Generation Controls database. The system will correct the calibration settings for the specific TCM when the calibration is downloaded. Flash the TCM with the updated calibration.

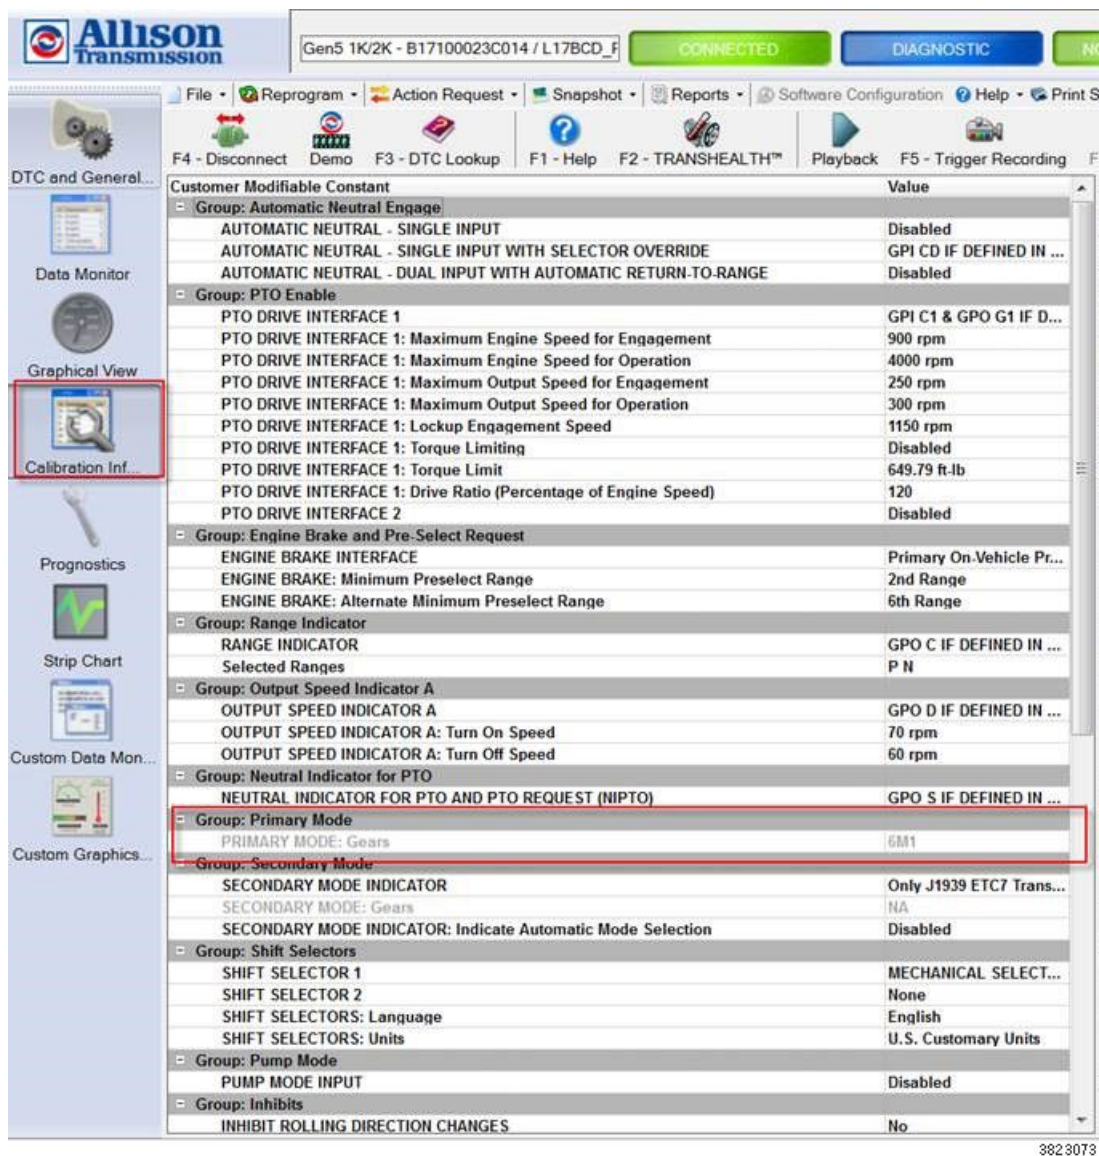
Figure 2. Example of the Correct Setting After Reflashing

Figure 2 is an example of the **correct** setting after reflashing. Notice the Value for Primary Mode: Gears is set to 6M1. The value may be 5M1 on some of these motorhomes.

**NOTE:** 6-speed transmission will use 6M1 and 5-speed transmissions will use 5M1.
