August 15, 2018

## SRS Indicator On with DTC B0090-87

### AFFECTED VEHICLES

Year	Model	Trim	VIN Range
2016	ILX	ALL	ALL
2017			ALL

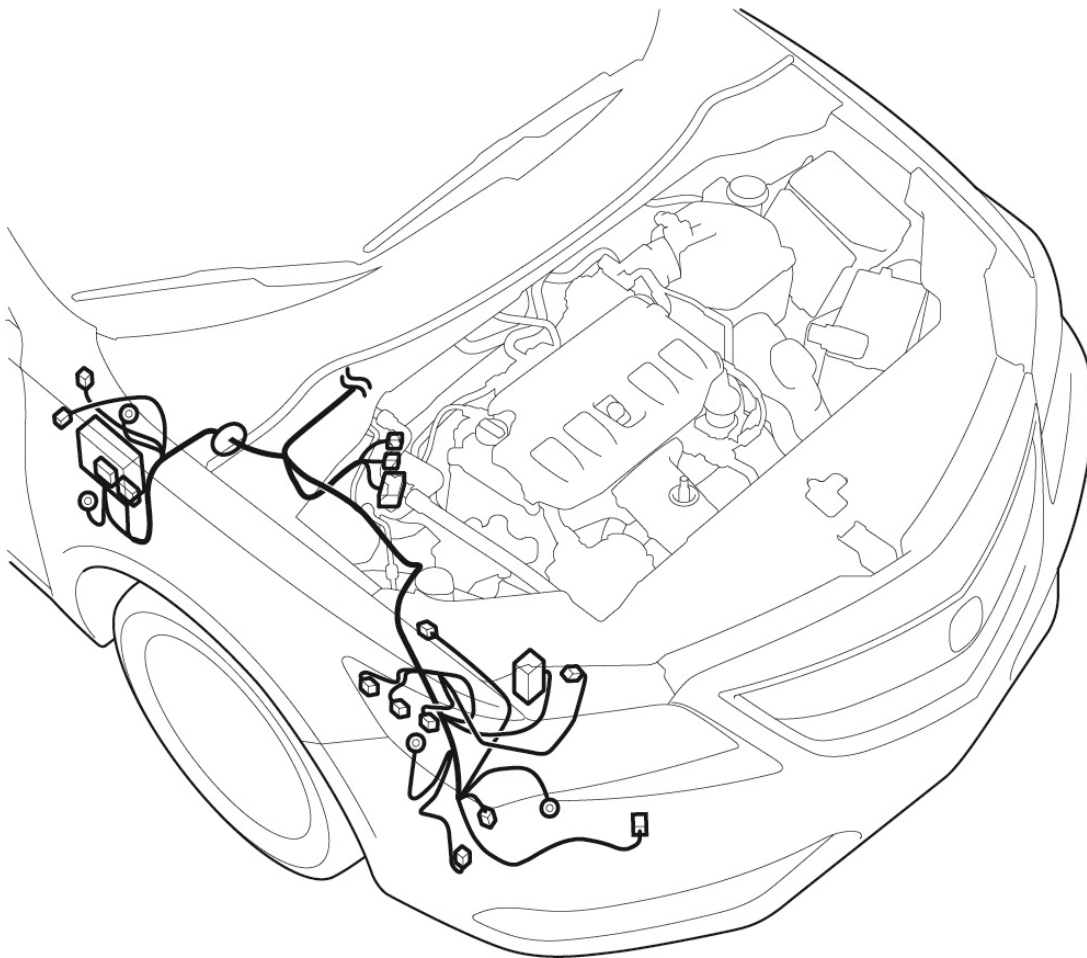
A wire diameter variance lets water enter the SRS front impact sensor connector and causes damage to the harness.

3. Vehicle interior: Remove the following parts. Refer to the service information.
  - Driver's door sill trim and kick panel (Do not remove the lock cylinder.)
  - Driver's dashboard lower cover
  - MICU
  - Passenger's door sill trim and kick panel
  - Passenger's dashboard undercover
  - EPS control unit
4. Unplug the engine room wire harness connectors and ground wires.
5. Starting from the interior on the passenger side, remove the harness. Follow the harness into the engine compartment.

- Remove the clips and harness through the firewall from underneath the vehicle.
- Temporarily re-attach the passenger side mount and bracket before raising the vehicle.
