# Technical Service Bulletin

| <b>Technical Service Bulletin:</b><br>TSB180114 | <b>Released Date:</b> 24-Aug-2018 |

## Campaign # 3475 -Low Coolant level (LCL) sensor Service kit for C100 D2Re

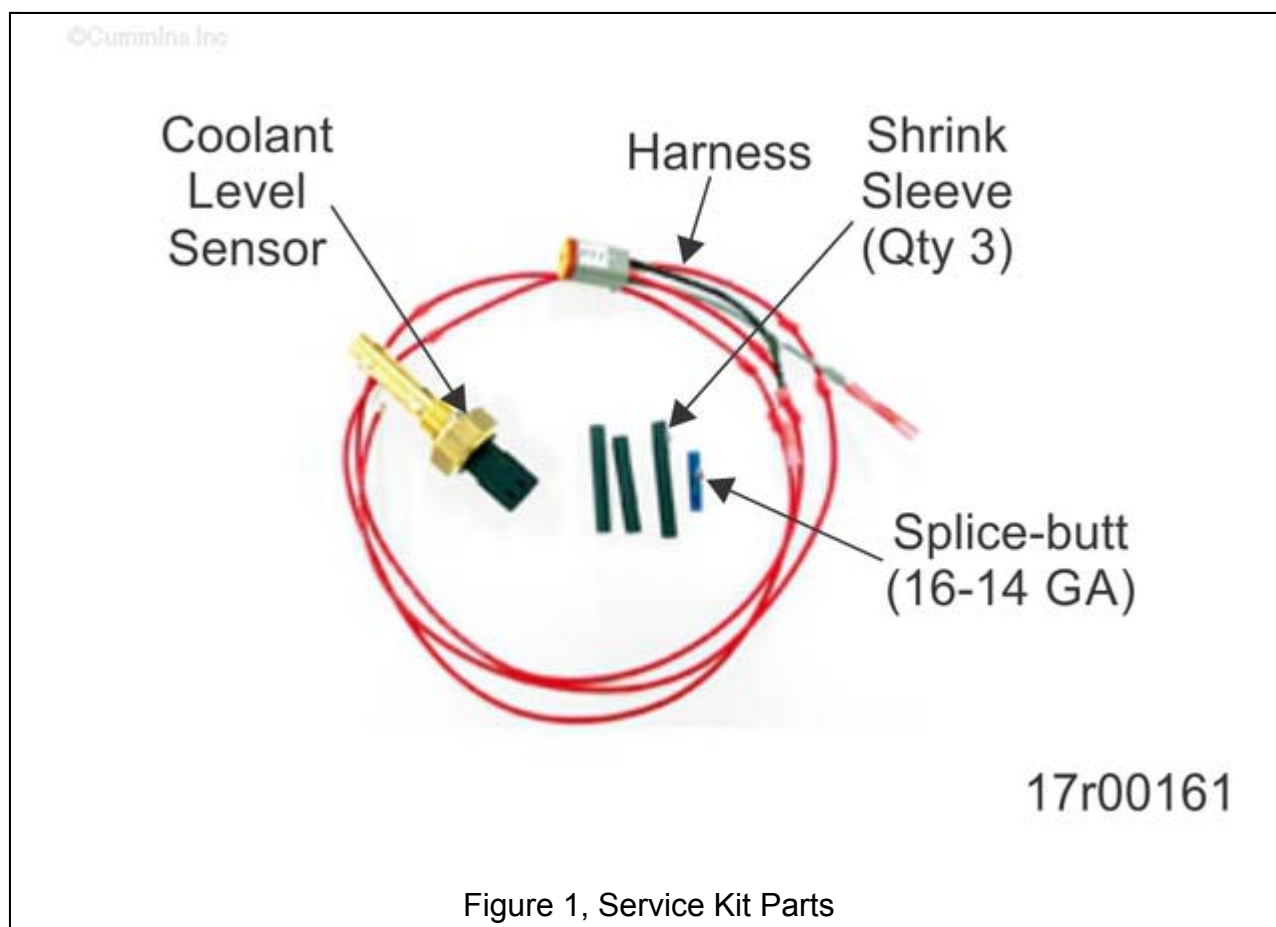
Order Service Kit A060N209 for C100 D2Re through MDC. Verify that the items shown in Figure 1 are included in the kit.
