PIP5468F Check Engine Light On with Leaks in the Charge Air Cooler System.

Brand:	Model:	Model Years:	VIN:		Engine:	Transmissions:
			from	to		
Chevrolet	Silverado	2017 - 2019	All	All	6.6 L5P	All
GMC	Sierra	2017 - 2019	All	All	6.6 L5P	All

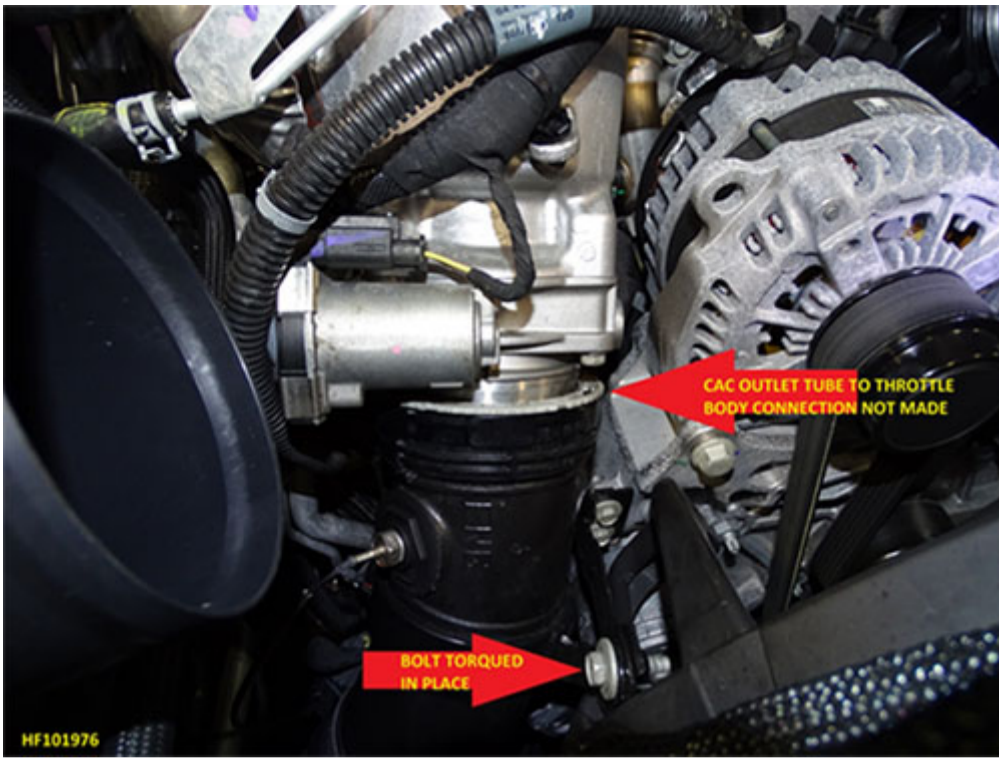
Check for non-secured connection of the charged air cooler pipe at the intake air flow valve (throttle body).
Check for proper alignment of the charged air cooler pipe bracket and bolt hole.

If P2463 was not set and a charge air cooler leak or disconnect was found, after repairing charge air cooler connections, command Diesel Particulate Filter (DPF) Regeneration Enable with the scan tool before returning the vehicle to the customer.

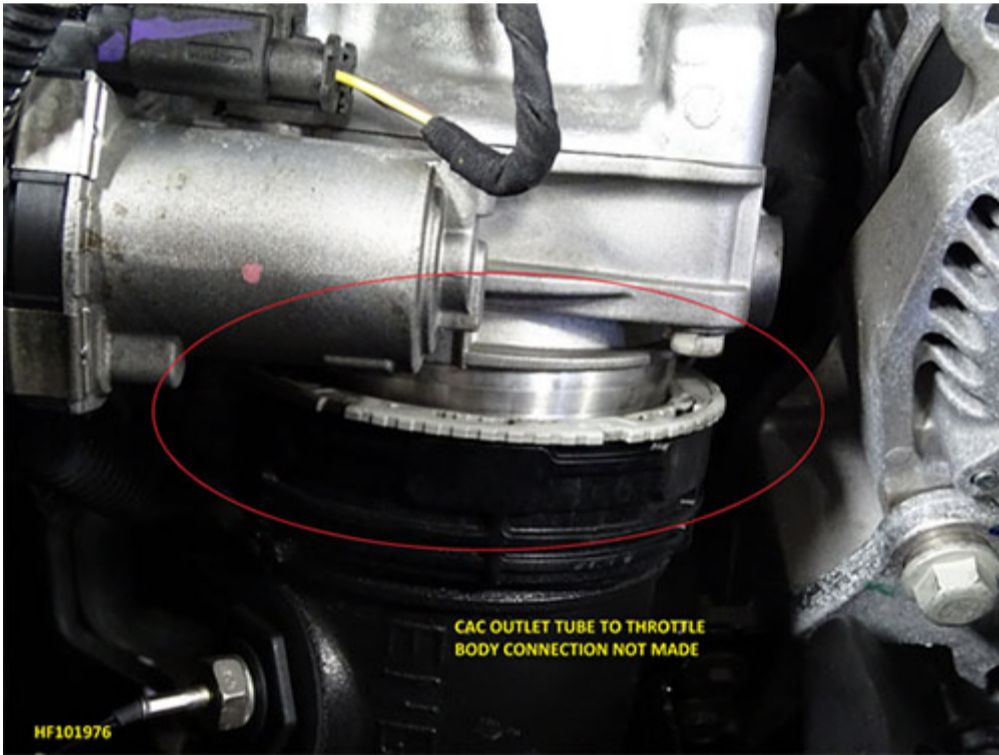
Non-secured connection.

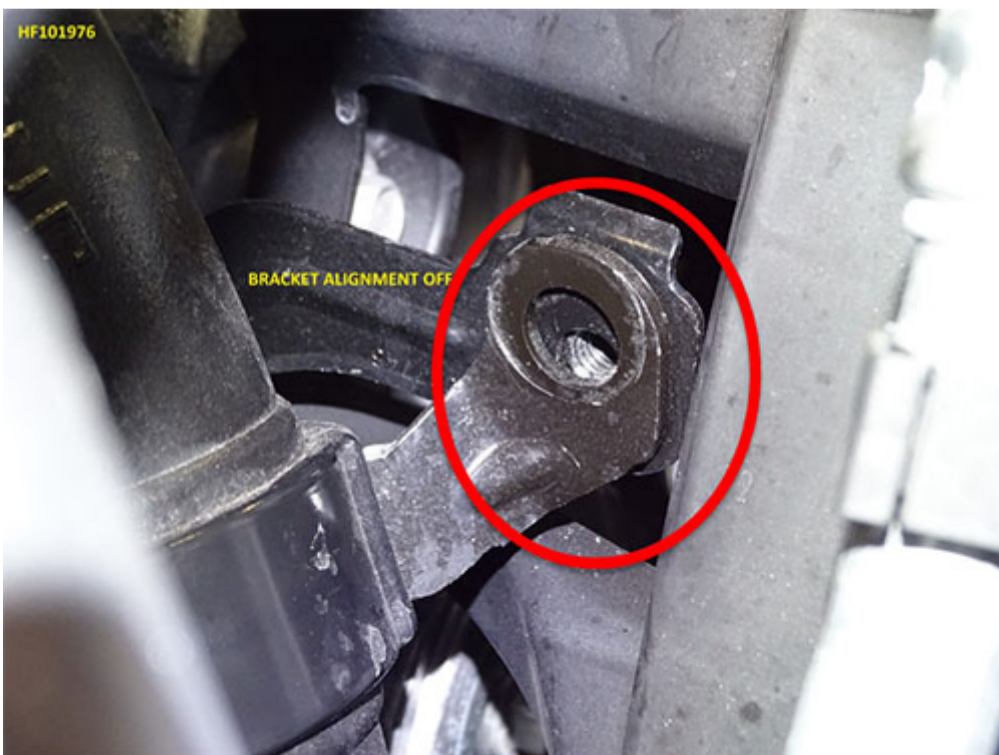
Mis-aligned charged air cooler pipe bracket and bolt hole after the charge air cooler outlet hose is connected properly to the throttle body.
