Preliminary Information

PIP3423P DTC P0016 P0017 P0018 P0019 P0008 P0009

Condition / Concern

Vehicles equipped with 2.8 LP1, 2.8 LAU, 3.0 LF1, 3.0 LFW, 3.6 LFX, 3.6 LFY, 3.6 LLT, or 3.6 LY7 HFV6 engines may exhibit two or more of the following DTCs: P0016, P0017, P0018, P0019, P0008 or P0009.

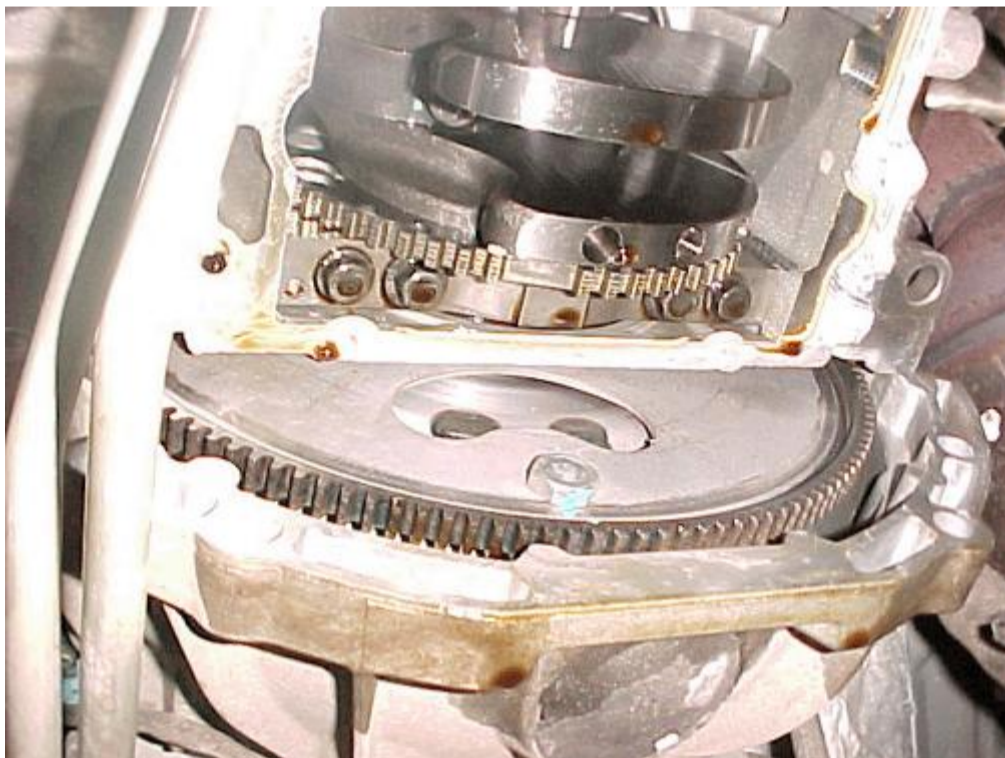
The reluctor for the crankshaft sensor pressed onto the rear of the crankshaft may have moved.

Refer to attached photographs for exact location.

If the reluctor has moved then replace crankshaft.

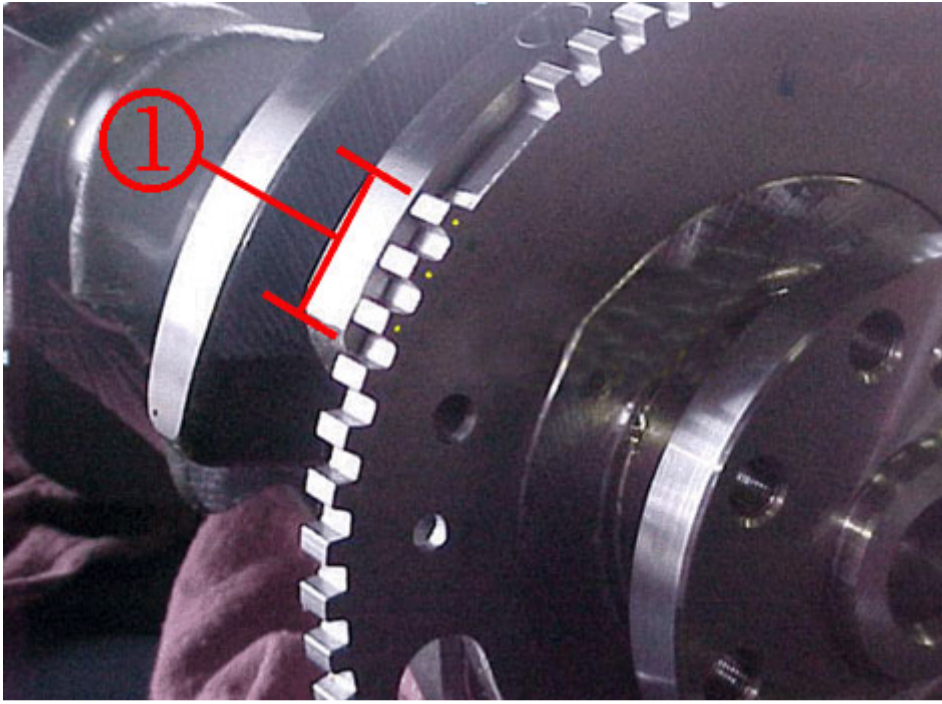
1= The actual measurement of a good Reluctor wheel.

25 to 26 mm This measurement is from the end of the machined surface of the crankshaft throw to the edge of the open space in the reluctor. (approximately 3 1/2 teeth)

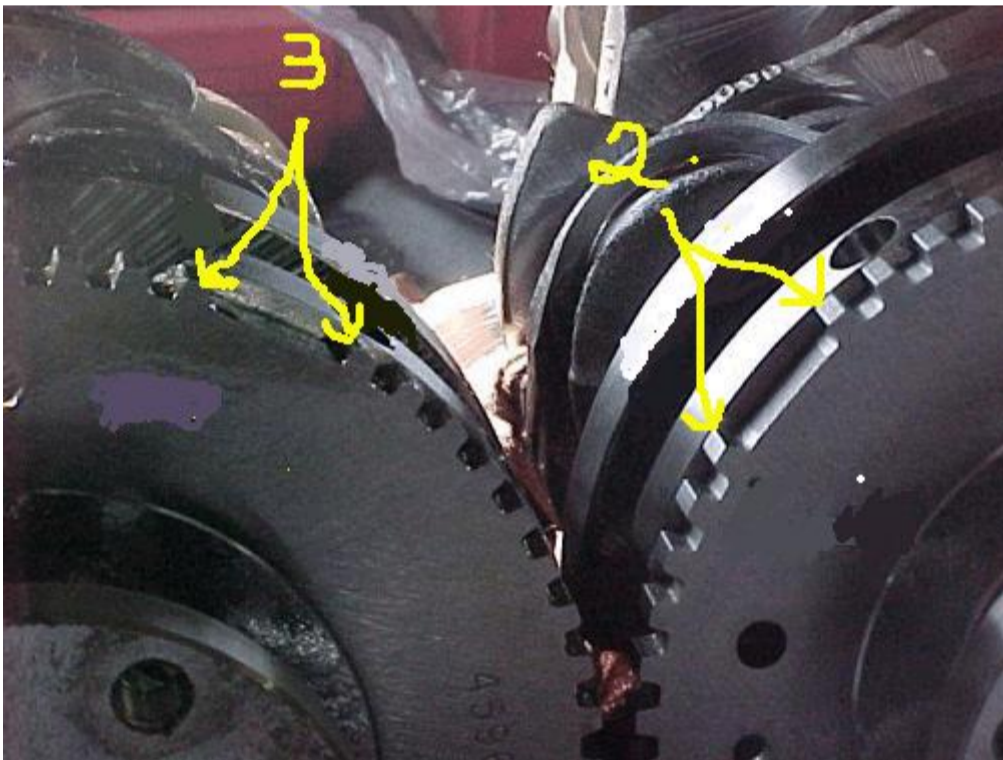
2 and 3 = Show a good reluctor next to a bad reluctor.

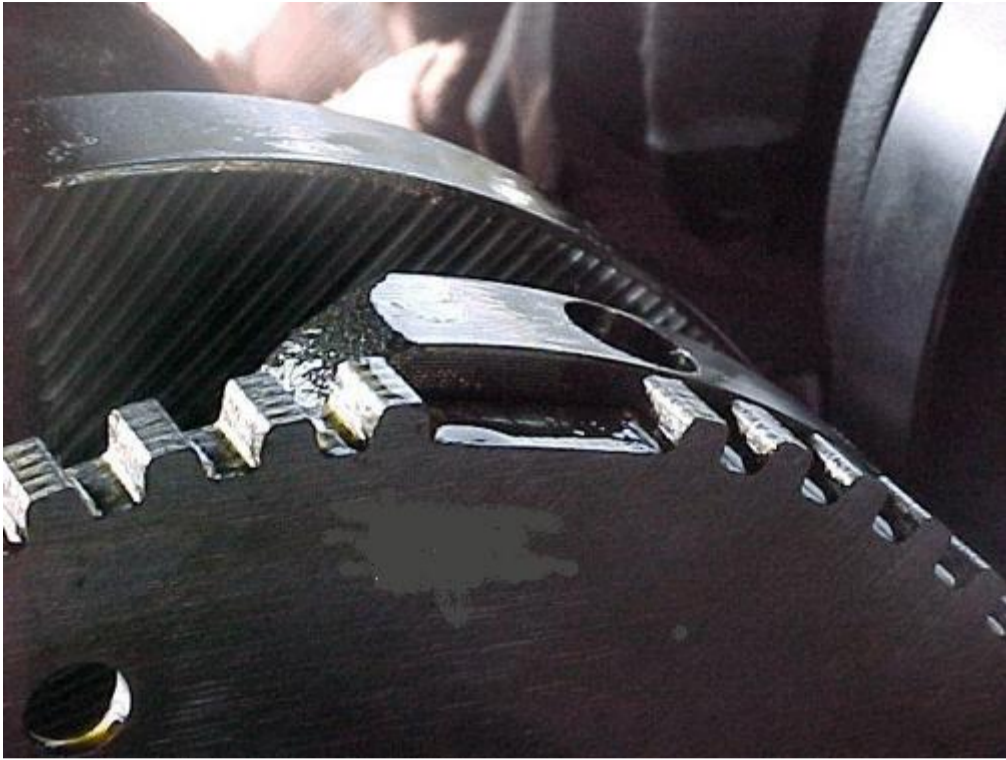
Crankshaft with bad reluctor wheel.

NOTE: The distance can be offset either clockwise or counter clockwise. Both will result in these codes.

NOTE: The balance hole does not come into play when determining if the reluctor has slipped or not.
