Preliminary Information

PIP5493G Misfire with DTC's P0300, P0301-P0306

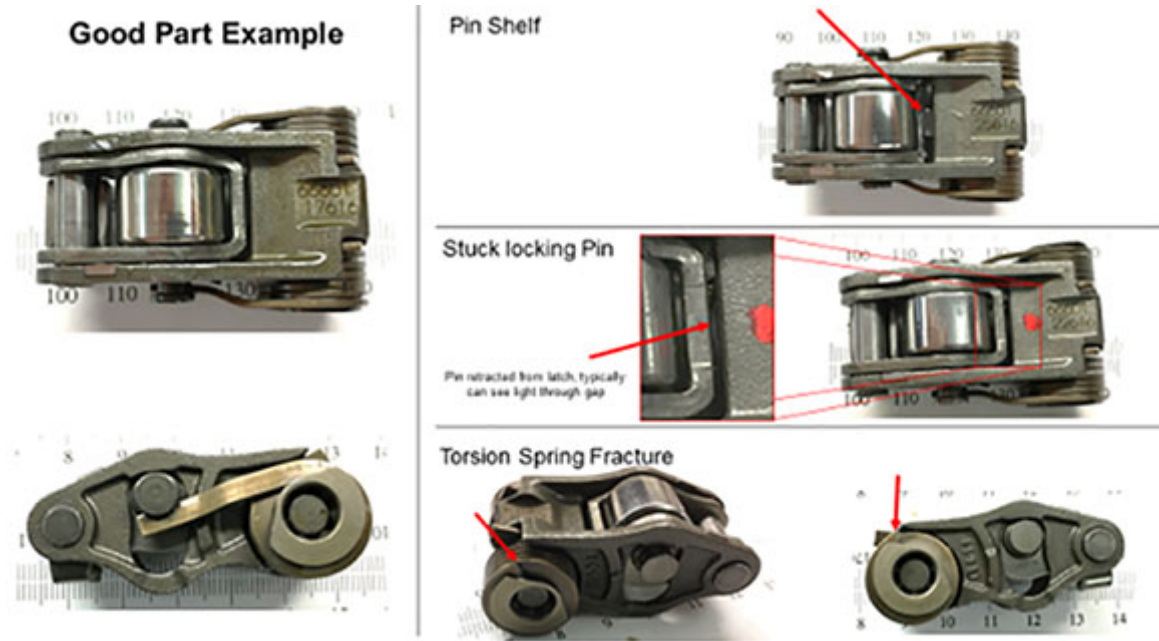
- 1) Perform normal eSI diagnostics testing all spark and fuel components for issues. (Coil grounds and wiring, injector concerns, spark plugs, etc)
If no concerns are found following ESI then follow this PI for repair.
- 2) Inspect for broken or dislodged SRFFs (rockers arms) per the pictures below.
While inspecting the rockers it will be necessary to rotate the engine over by hand to ensure that the rockers are

opening the valves.

If any one of the SRFF's are damaged it will be necessary to replace all four on the affected cylinder.

4) If any broken parts are found during inspection replace all damaged parts. It will also be necessary to replace the AFM OCV in the camshaft cover for both banks.

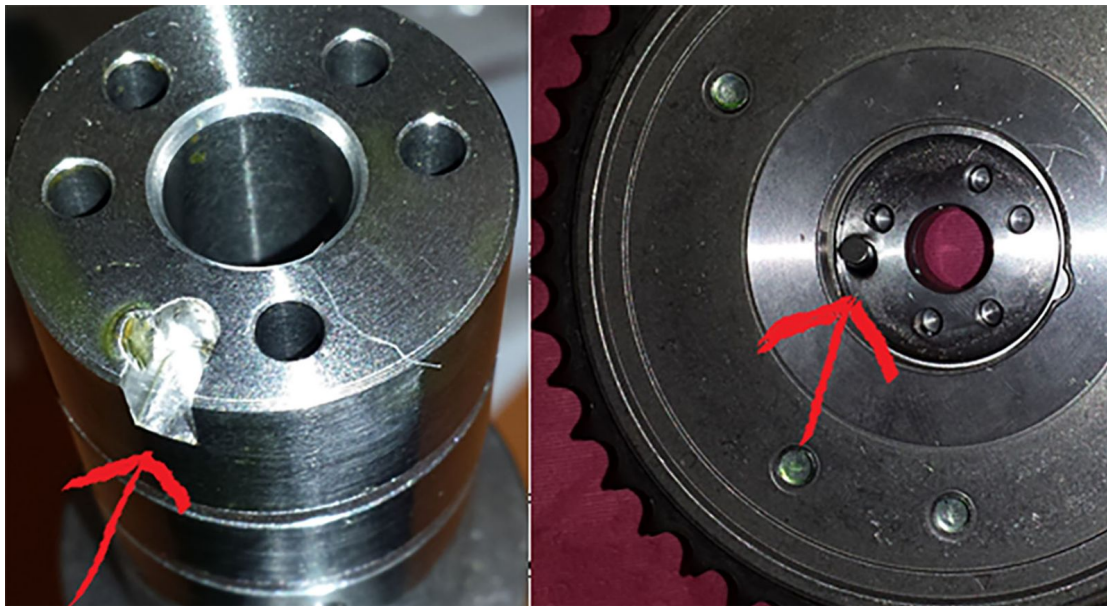
3) Remove the camshaft actuators on the bank that is misfiring and inspect the end of the camshafts and the pin in the actuators for being bent example shown below.
