Preliminary Information

PIP5486D Ticking, Tap, or Rattle Noise From Engine With Possible Misfire DTCs.

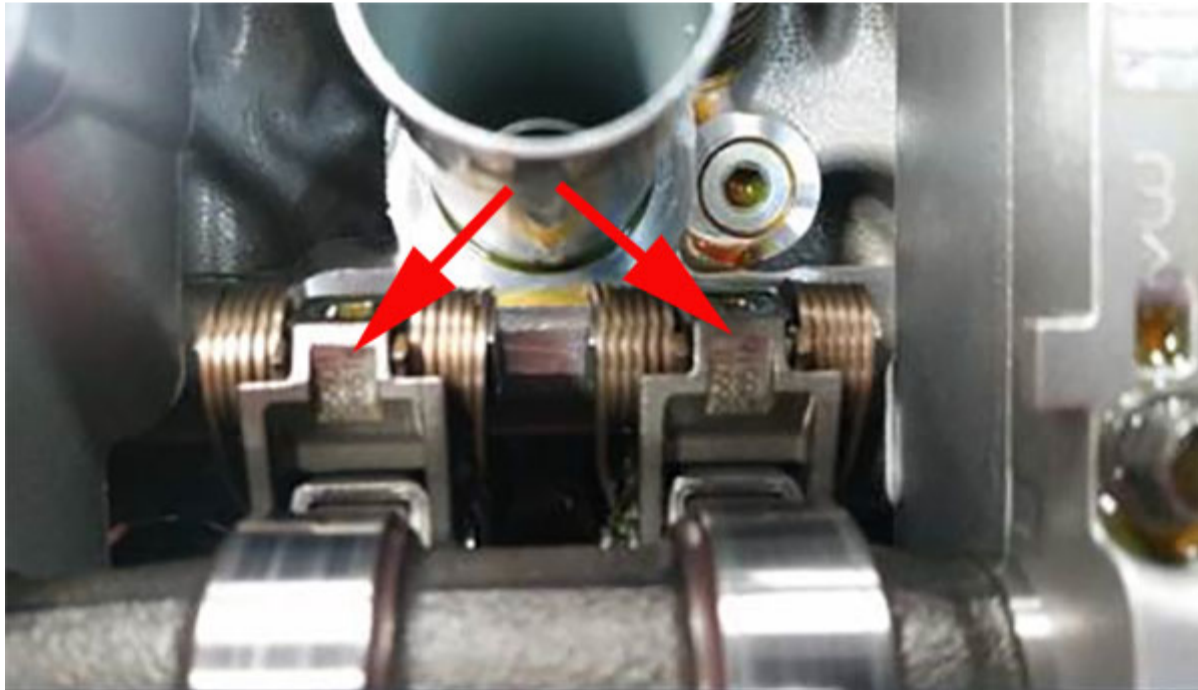
- a) Push down on the rocker end at the SHLA to test for soft or spongy feel. (See below)**

c) If soft , spongy, or damaged SHLAs or rockers are found on either the intake or exhaust side of any cylinder it will be necessary to replace all the affected cylinder SHLAs or rockers and retest.

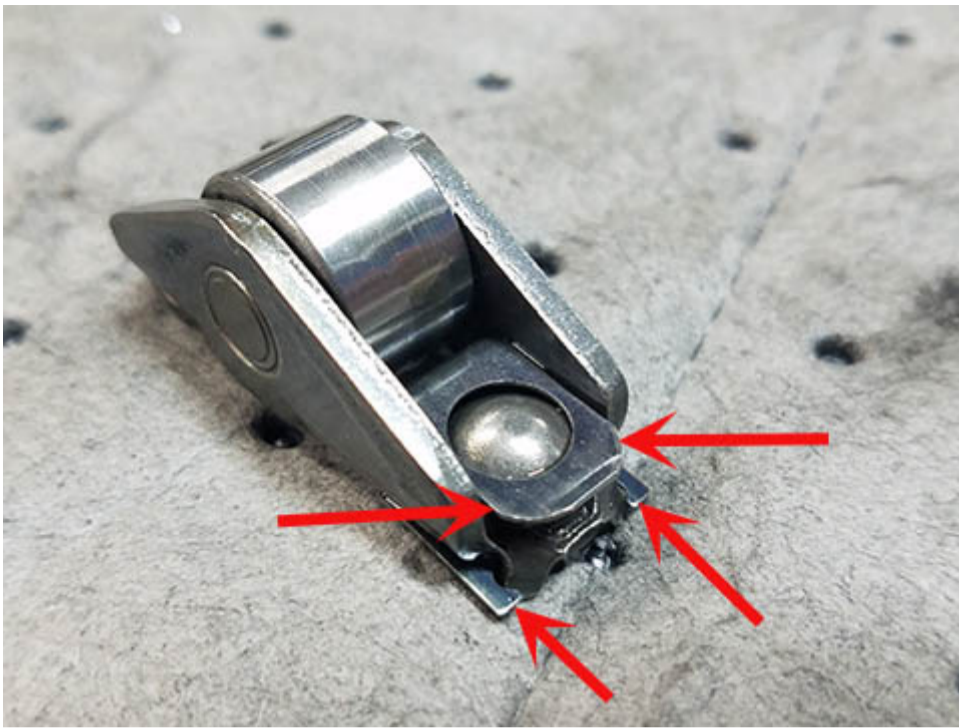
- b) Check for any visible damage to non-AFM rocker clips and replace as needed. (See Below)**

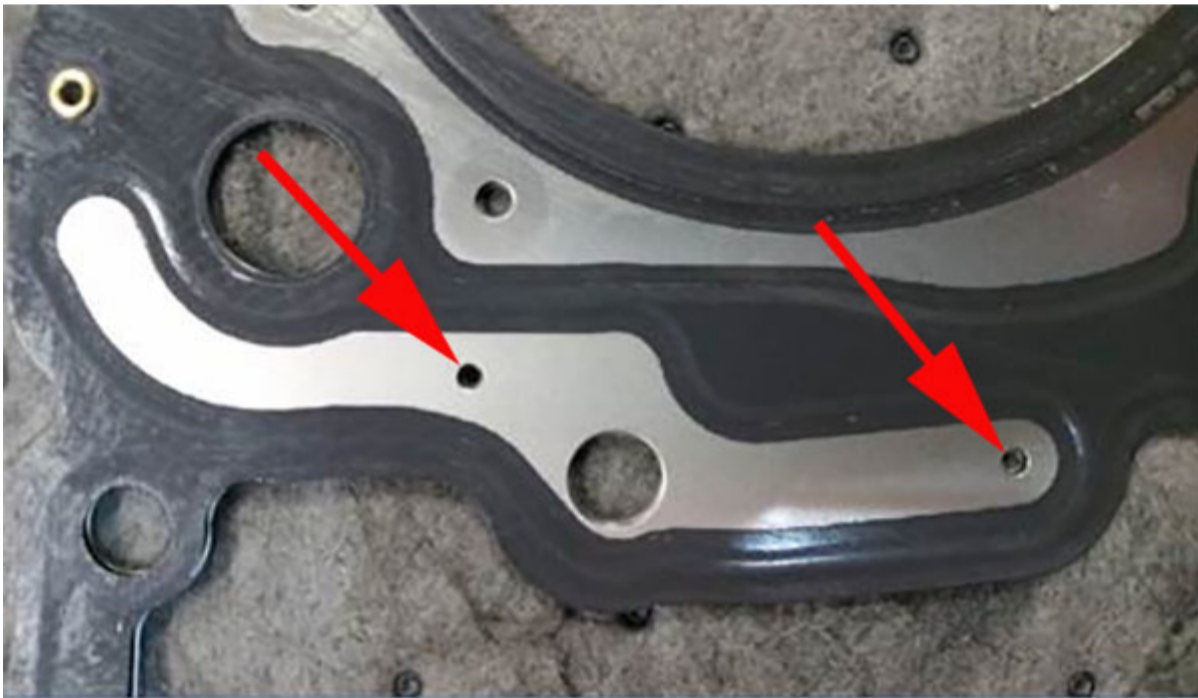
a) If the replacement SHLAs are still spongy it will be necessary to remove the affected head and inspect the head gasket for debris in the oil passages noted below.

b) If debris is found, inspect the camshaft caps for wear or discoloration due to lack of oil.

c) If wear or discoloration is found then replace the cylinder head assembly with camshafts.

d) If there is no wear or discoloration, clean the oil passages and replace the head gasket.

e) Change the oil and filter

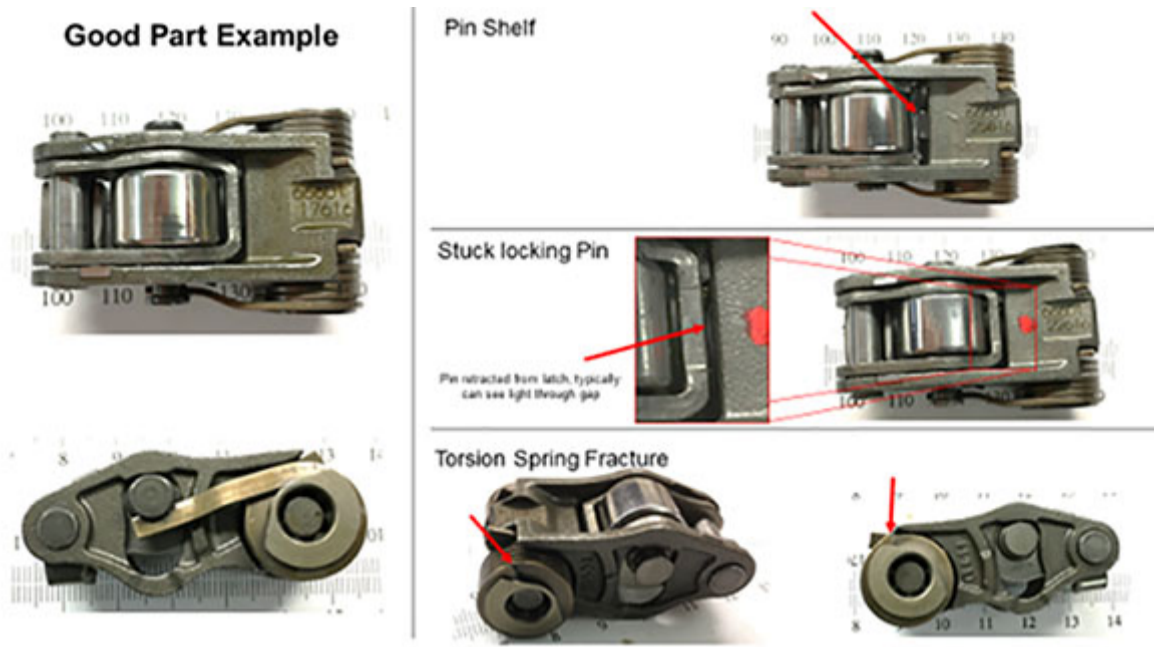
Below are pictures of possible SRFF failures.

If any one of the SRFF's are damaged it will be necessary to replace all four on the affected cylinder.

For the above conditions engine replacement is not necessary.
Please perform the repairs for these conditions.
