Preliminary Information

PIP5489C Concerns Caused By Restricted Air Filter Element

Brand:	Model:	Model Years:	VIN:		Engine:	Transmissions:
			from	to		
Chevrolet	Silverado	2017 - 2019	All	All	6.6 L5P	All
GMC	Sierra	2017 - 2019	All	All	6.6 L5P	All

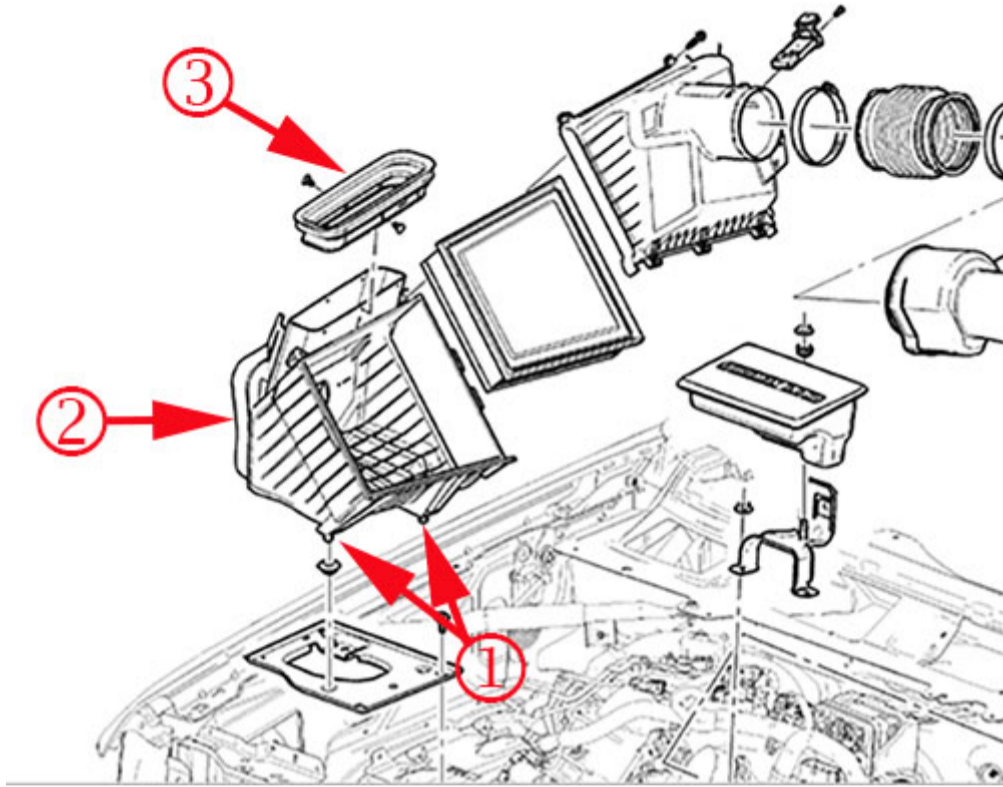
1. Check alignment of box at points 1 and 2 (Refer to illustration above)

- If airbox alignment is poor – realign airbox
- If ok, move to next step

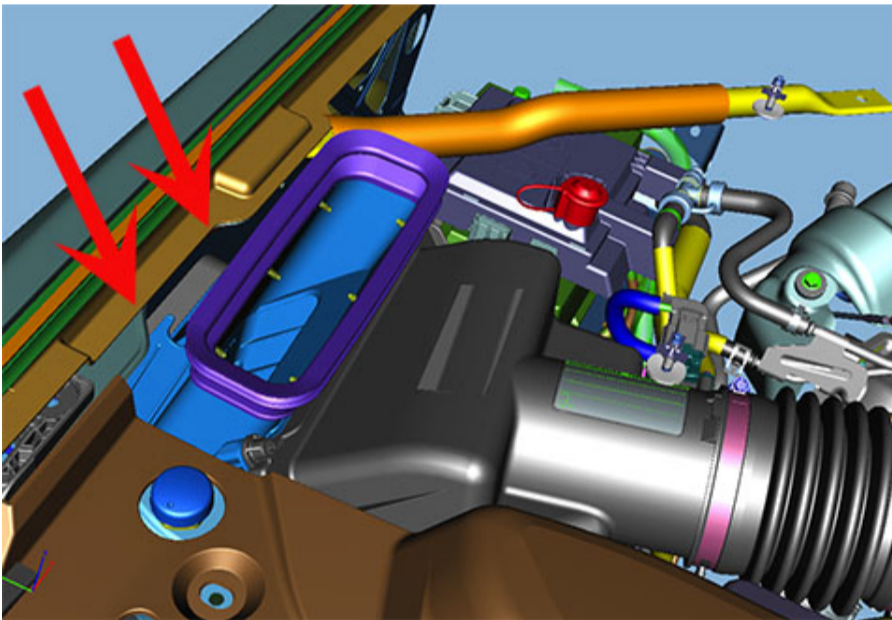
The picture above is of a properly aligned and sealed air box to fender.

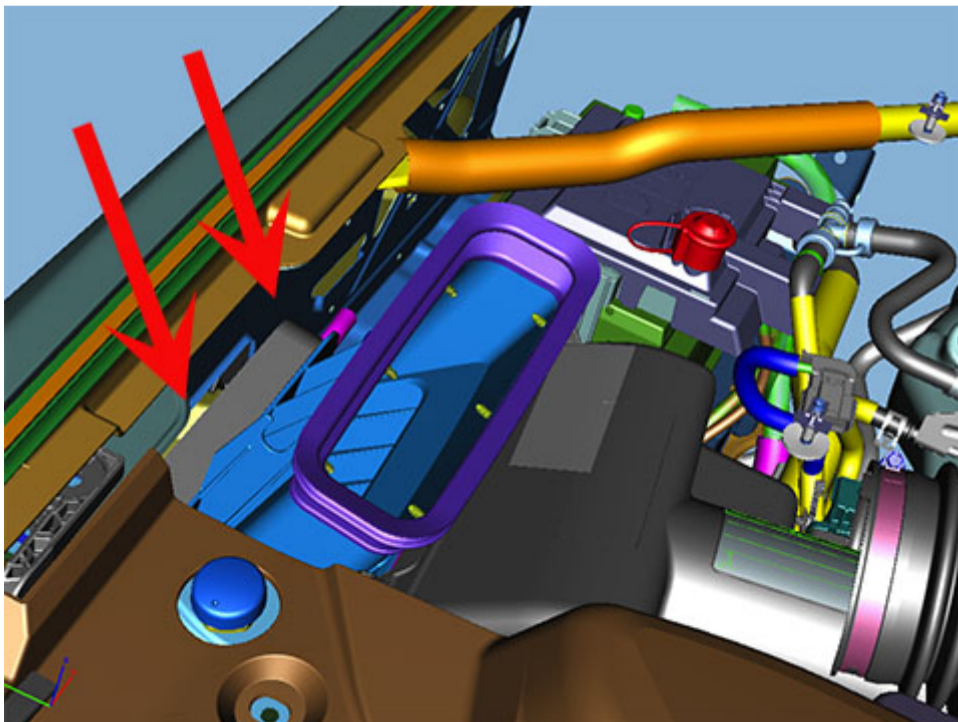
The picture above is of a misaligned air box.

If the air filter box is not positioned properly, it may compromise the sealing between the hood and the inner fender.

If sealing is compromised, snow can reach the air cleaner element along with warm air pulled from under the hood.

This can cause the snow to melt and re-freeze on the air cleaner element blocking it with ice.

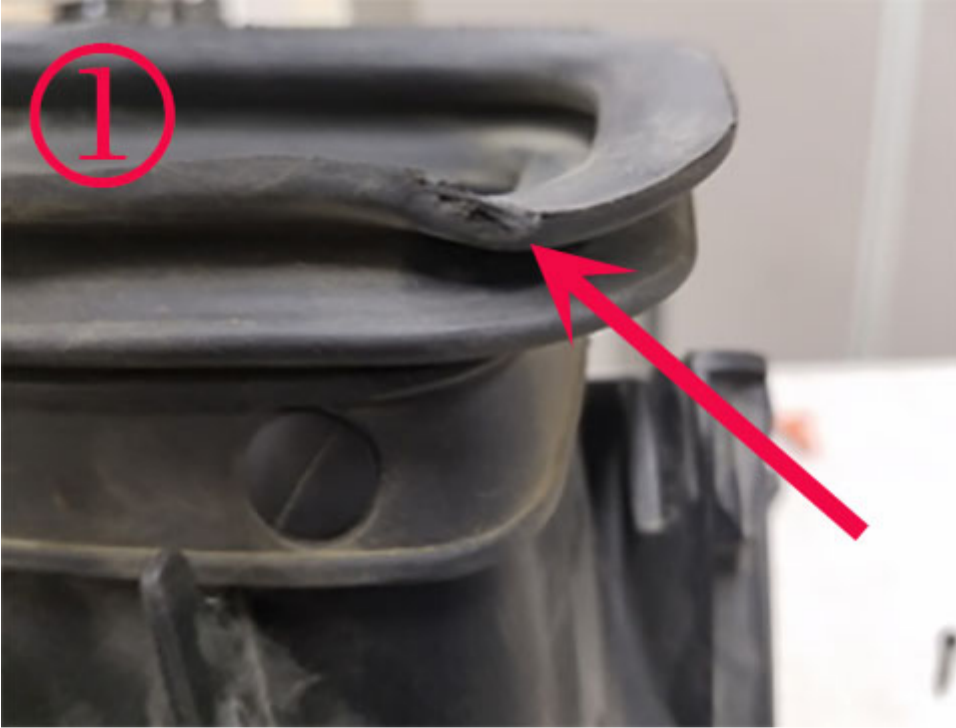
Example of torn seal (Picture 1)

- If seal is found damaged, only replace upper seal
- If seal is found ok, move to next step

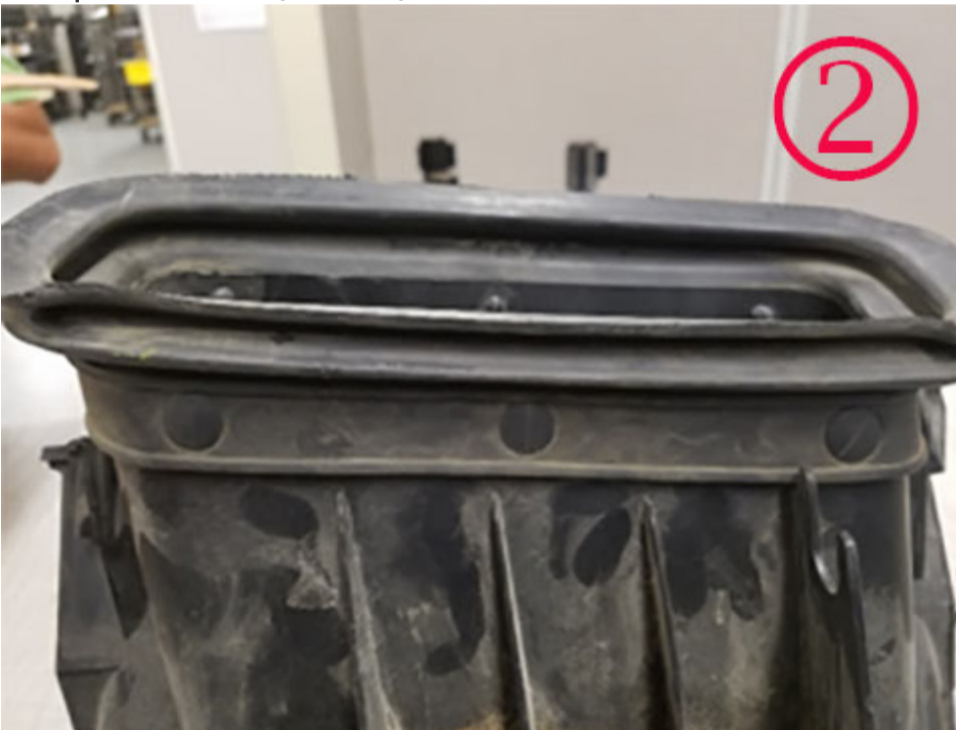
Example of bent seal (Picture 2)

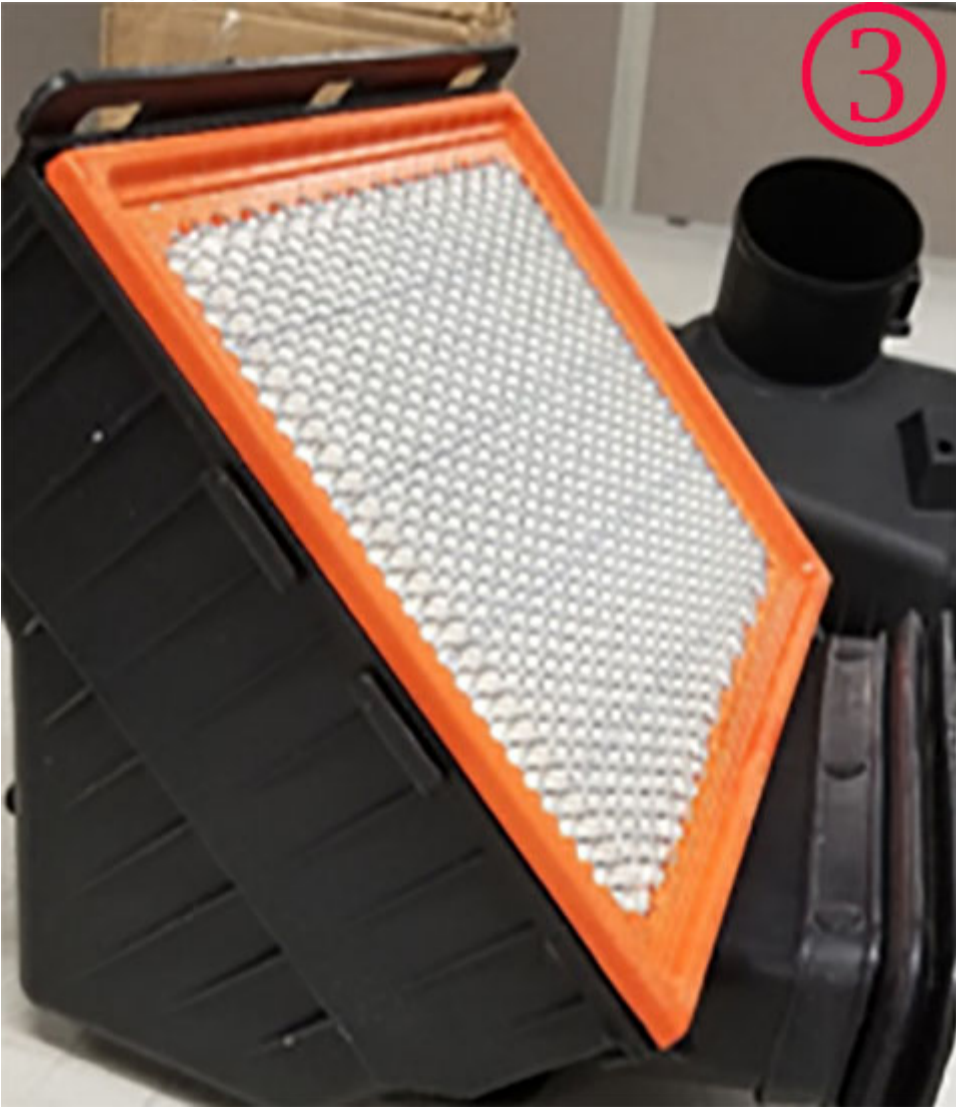
Example of a good air filter (Picture 3)

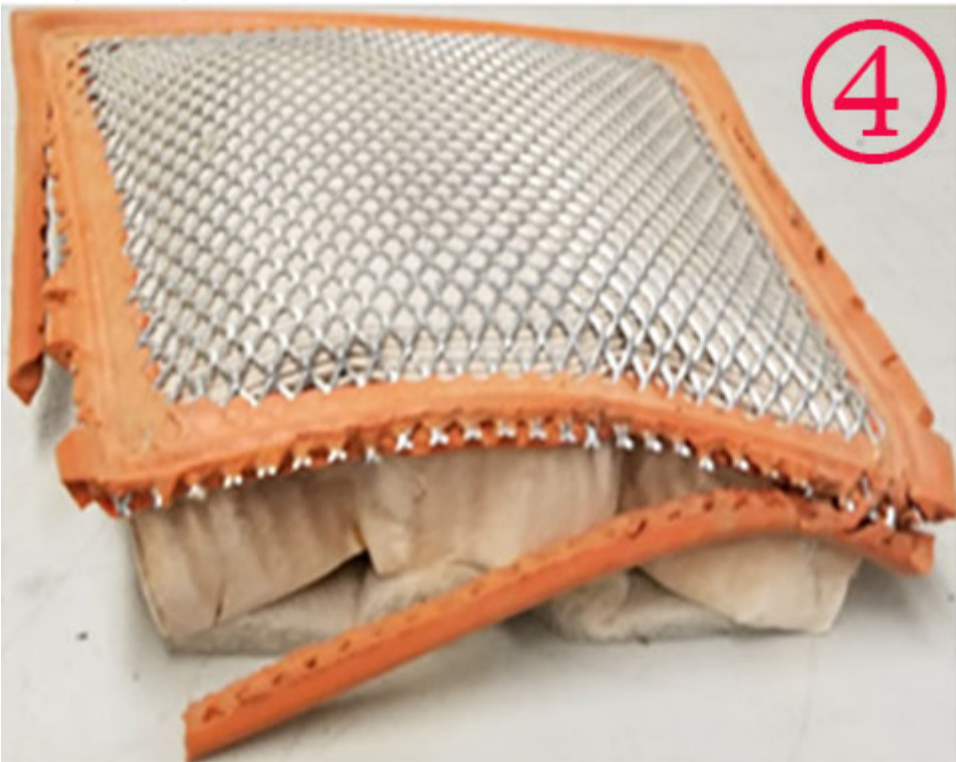
Example of a collapsed air filter (Picture 4)

- If filter is found damaged, replace
- If there is no trouble found with the filter, please refer to Service Information for further diagnostics.

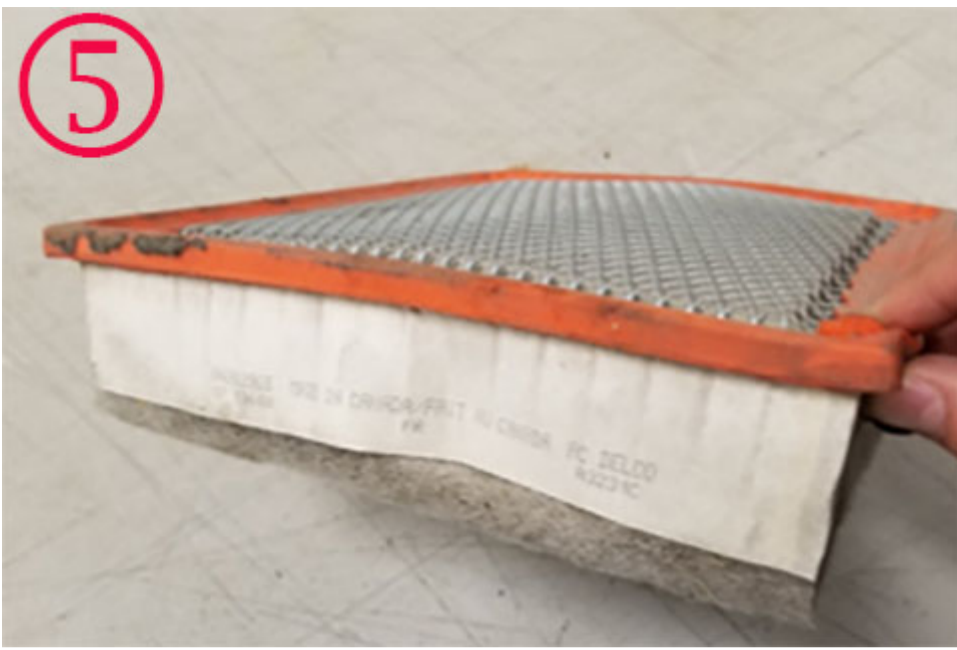
Example of Filter – Early Collapse (Picture 5)

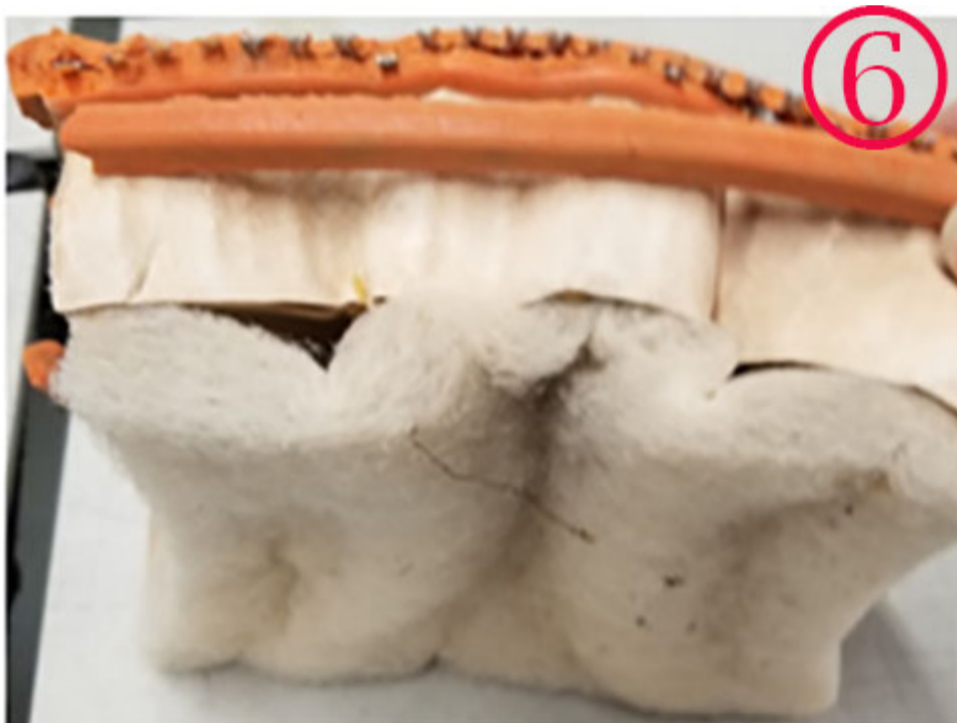
Example of dirty side damage (Picture 6)

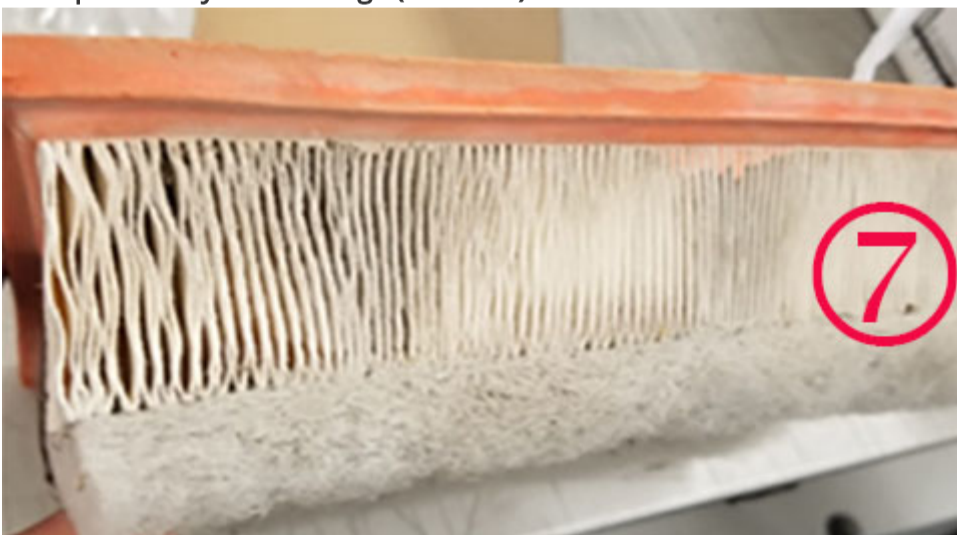
Example of moisture damage (Picture 7)

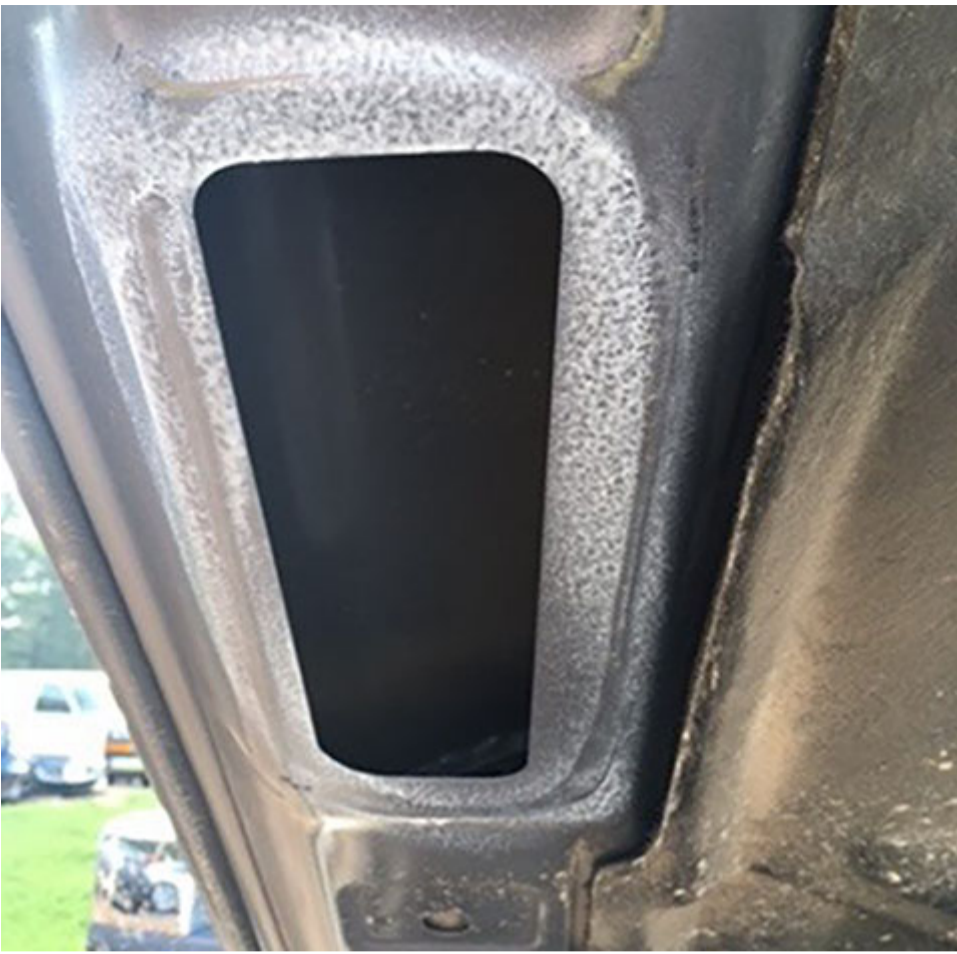
Proper sealing between the air box upper gasket (3) and hood can be checked by wetting the gasket (foaming glass cleaner was used in the photos below), closing the hood and then checking for a contact ring witness mark around the entire hood duct opening to the air cleaner assembly.

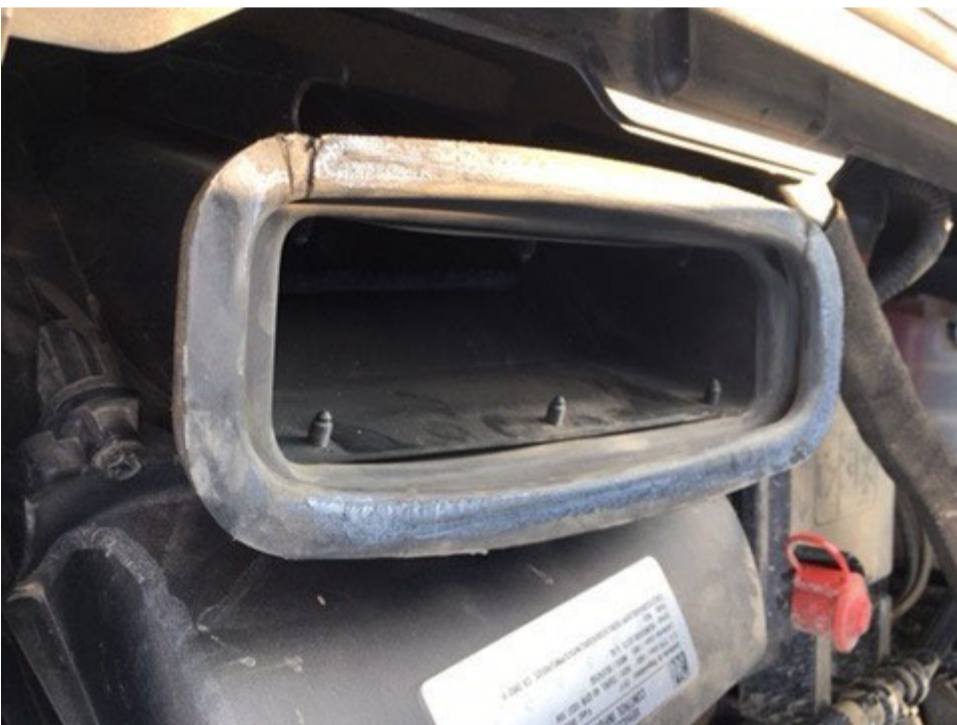
The photo below shows a lack of contact in the front edge of the air cleaner seal.

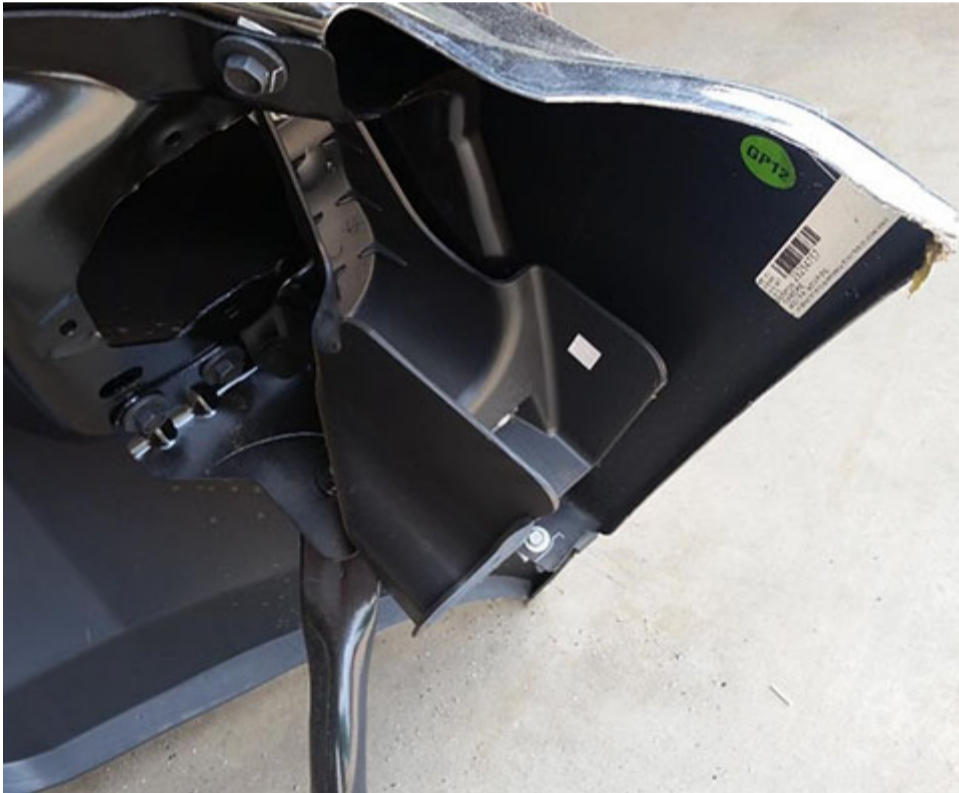
OEM bumper with intake air box protection to help prevent moisture and other debris getting into the air cleaner box.

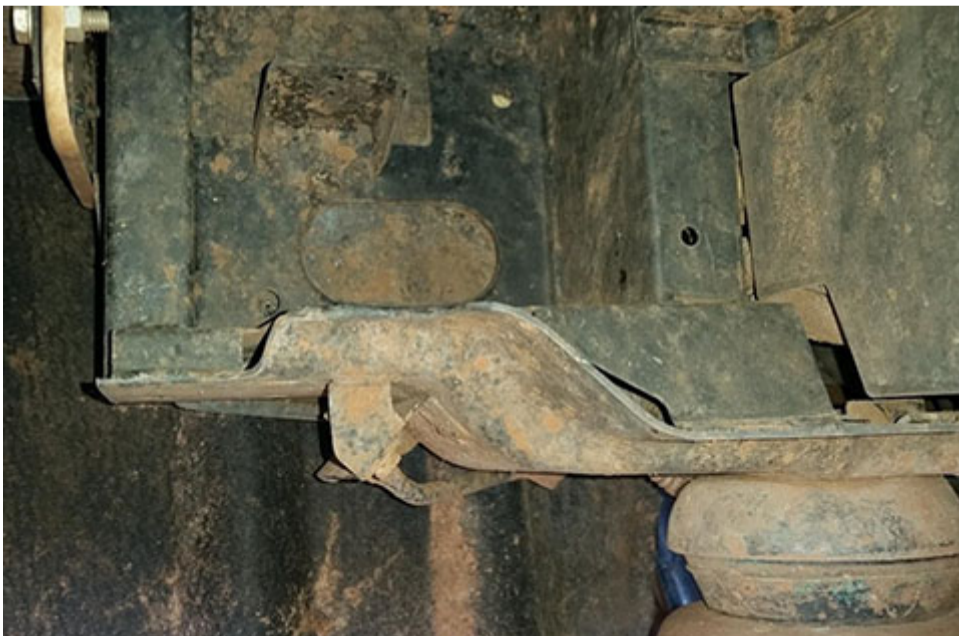
Aftermarket bumper without intake air box protection.
