# Preliminary Information

## PIP5557C Intermittently Vehicle May Not Go Above 30 MPH Stuck In 2nd Gear Will Not Upshift MIL On DTC P2821 Set

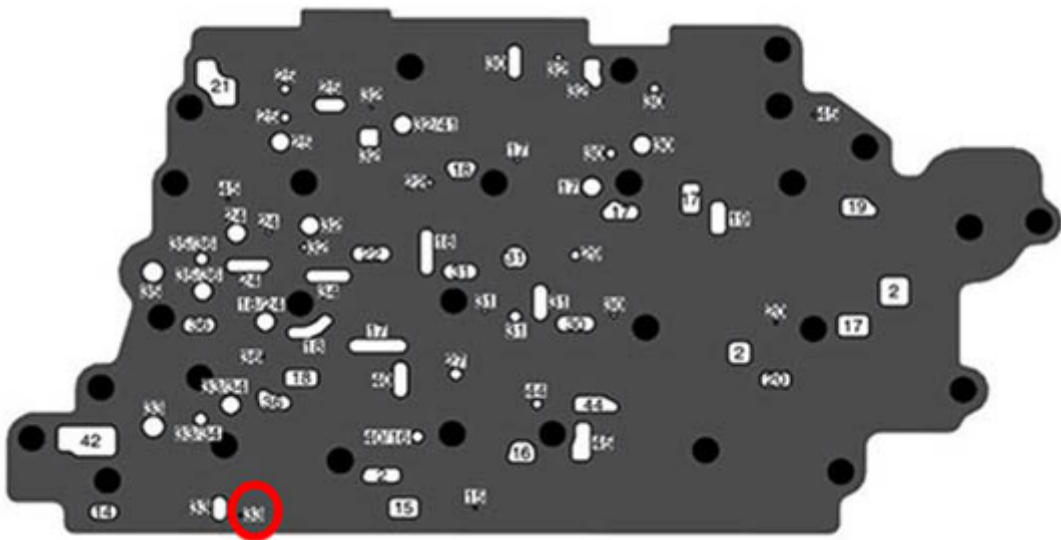
If the diagnostics procedures have found no conditions that set the codes, inspect the Control Valve Body spacer plate Orifice #33 for blockage.

**Note :** This spacer plate is between the trans assembly case and the valve body assembly, item #456, using SI #4368440.

**NOTE:** Since the hole is only 0.5 mm in diameter the best way to inspect is to shine a light

**from behind the spacer plate and look for the light through the hole.**

If the orifice is blocked, replace the spacer plate with a new one.

**Note :** If the spacer plate is to be replaced, refer to TSB 18-NA-121 as the spacer plate and TCM update as per the TSB must be performed at the same time.
