# Preliminary Information

## PIP5472E Short Duration Misfire - Rough Idle - MIL On During Cold Start - P050D

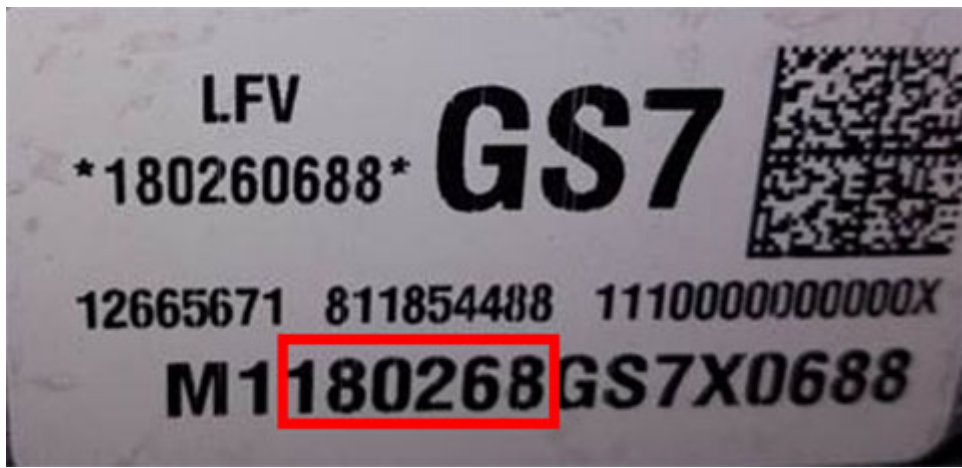
**Example Engine Unit Number:**

The engine Unit Number Label is located on the engine front cover.

The first digit = engine plant.

The second digit reflects the shift, in this case 1 = First Shift

The third and fourth digits reflect the model year, in this case 18 = 2018

The fourth, fifth and sixth digits reflect the day of that calendar year 026 = 26<sup>th</sup> day of 2018 calendar year (build date)

If the engine you are working on was built on or after 17135, the SHLA's (Stationary Hydraulic Lash Adjuster) should not be replaced for this concern.

If the engine you are working on was built before 17135, then replace all Exhaust SHLA's. (Stationary Hydraulic Lash Adjuster)
