SERVICE BULLETIN

Classification: EC13-007d	Reference: NTB13-054d	Date: June 29, 2018
------------------------------	--------------------------	------------------------

ALTIMA AND ROGUE; ENGINE TURNS OFF OR HESITATES WHEN ACCELERATING FROM A STOP DURING HOT AMBIENT TEMPERATURES (+100° F)

APPLIED VEHICLES: 2013-2017 Altima Sedan (L33)
2014-2017 Rogue (T32)

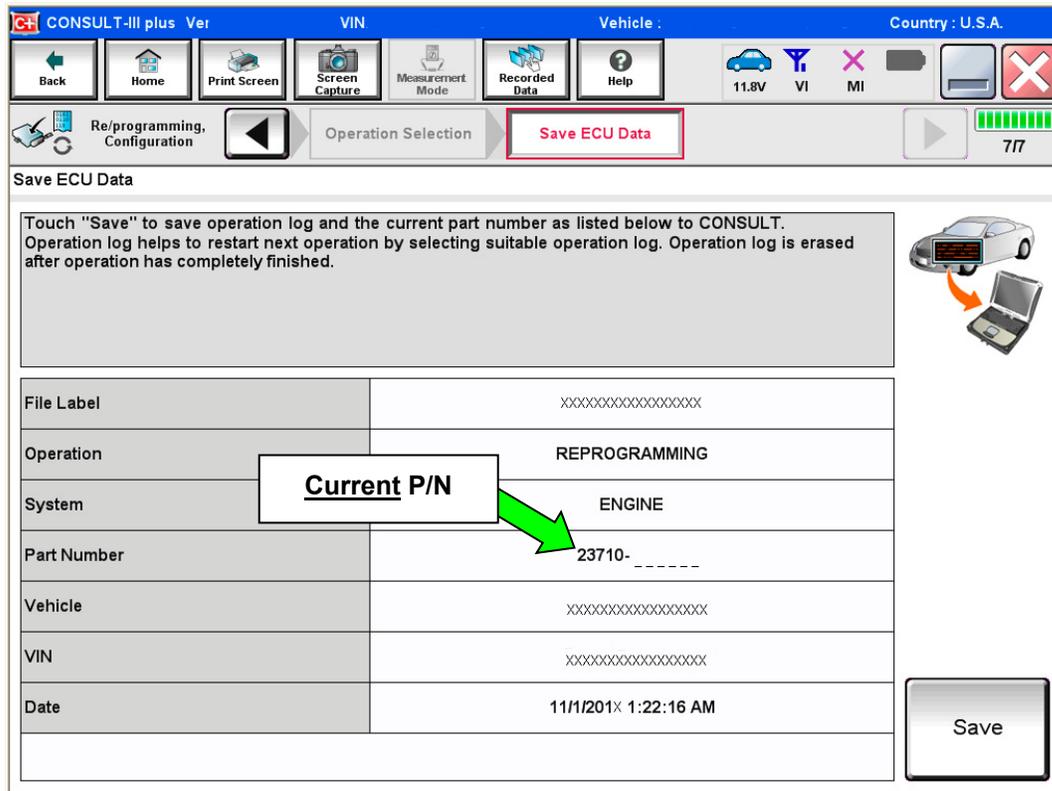
Figure 2

6. When you get to the screen shown in Figure 2, confirm this bulletin applies as follows:

A. Find the ECM **Part Number** and write it on the repair order.

NOTE: This is the current ECM Part Number (P/N).

B. Compare the P/N you wrote down to the numbers in the **Current ECM Part Number** column in **Table A** on pages 5 - 7.

- If there is a match, this bulletin applies. Continue with the reprogramming procedure.
- If there is not a match, this bulletin does not apply. Return to ASIST for further diagnostic and repair information.

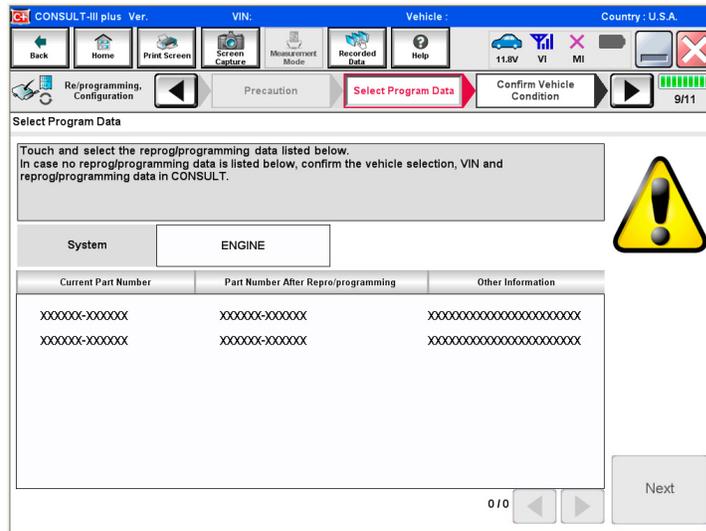
- In some cases, more than one new P/N for reprogramming is available.
 - In this case, the screen in Figure 3 displays.
 - Select and use the reprogramming option that **does not** have the message “Caution! Use ONLY with NTBXX-XXX”.
- If you get this screen and it is blank (no reprogramming listed), it means there is no reprogramming available for this vehicle.

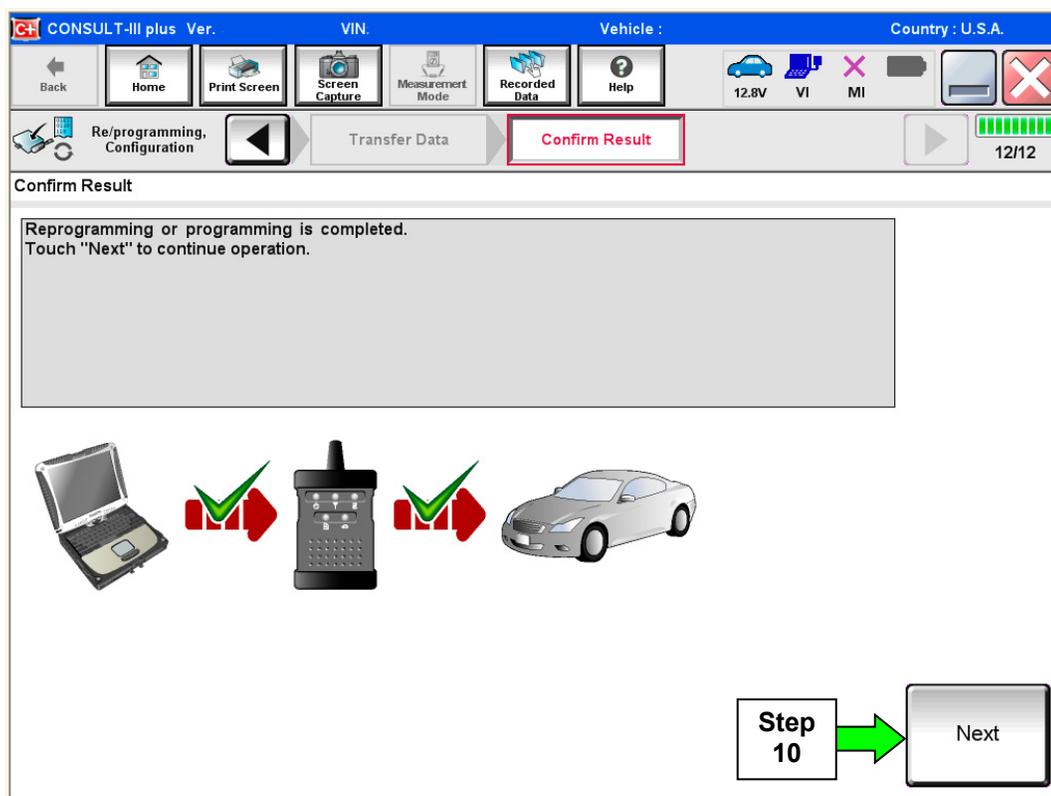
8. When the screen in Figure 5 displays, reprogramming is complete.

NOTE: If the screen in Figure 5 does not display (which indicates reprogramming did not complete), refer to the information on the next page.

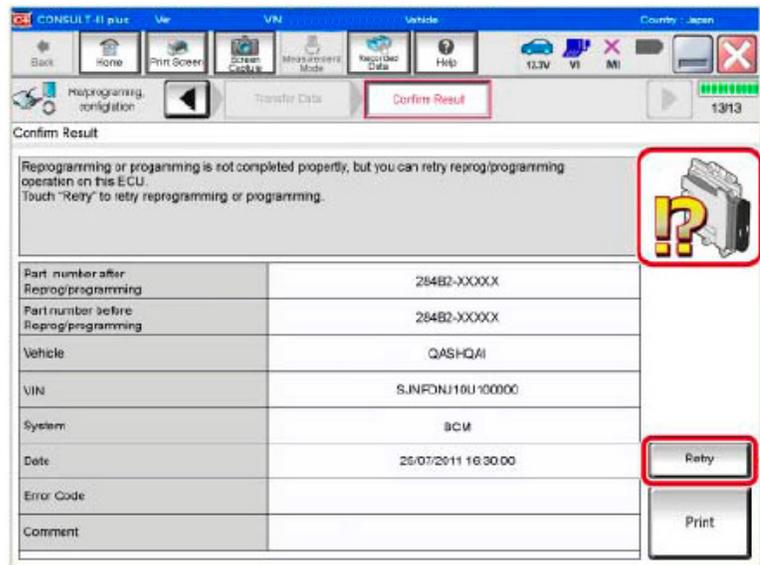
Figure 6

If reprogramming does not complete and the “!” icon displays as shown in Figure 6:

- Check battery voltage (12.0 - 15.5 V).
- Ignition is ON, engine OFF.
- External Bluetooth® devices are OFF.
- All electrical loads are OFF.
- **Select retry and follow the on screen instructions.**
- “Retry” may not go through on first attempt and can be selected more than once.

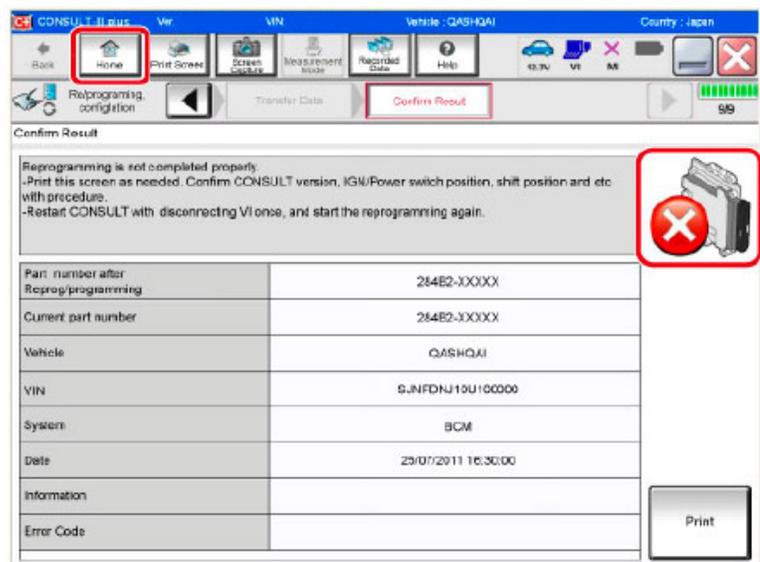
Figure 7

If reprogramming does not complete and the “X” icon displays as shown in Figure 7:

- Check battery voltage (12.0 - 15.5 V).
- CONSULT A/C adapter is plugged in.
- Ignition is ON, engine OFF.
- Transmission is in Park.
- All C-III plus / VI cables are securely connected.
- All C-III plus updates are installed.
- **Select Home, and restart the reprogram procedure from the beginning.**

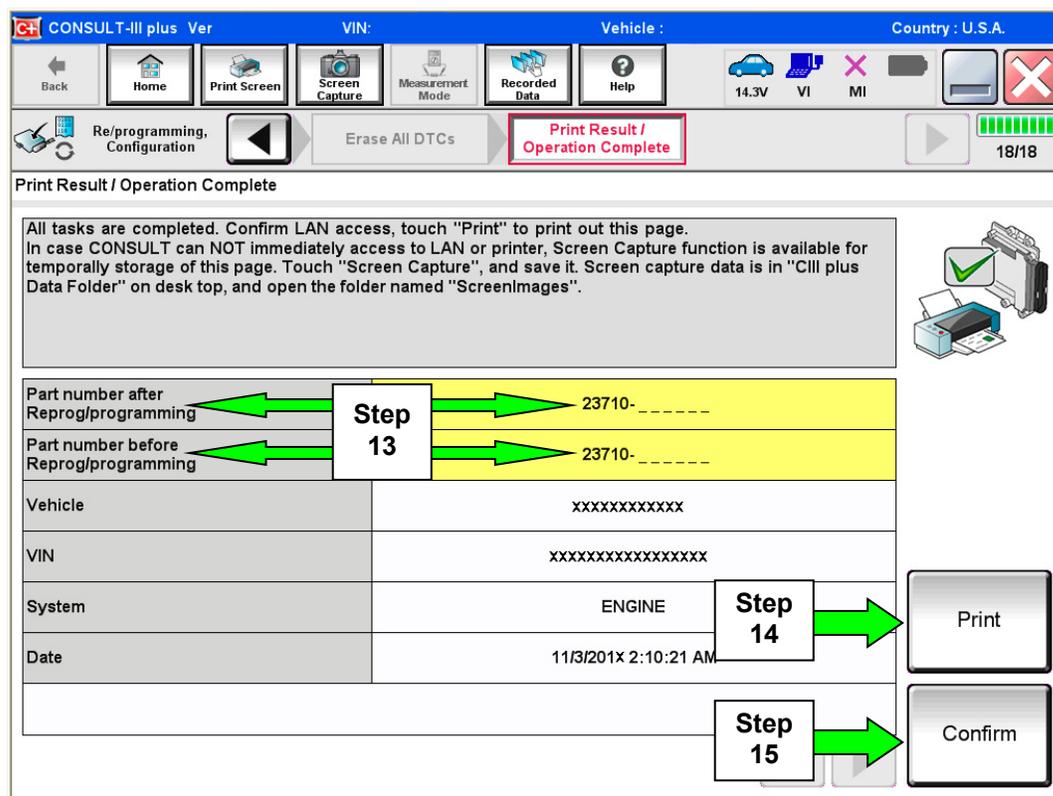
12. When the entire reprogramming process is complete, the screen in Figure 8 will display.
13. Verify the before and after part numbers are different.
14. Print a copy of this screen (Figure 8) and attach it to the repair order for warranty documentation.
15. Select **Confirm**.
