SERVICE BULLETIN

Classification: EL15-006p	Reference: NTB15-049p	Date: August 3, 2018
-------------------------------------	---------------------------------	--------------------------------

TELEMATICS SERVICE INFORMATION

- APPLIED VEHICLES:**
- 2016-2018 Altima (L33) – **SL with Technology Package**
 - 2018 Armada (Y62)
 - 2017-2018 GT-R (R35)
 - 2018 LEAF (ZE1)
 - 2016-2018 Maxima (A36) – **Platinum**
 - 2017-2018 Murano (Z52) – **Platinum**
 - 2017 Pathfinder (R52) – **SV and Platinum, SL with Tech Package, SL with Premium Package**
 - 2018 Pathfinder (R52) – **SL and Platinum, SV with Tech Package**
 - 2016-2018 Rogue (T32) – **SL**
 - 2017-2018 Rogue Hybrid (T32) – **SL**
 - 2017-2018 Rogue Sport (J11) – **SL and SV with Premium Package**
 - 2016-2018 Sentra (B17) – **SR and SL with Tech Package**
 - 2016-2018 Titan/Titan XD (A61) – **SL and Platinum, Pro-4X with Convenience Package**

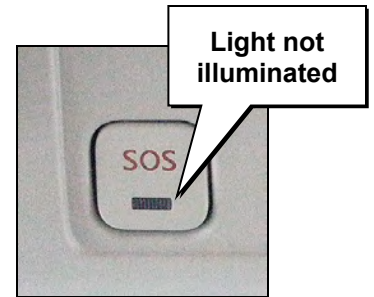
Figure 1a

1. With the vehicle in an area of known good reception, turn the ignition ON and check whether or not the green light on the SOS button is illuminated (see Figure 1a).

- If the green light **is** illuminated, the process to turn ON the TCU is complete and no further action is needed.
- If the green light **is not illuminated**, go to **Turn ON TCU** on the next page.

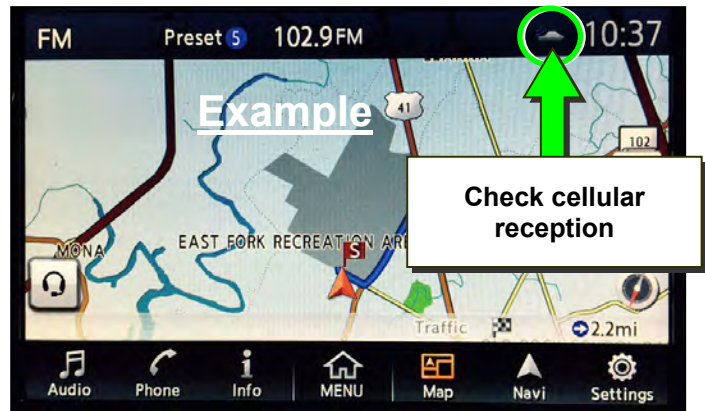
Figure 1c

1. Check TCU cellular reception.

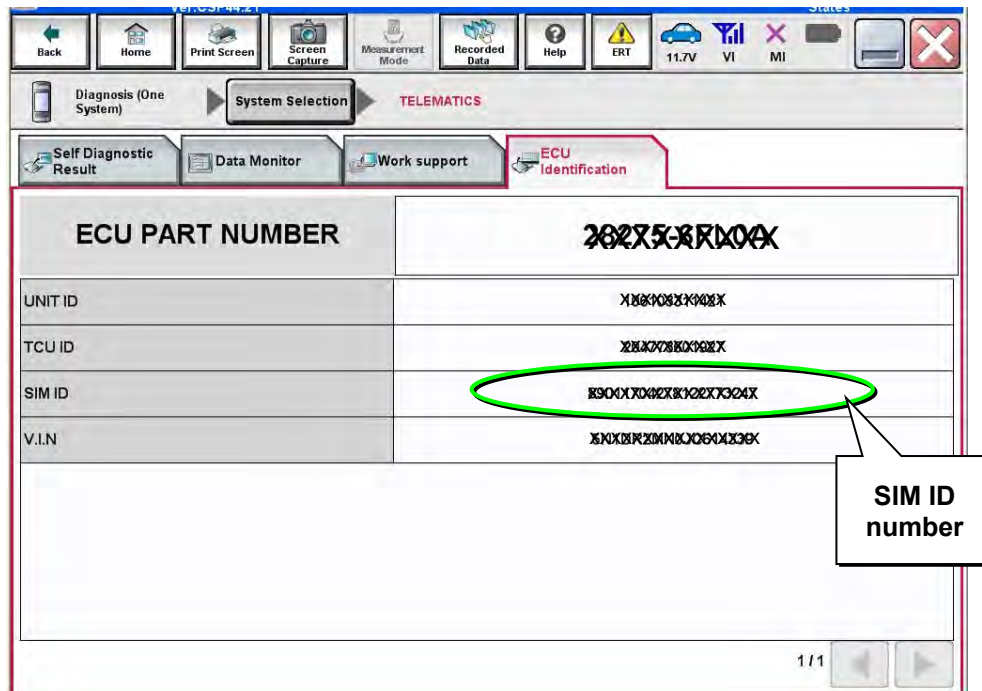
Figure 7d

b. Locate the SIM ID number and write it on the repair order as “Original SIM ID”.

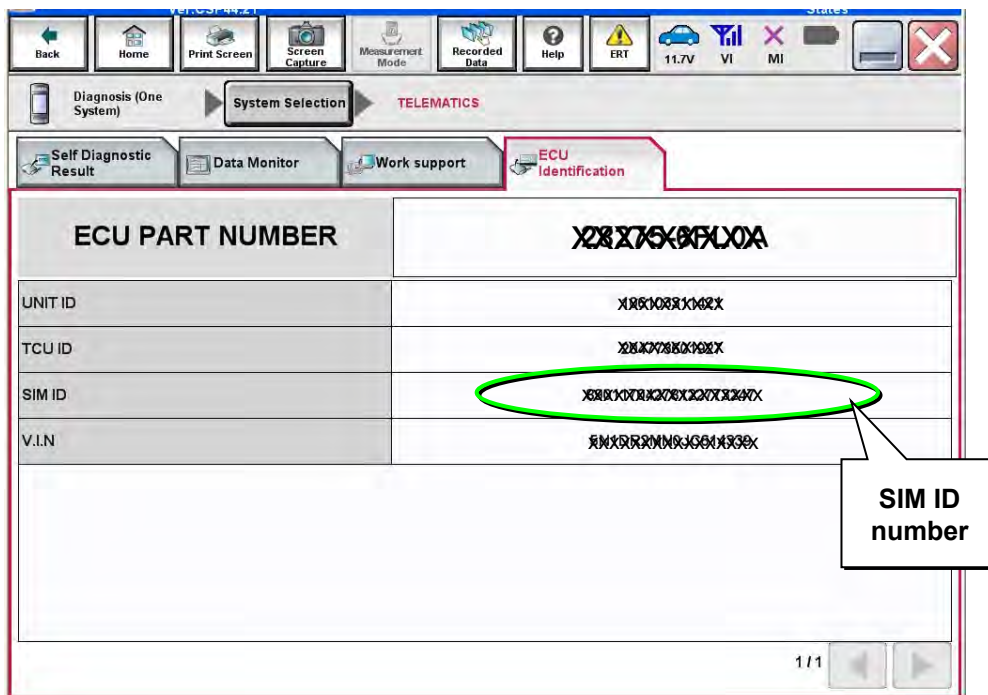
Figure 12d

* For Rogue Sport and Armada vehicles, Manual TCU Configuration is needed only if the TCU ID number (see Figure 12d) begins with “2047”.

* For Rogue Sport vehicles, Intelligent Key Registration is needed only if the TCU ID number (see Figure 12d) begins with “2047”.
