SERVICE BULLETIN

Classification: EL17-008a	Reference: NTB17-097a	Date: August 29, 2018
-------------------------------------	---------------------------------	---------------------------------

2016-2018 ROGUE AND 2017-2018 ROGUE SPORT; WHISTLE NOISE TRANSMITTED TO CALL RECIPIENT WHEN USING BLUETOOTH HANDS-FREE PHONE SYSTEM

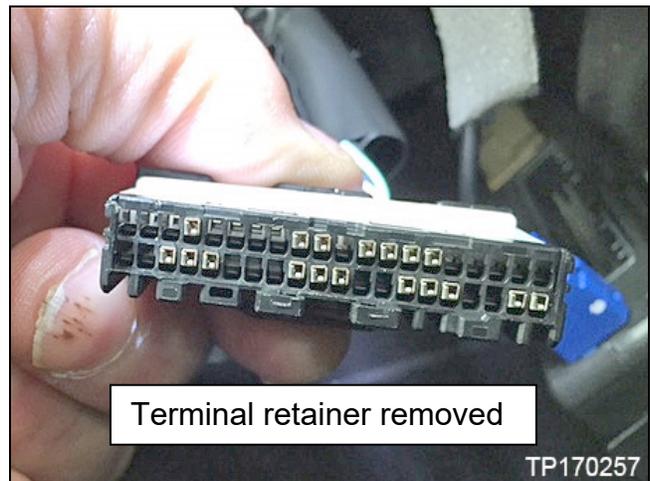
- Figure 5 shown without the front terminal retainer.

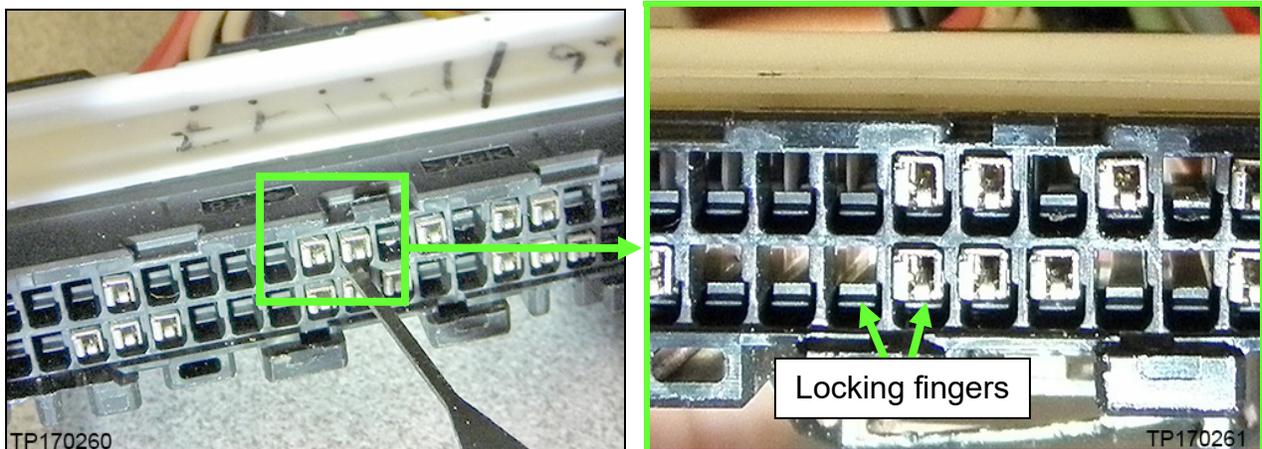
Figure 9

IMPORTANT: Locking fingers are fragile.

- Press down on locking fingers (Figure 9) to release each terminal.

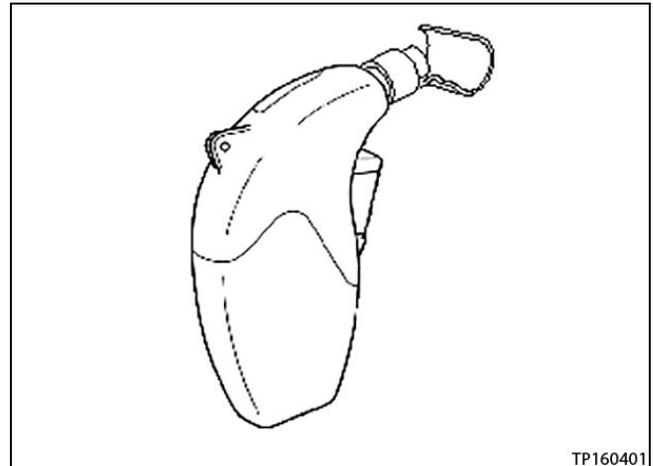
CAUTION: For the next step, do not use an electric type soldering tool. An electric type soldering tool may generate a current that may damage the ECU.

11. “Install” the solder sleeve connector by shrinking it to the wire with essential tool Flameless Heat Gun J-46538 or similar flameless heating tool (see Figure 12 and 13).

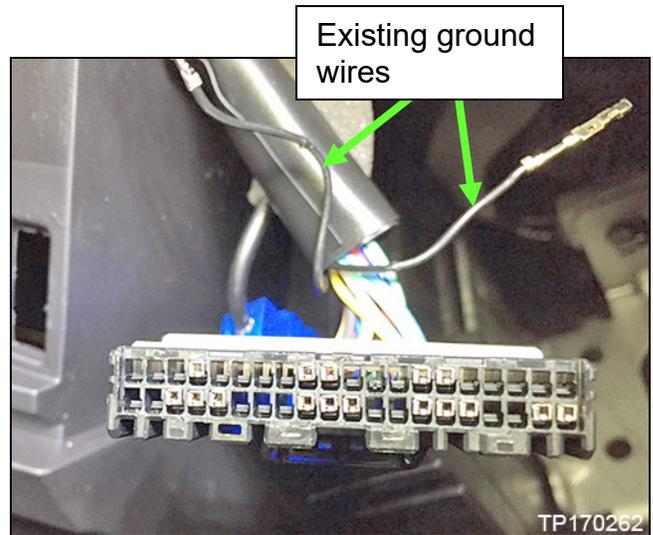
- Figure 22 shows the existing ground wires removed.

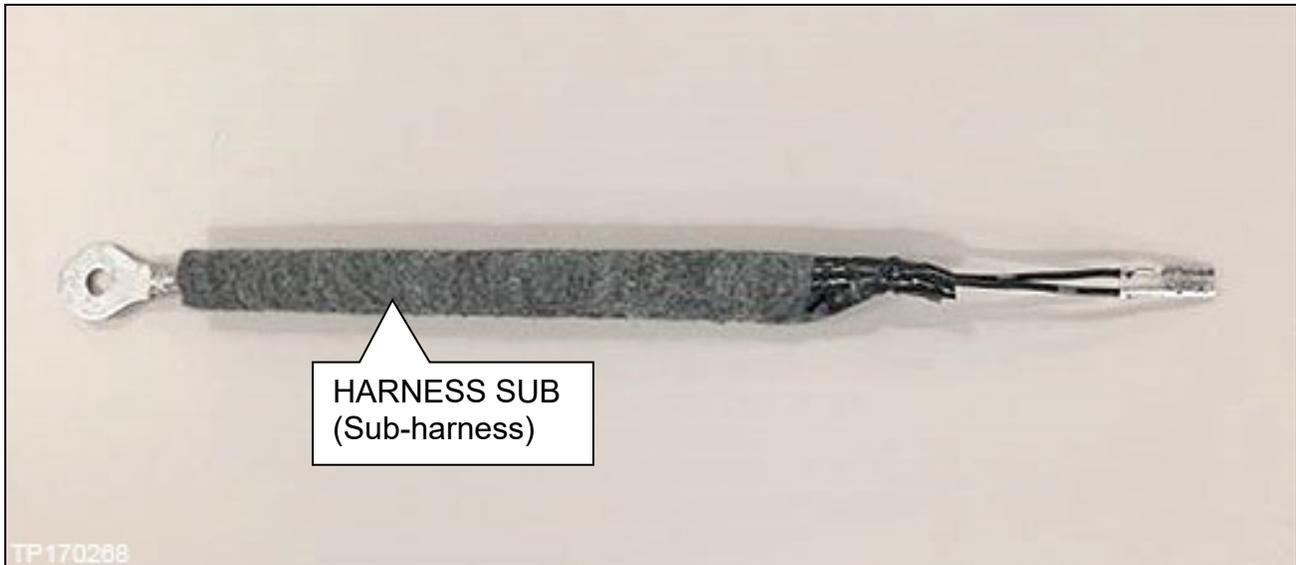
- Figure 29 shows sub-harness.
