# Technical Service Bulletin

## 91 SOS warning displayed in instrument cluster, DTC B191604

91 18 02 2051664/1 June 26, 2018.

Model(s)	Year	VIN Range	Vehicle-Specific Equipment
A4, A5, Q5, and Q7	2018 - 2019	All	With connected gateway

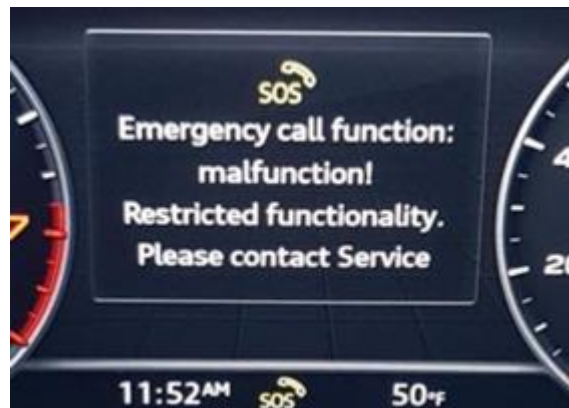
- A warning message appears on the instrument cluster. The message reads “Emergency call function: malfunction! Restricted functionality. Please contact Service” (Figure 1).

*Figure 1. Warning message shown in instrument cluster.*

- DTC B191604** (Backup battery Faulty).

Incorrect software parameter for the connected Gateway’s back-up battery charge monitoring. The system must be reset by performing a manual discharge of the connected Gateway’s backup-battery.

1. Perform a manual discharge of the connected gateway's back-up battery by removing constant power (KL30) and accessory power (KL15), while KL15 is switched on.

In the event that fault does not clear, and is marked as Active, then replace the connected gateway's backup battery. Consult the repair manual for instructions on replacing the connected gateway's backup battery. Consult the parts catalog for the correct part number of the connected gateway's backup battery.

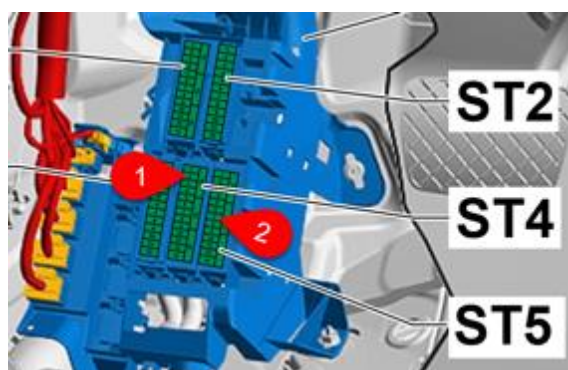
**Figure 2.** Q7 Driver's Side Footwell Fuse Box. 1: KL15 Fuse. 2: KL30 Fuse.

2. Gain access to fuse panel SB, located behind the driver's side footwell cover. Consult the repair manual for instructions on accessing fuse panel SB.
3. Locate the two fuses which supply constant power (KL30) and accessory power (KL15) to the connected gateway. Consult the wiring diagram, or owner's manual for fuse location and size.
4. Ensure that accessory power (KL15) is ON.
5. Remove the two fuses identified in Step 3.
6. Wait 30 seconds with both fuses removed.
7. Reinstall the two fuses.
8. Turn off accessory power (KL15).
9. Repeat steps 4 through 8 **six** additional times. This will result in a total of seven discharge cycles.
10. Following seven discharge cycles, clear the fault memory of the connected gateway module:
  - In ODIS GFF, recheck the fault memory of the connected gateway.
  - The fault should now be static and should not return after clearing the fault memory.

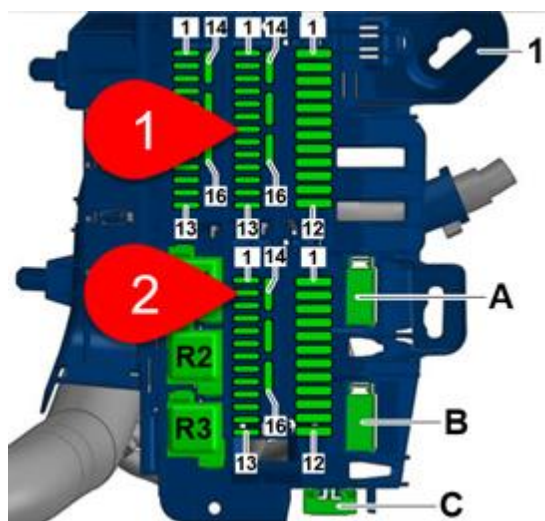
**Figure 3.** A4, A5, and Q5 Driver's Side Footwell Fuse Box. 1: KL30 Fuse. 2: KL15 Fuse.
