# Vantage Mobility International

## Inspection for Proper Torque on L-Track

Document Number: TS-WI-0290

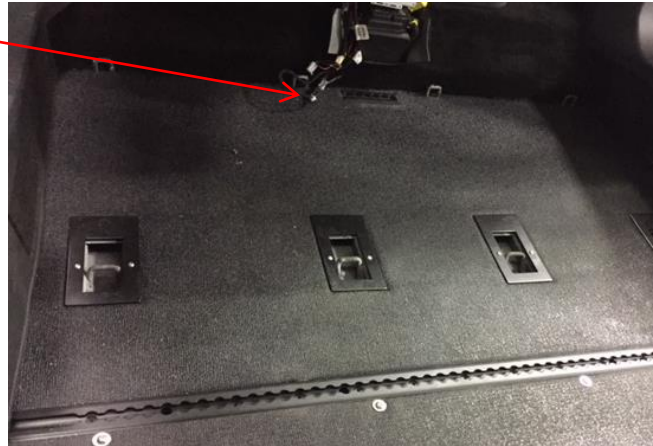
The possibility of L-track tie down bolts loosening up over time has been discovered through VMI continuous improvement efforts. Testing and inspection efforts show that the average amount of movement is less than ¼ turn. Because of this finding, VMI tested the ability of the L-track to effectively secure a wheel chair. Testing has shown that bolts that had backed out over twice that distance did not impact the L-tracks holding a wheelchair securely. This Bulletin is being published to ensure the vehicle is maintained to factory approved torque specifications

If necessary, remove front seats to gain access to the front L-Tracks (see picture for example)

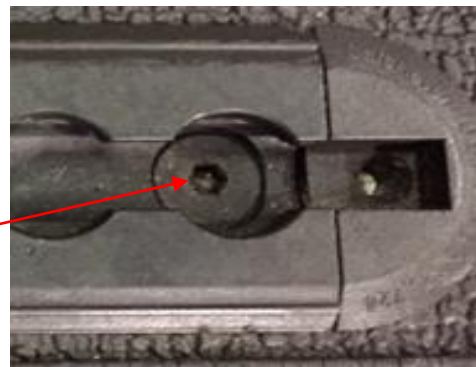
***If the bolt heads are not clean and free of debris, the hex socket may not engage completely. This may result in stripped heads and improper torque readings.***

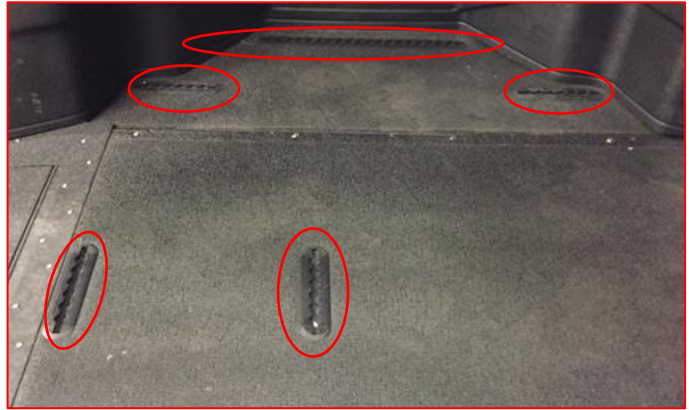
\*\*\*NOTE in many cases the bolt will not move. This will signify that the bolt is still set to the required 9 ft/lbs.

**Set the torque wrench for 9 ft/lb.**

Beginning in the rear of the vehicle insert the 3/16 hex socket into each bolt head in every piece of L-Track and turn clockwise until the bolt is tightened to specification. (see example of L-Track placement)
