DOC #	PROCESS NAME	PAGE	REVISION	STATION	BY	DATE
AR860	Front Pivot Mount Inspection and Repair	1 OF 2		SER-E	C.WARD	8/2/2018

Complaint: Pivot Mount Bolts having repeated premature failure

Cause: Spring Pivot Bolt movement allowed by elongated mounting hole

Correction: Inspect/replace bolt

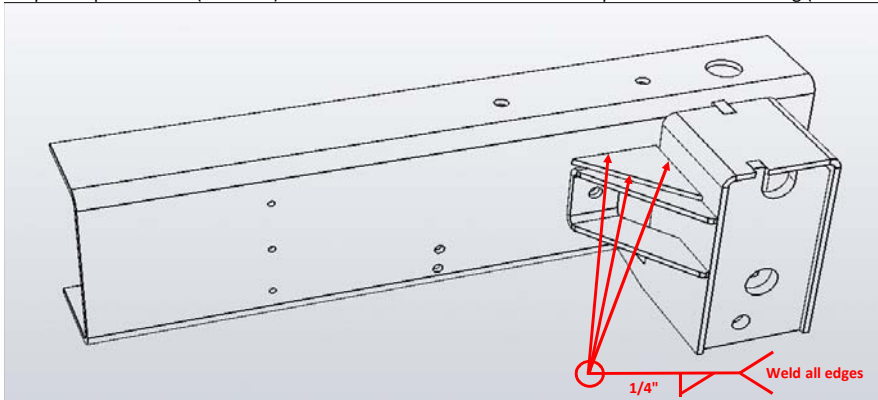
Step 3: Inspect Gusset (1310070) to ensure it has been welded to the top side of the bracket leg (forward side) and all edges per illustration below

Step 5: Install new bracket by following welding guidelines supplied in step 3 & 4 in the inspection process

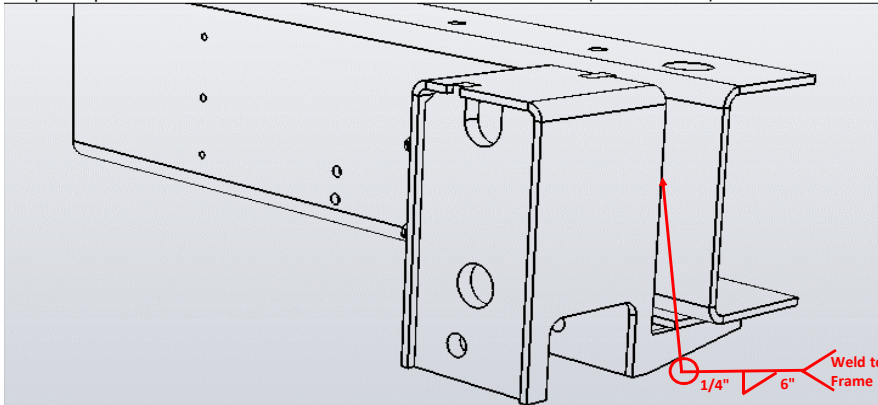
Step 4: Inspect bracket to ensure it has been welded to chassis frame (rearward side)

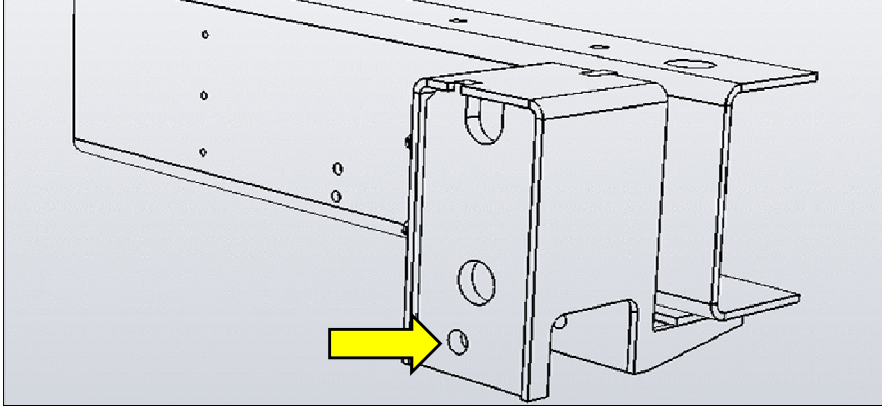
Step 6: Inspect mounting hole and ensure hole has not been elongated

Step 1: Lift the Z-Spring back into place and install new bolt (torque = 315 FT/LBS).

Step 2: Remove Bracket by cutting welds and removing three 1/2-13 bolts (discard)

Step 6: Lift the Z-Spring back into place and install new bolt (torque = 315 FT/LBS).
