SERVICE BULLETIN

APPLICABILITY: 2015-2018MY WRX and WRX STI **NUMBER:** 07-139-18R
SUBJECT: LED Headlamp Deformation -Design Change **DATE:** 08/09/18
REVISED: 08/24/18

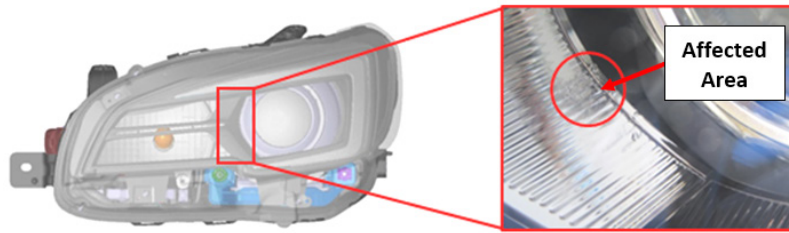
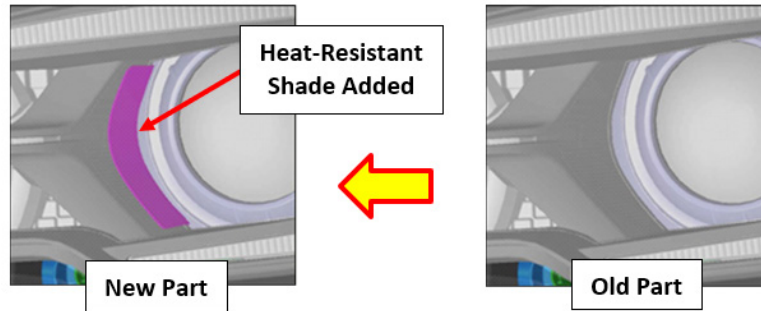
This bulletin outlines a design change made to the inner lens extension portion of the LED headlamp assembly. Under the right conditions, the shape of the lens for the actual head lamp light source can cause sunlight to be focused onto the extension portion of the lens resulting in deformation. A heat-resistant shade has been added to protect the affected area.

The images below show the affected area of the lens where the deformation can occur along with a comparison between the new style lamp with the shade added and the original.

IMPORTANT: When either headlamp is confirmed to have the described condition, BOTH left and right must be replaced as a set.
