SERVICE INFORMATION BULLETIN

APPLICABILITY: NUMBER: 12-248-18 2017-2018MY Legacy

SUBJECT: Trunk Hinge Flange Bolt Change **DATE:** 08-09-18

Bulletin Number: 12-248-18; Date: 08/09/18

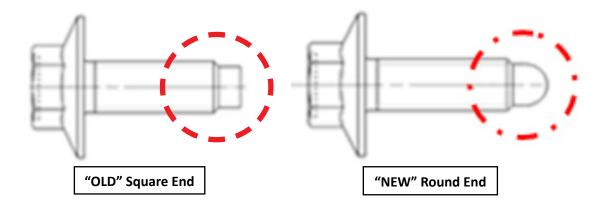
This Service Information bulletin announces a change made to the trunk hinge mounting bolts. The threaded end of the new flange bolts has been changed to a round type instead of square to prevent getting caught on items as they are loaded into and out of the trunk.

The part number for the new flange bolts is: 901000458.
